# 08 ARAB SARAI GATEWAY

# 05 Arab Serai Gateway

This 48' high gateway served as the southern entrance of the Arab Serai - built to accommodate the 300 Persian craftsmen whom Hamida Banu Begum, had brought with her on her return from pilgrimage to Mecca. These craftsmen were involved in the building of Humayun's Garden-Tomb. The integrity of the whole complex is now disturbed as the major portion of the Arab Serai is today the Industrial Training Institute and is inaccessible to visitors. Over the last century the portions of this lofty gateway had collapsed including the domed entrance chamber thus severely compromising the structural stability of the remaining structure like front façade, portions on the upper levels etc. The collapsed portions of the gateway suggest that half of the entrance chamber was not able to bear the load of the dome which should be uniformly transferred to the piers. Conservation works includes conservation of the main wooden doorway, conservation of the Stone façade, reconstruction of the partially collapsed entrance chamber, conservation of the chambers at ground floor, reconstruction of the upper chambers and providing adequate flooring.

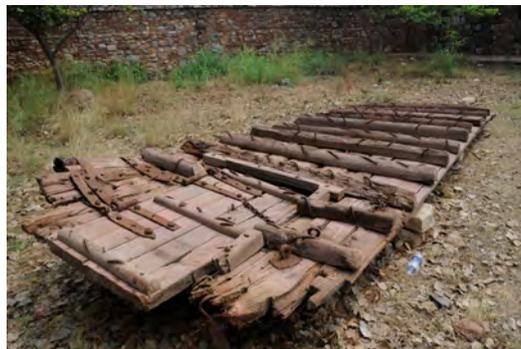
- This original wooden door had suffered structural failure and deterioration due to dampness and inadequate maintenance over the years.
- Since wood is hygroscopic in nature, its unprotected surface tends to absorb moisture and to swell during humid and rainy weather, and to lose moisture and shrink in periods of dry weather. This has led to the change in dimensions which eventually resulted in the gaps between the planks. This significantly disfigured the functionality of the doorway.

- Also portions of the gateway suffered weathering which has changed the colour of the wood into silver grey. However, as the weathering continues, the wood fibers become partially loosened and if weathering is permitted to proceed further, the surface develops larger and deeper gaps, which become visible. This, combined with the abrasive effect of rain, wind-borne particles, etc. caused the wearing of the surface layers and a roughened appearance of the surface.

(Top) The original wooden door had suffered weathering, dampness and deterioration due to inadequate maintenance over the years;

- The doors were taken down and wooden members were assessed in detail to check the condition. The wooden doors were then repaired by replacing decayed wooden members with new members as per original material, sectional specifications etc.

- All the loosely fitted members were tightened to maintain full bearings.
- All new and old wooden members were then treated with double boiled linseed oil.

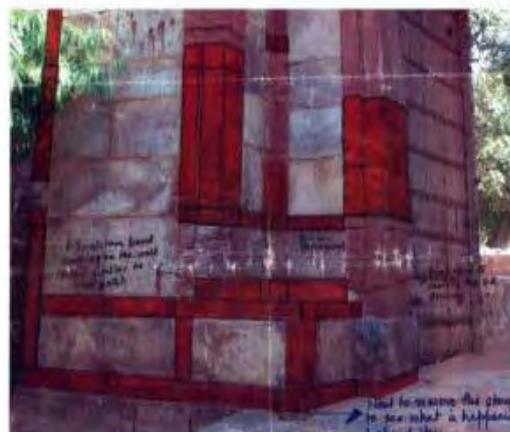
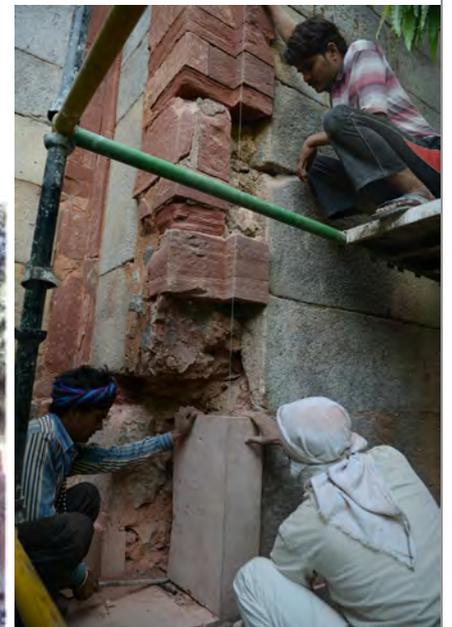
- The major defects identified are de-lamination, erosion and splitting of the stone members. At other places the stones are replaced to ensure long term preservation by replacing damaged stones or those used inappropriately in 20<sup>th</sup> century repairs. Stones which are replaced are mainly severely decayed stones which are beyond repair, single stones replaced with multiple stones and inappropriately repaired stones such as wrong sectional specifications and material.

- A minor proportion of stones, under 5% of the total stones are proposed to be replaced with new stone as these stones were considered to be beyond repair. Furthermore most of these stones replaced in the late 20<sup>th</sup> century by inappropriate sized pieces.

(Above) Degeneration of stone at various points in the facade (Right) Condition assessment of the facade prior to stone replacement process (Extreme Right) Conservation of the facade by matching stone in all its geological and sectional composition to the original

- The 19<sup>th</sup> century repairs done in *lakhori* brick are kept intact as a layer of history showing the historic repairs.
- The hard cement mortar was raked out and was replaced with lime mortar pointing.

- Rusted iron clamps binding the sandstone to underlying masonry were replaced with new stainless steel clamps.
- Following a stone-by-stone documentation, stones have been replaced on the lower part of the façade.

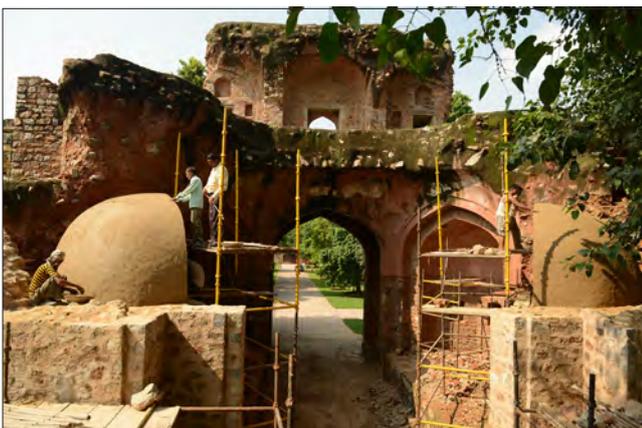
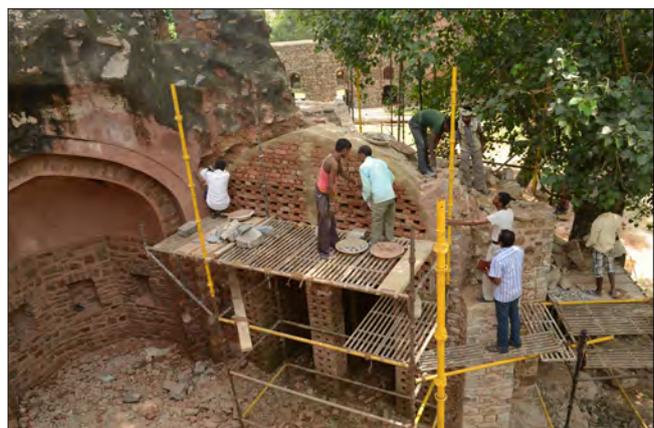
- Over the last century the portions of this lofty gateway had collapsed including the domed entrance chamber thus severely compromising the structural stability of the remaining standing structure.

*(Below) Reconstruction of the partially collapsed entrance chamber as per existing alcove's design and profile using traditional materials and techniques*

- The collapsed two arched alcoves are reconstructed as per existing alcove's design and profile using traditional materials and techniques.
- Clearance of earth was carried out to expose the original foundation of the collapsed wall of the south façade. Missing masonry wall was reconstructed over the original foundation using similar materials and construction techniques.

- The missing arch of the south façade is reconstructed to match the northern arch.
- The two missing arched alcoves on the east and west sides are reconstructed as per existing two alcoves on the same façades. Existing profile of the alcoves were traced and transferred to the new construction to maintain the original architectural detail.

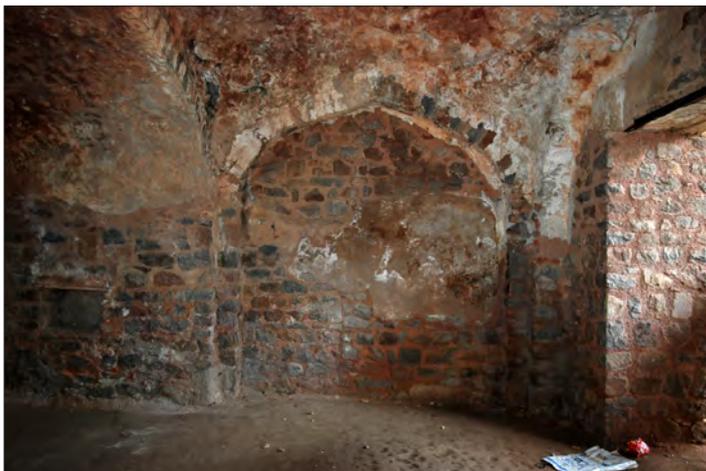
- The arched chambers on both the sides of the entrance chamber were in extremely dilapidated condition posing a great threat to the structure above.
- The external arched chambers had collapsed over the years due to a combination of vegetation damage, neglect, and structural failure.

(Left) Condition of chambers prior to the conservation works

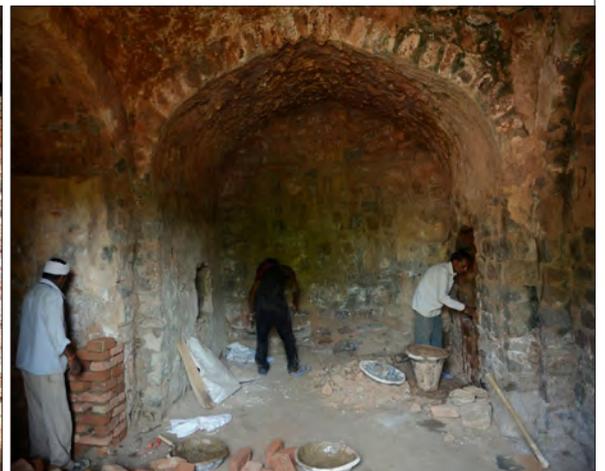
(Right) Internal chamber during conservation works

- The wall surfaces were cleaned to remove later repair-works and other deposits. The cement and dead pointing works were raked out and replaced with lime mortar. The consolidation of the existing masonry was done using the lime based grouting.

- The structural repairs include stitching of the cracks, grouting and anchoring took place.
- The inappropriate past preservation works on the southern façade was carefully dismantled followed by reconstructing the arched profiles on each of the six bays. The wall surfaces were built on the original foundations that required to be strengthened by grouting of lime mortar.

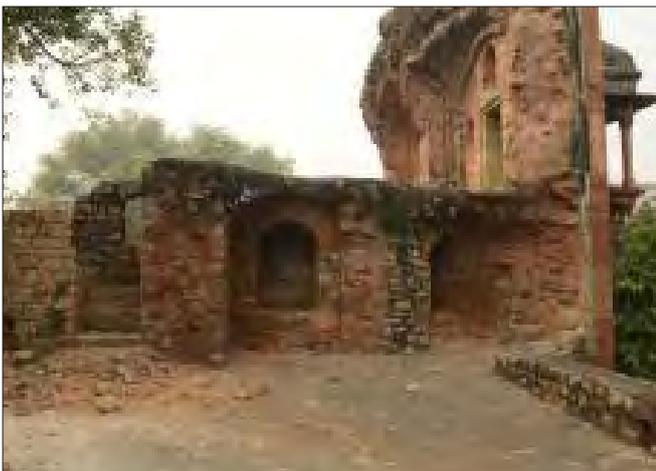
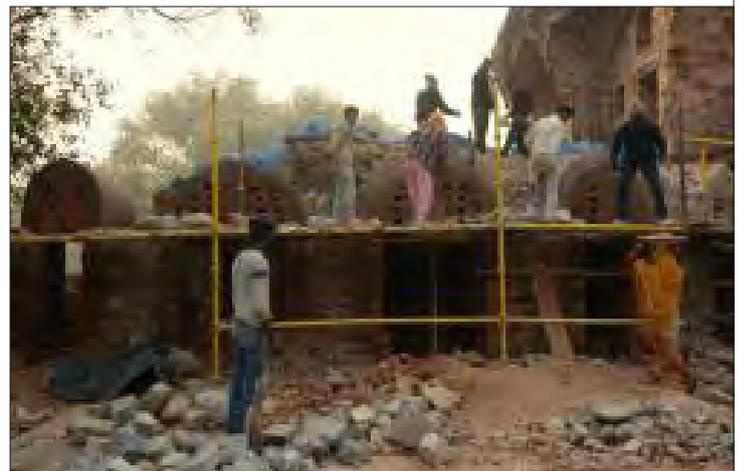
*The structure on the second and third floor levels had almost completely disintegrating thus all supports to the ornamental facade were lost. Conservation works on the upper chambers have aimed at restoring support and structurally tying the facade to the chambers here.*

*(Left) Image showing collapsed vaulted chambers  
(Right) Vaulted Chambers after the conservation works*

- Partially collapsed chambers would be completed to the extent that it provides structural stability to the monument as well as to revive the lost architectural integrity of the monument.

- The existing staircase, arches, walls etc. have been conserved. The construction of parapet is complete.
- The terracing works on both the levels will require complete removal of cement concrete and laying a traditional lime concrete terracing to original slope.

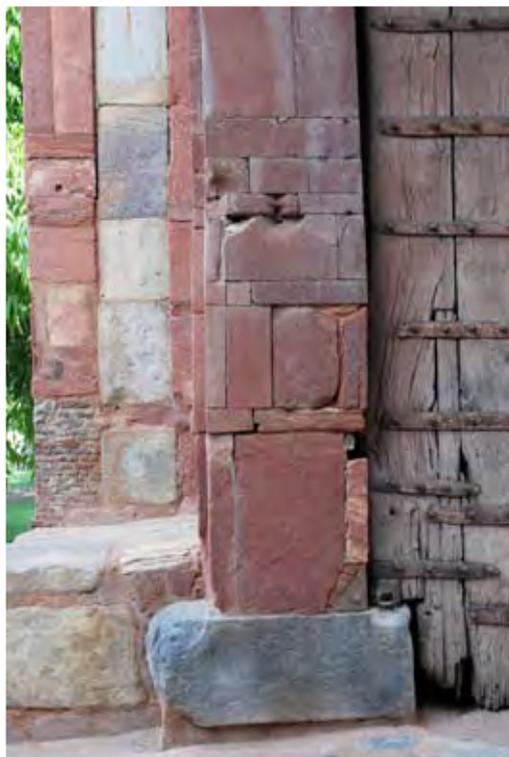
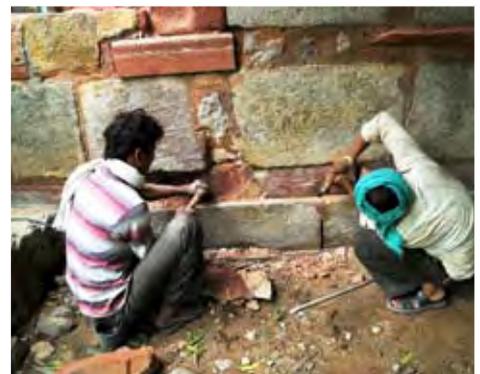
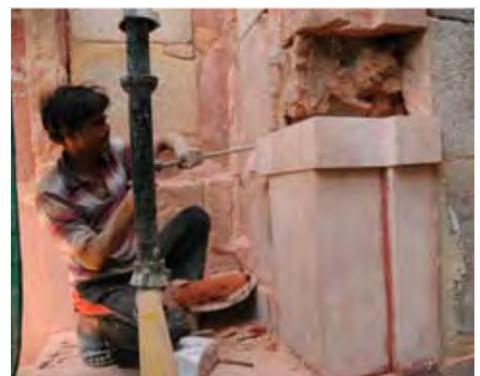
- The major defects identified are de-lamination, erosion and splitting of the stone members. At other places the stones are replaced to ensure long term preservation by replacing damaged stones or those used inappropriately in twentieth century repairs. Stones which are replaced are mainly severely decayed stones which were beyond repair, single stones replaced with multiple stones and inappropriately repaired stones such as wrong sectional specifications and material.

*(Right) Following a stone-by-stone documentation, decayed sandstone was replaced by new stone pieces by carefully matching the original.*

- The hard cement mortar was raked out and was replaced with lime mortar pointing.
- Rusted iron clamps binding the sandstone to underlying masonry were replaced with new stainless steel clamps.

- Following a stone-by-stone documentation, stones have been replaced on the lower part of the façade.
- Stone replacement is now complete. The conservation works including cleaning, stone replacement, restoration of tiles and lime plastering is also complete on the projected *jharokhas*.

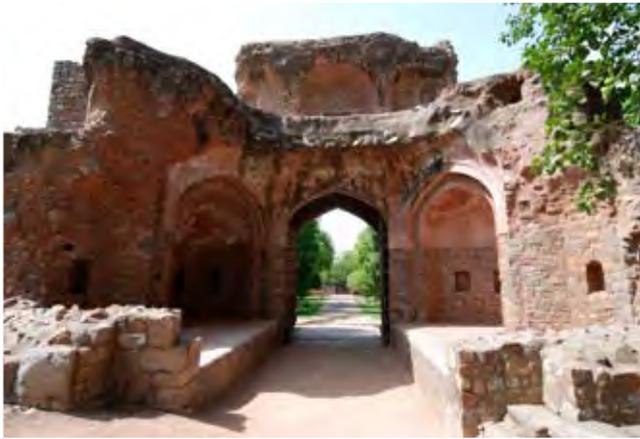
*(Above) Over the last century the portions of this lofty gateway had collapsed including the domed entrance chamber thus severely compromising the structural stability of the remaining structure like front façade, portions on the upper levels etc. The façade was recorded to be dangerously tilting.*

- The tall façade was found to have a significant tilt – leaning outwards – and possibly on the verge of collapse as has occurred in the Sher Shah Gateway west of Purana Qila. It was thus considered necessary to reconstruct some of the collapsed portions to tie the façade back into the masonry.

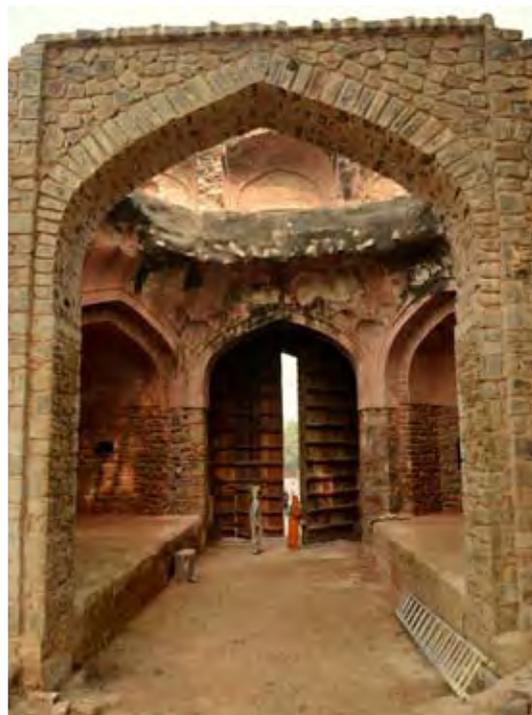
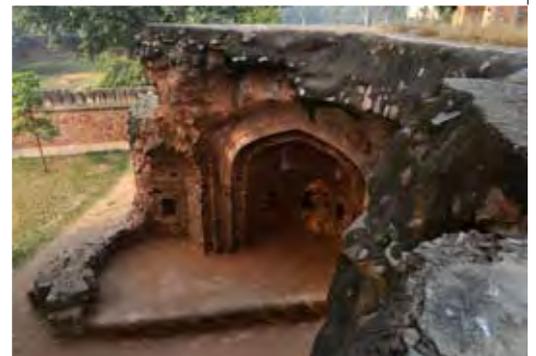
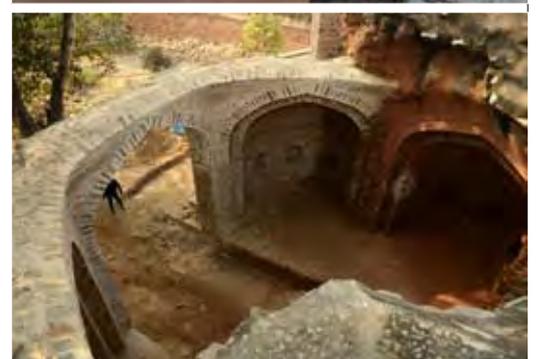
*(Right) The east and west sides are reconstructed as per existing two alcoves on the same façades. Existing profile of the alcoves and transferred to the new construction to maintain the original architectural detail.*

- The missing arch of the south façade is reconstructed to match the northern arch.
- The two missing arched alcoves on the east and west sides are reconstructed as per existing two alcoves on the same façades. Existing profile of the alcoves were traced and transferred to the new construction to maintain the original architectural detail.

- The existing alcoves are also repaired including removal of the cement plaster and other cement works. Layers of cement and inappropriate repair works are dismantled carefully. Also the arches are lime plastered as per original profiles and shapes.

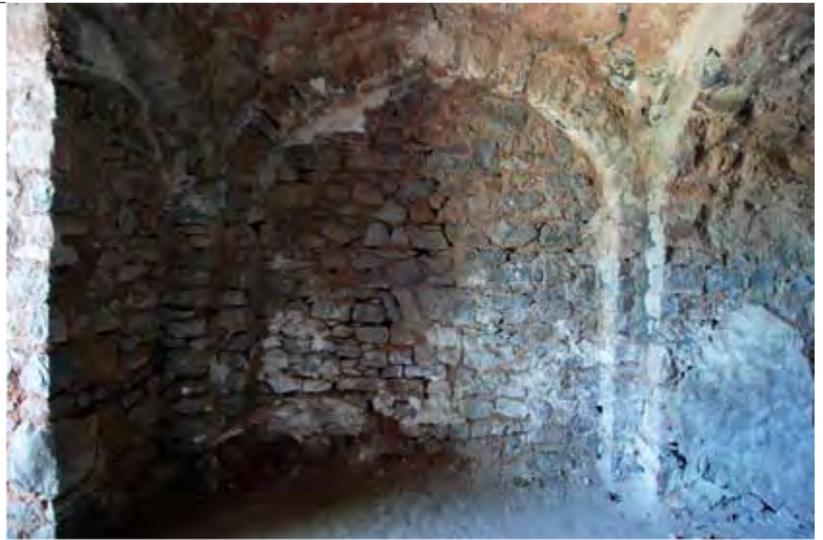
- The arched chambers on both the sides of the entrance chamber were in extremely dilapidated condition posing a great threat to the structure above.
- The external arched chambers had collapsed over the years due to a combination of vegetation damage, neglect, and structural failure.

*(Above) All chambers on the eastern and western side of the main gateway were in various states of collapse; (Right Top) Architectural documentation of the Gateway*

- The wall surfaces were cleaned to remove later repair-works and other deposits. The cement and dead pointing works were raked out and replaced with lime mortar. The consolidation of the existing masonry was done using the lime based grouting.

- The structural repairs include stitching of the cracks, grouting and anchoring took place.
- The inappropriate past preservation works on the southern façade was carefully dismantled followed by reconstructing the arched profiles on each of the six bays. The wall surfaces were built on the original foundations that required to be strengthened by grouting of lime mortar.

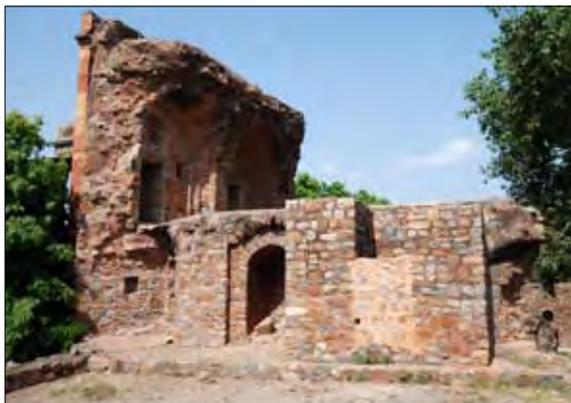
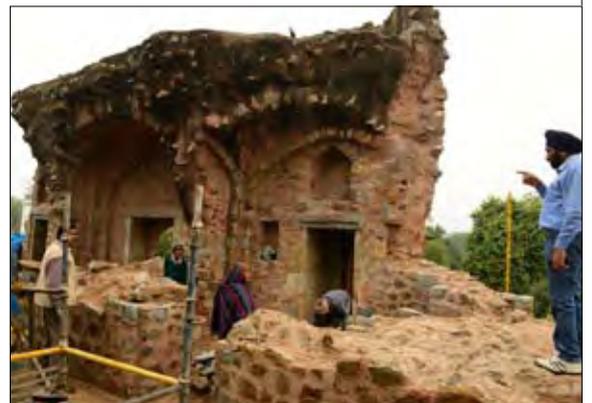
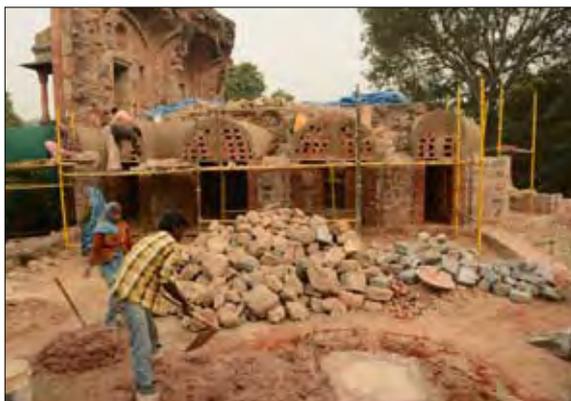
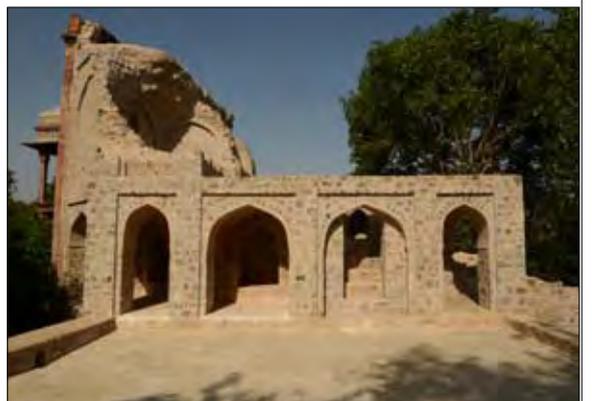
*Due to the collapse of portions of the gateway, its top member had become structurally unstable. With the chajja tilting on the facade, this would have resulted in toppling of the entire gateway towards the frontal lean. As part of the conservation efforts, when the arcade and chamber was restored (Below) on the upper floor, they also provide much needed additional support and tie-in to the gateway from rear side. Restoring the corner chambers also resulted in the decrease of the slenderness ratio of the structure, lending the Gateway more stability*

- Partially collapsed chambers were completed to the extent that it provides structural stability to the monument as well as to revive the lost architectural integrity of the monument.

- The existing staircase, arches, walls etc. have been conserved. The construction of parapet is complete.
- The terracing works on both the levels required complete removal of cement concrete and laying a traditional lime concrete terracing to original slope.

- The existing remains of the central dome is now repaired to the possible extent as per original construction details and profiles to provide the structural stability to the monument.
