17 BU-HALIMA'S TOMB - GARDEN

Garden Restoration

09 BU-HALIMA GARDEN-TOMB

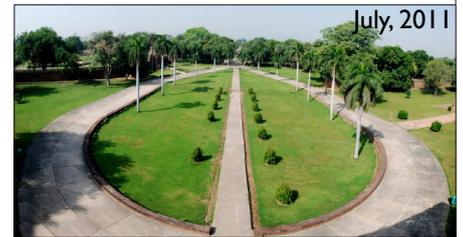
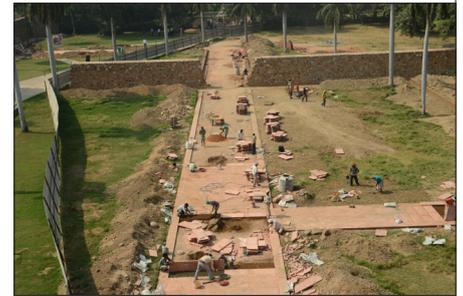
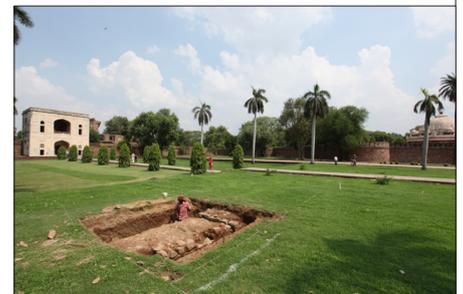
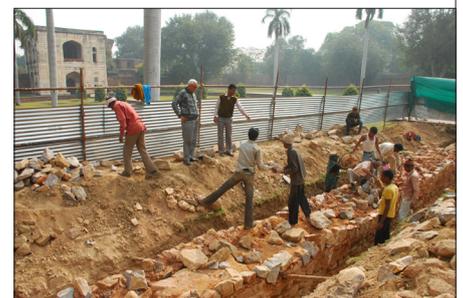
Bu-Halima Tomb - Garden ▲

Bu Halima's tomb garden, also dating from the 16th century, stands abutting Isa Khan's Tomb at the entrance zone of the Humayun's Tomb complex. In the 1920's portions of the enclosure wall were demolished to make a circular roadway thus destroying the character of the enclosure as well as disfiguring the historic character of the site with vast quantities of cement concrete.

Early 20th century British-era carriageway disfigured the historic character of Bu Halima's Tomb - Garden and the entrance zone of the World Heritage Site. Works underway on the landscape and restoration of the enclosure wall

- Clearance of earth revealed the foundations of the demolished portions of walls to be merely 10-15 cm below existing ground levels.
- Random rubble masonry wall was built on the original foundations matching the height of the standing portions of the enclosure wall.

- The 10 m wide cement concrete roadway has been dismantled and a central pathway matching the width of the pathway leading from Bu Halima Gateway to West gateway of Humayun's Tomb has been built in sandstone.

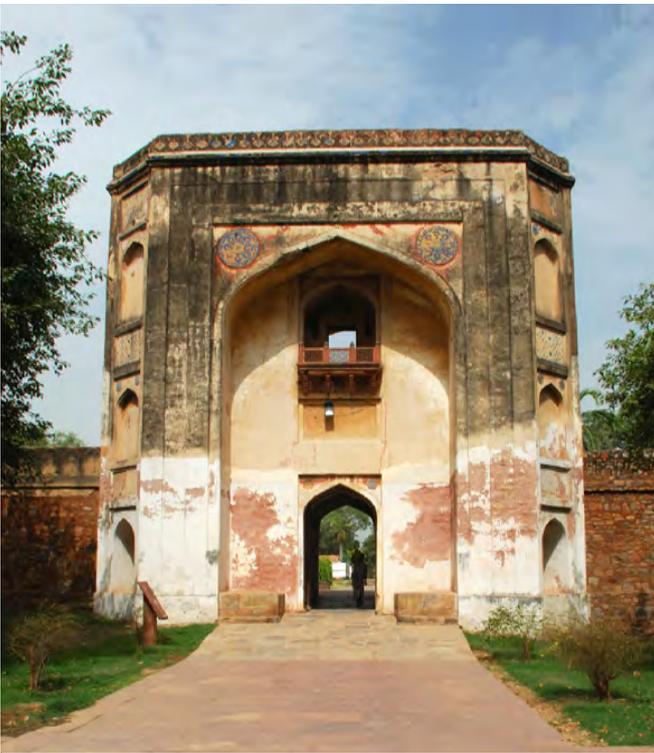
(Above) View of Bu Halima Gateway in 2012 prior to conservation works

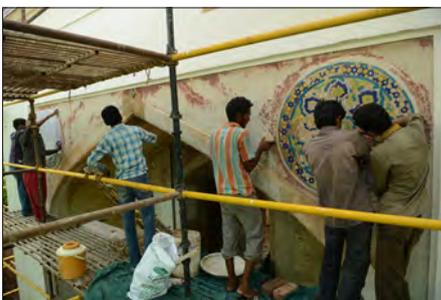
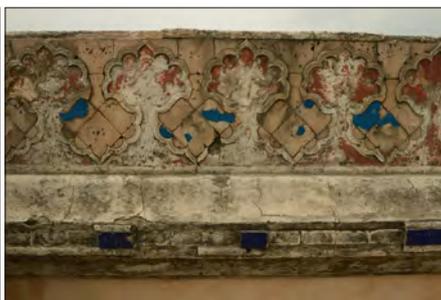
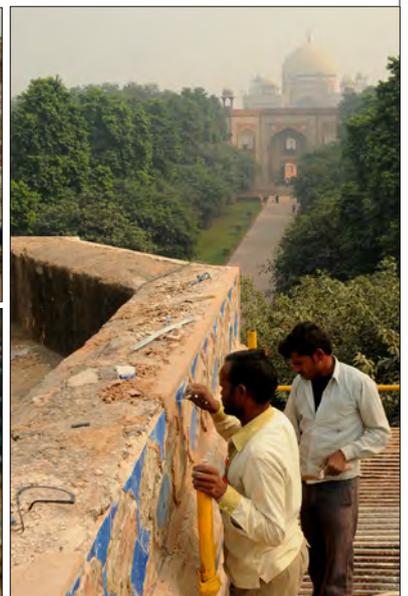
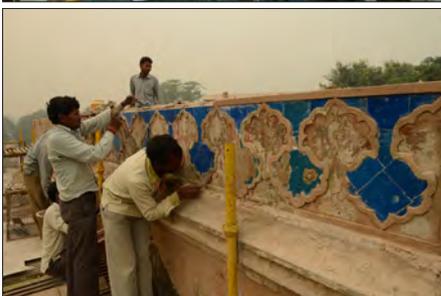
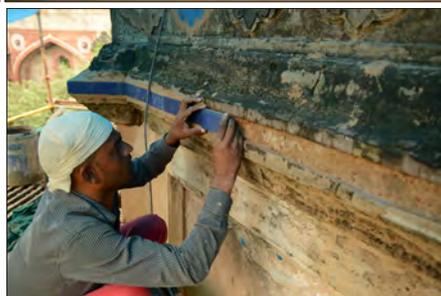
Some portions of the exquisite glazed tile work on the Bu-Halima Gateway were still present on the eastern façade in the form of tiled medallions in the spandrels of the large recessed arch, tile inlay work in the panels of chamfered surfaces and in kangura patterns on the parapet.

(Below) Restoration of the exquisite tilework on the medallion, parapet and spandrel of Bu Halima's Gateway

- The extensive documentation of the tile remains, of the large medallions comprising of small pieces of tiles beautifully put together, were carried out and the shapes and sizes of missing tiles were recorded.
- For missing tiles, new tiles matching the original were then prepared.
- All original tiles were retained, even where these had lost their glaze in continuation of the philosophy agreed upon for the Humayun's Tomb conservation.

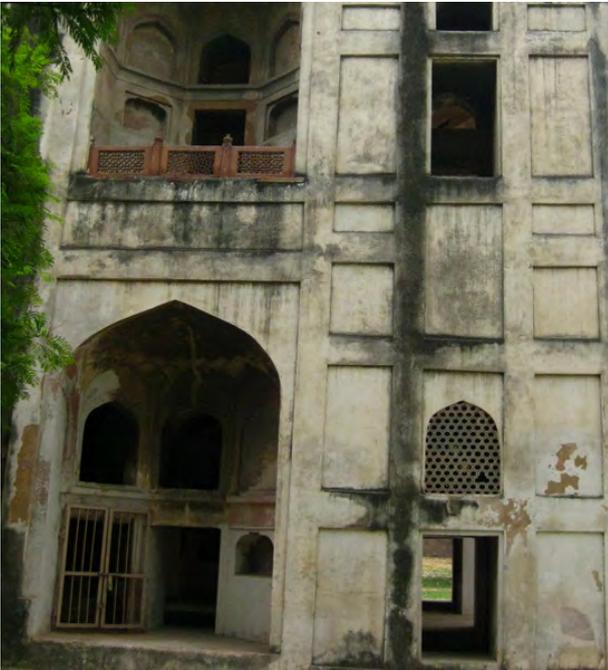
- The plaster on the lower half of the façade was mostly lost and has been re-plastered on at least two occasions since 2001, and plasters using inappropriate modern mixes were used on both occasions thus accelerating the decay process for the lime plaster that remained.

- The new plaster was also found to be peeling off with deterioration caused due to a variety of reasons such as dampness, inappropriate mix, preparation and bonding between adjacent layers.

(Above) On the basis of a careful study, the additional concrete layers has been removed, addressing the serious issues of deteriorations. Master craftsmen used traditional materials, tools and building techniques to undertake conservation works and carefully removing all the cement and other modern plastered portions, on the façade and the interior spaces.

- After allowing the masonry to dry out the portions where modern plaster layers were removed, the surface was re-plastered in lime mortar.
- The roof has a raised platform over the central dome and the remaining portions have, like most other buildings in the complex, been laid with additional layer/s of concrete. The parapet ornamented with the Kangura motif, which had collapsed in portions and poorly rebuilt, are now reconstructed and tiles are laid where they were missing.

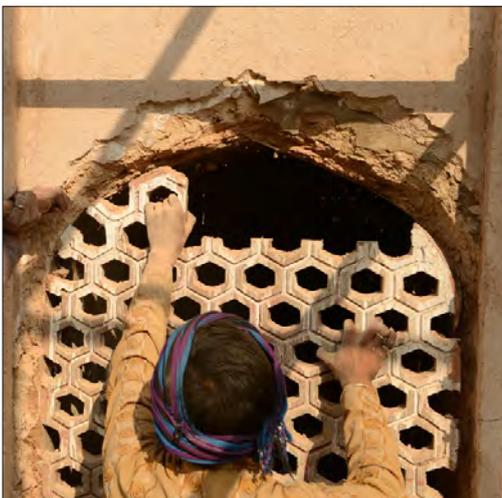
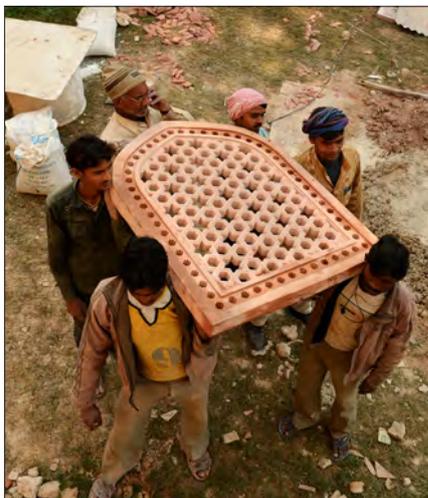
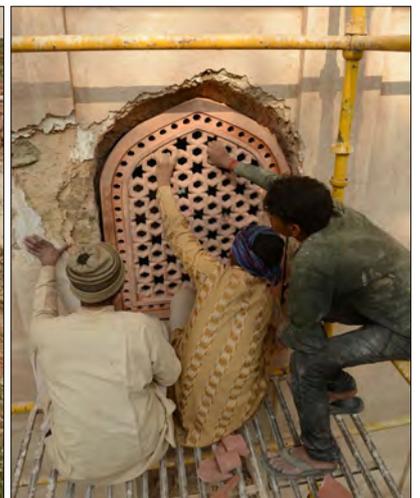
As is visible in archival images, sandstone lattice screens were originally used on the gateway in the arched niches over the doorways and parapets. These screens seem to have been replaced with cement screens (as shown in the image above) on some of the openings and altogether removed from the parapets on the northern and southern sides. The conservation effort aimed at removing cement screens and restoring hand chiselled sandstone screens.

(Above) View of the Gateway before commencement of conservation works; (Below: Left to Right) Removal of cement jaali/lattice screen and installation of sandstone jaali's by the craftsmen

- The careful documentation of all the openings was carried out to determine accurate sizes of all screens required.
- Seventeen lattice screens hand crafted by the master craftsmen are being prepared and seven have already been installed in the arched openings on the lower floor.

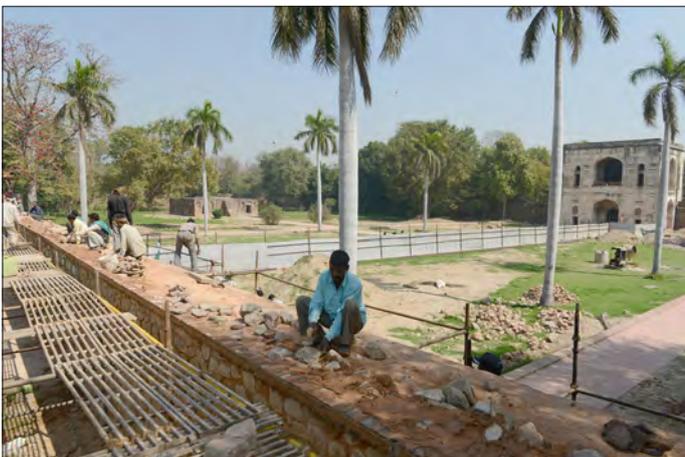
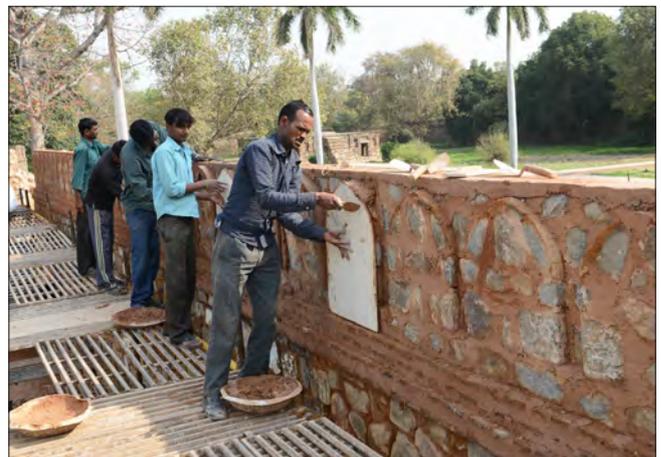
As with Emperor Humayun's Tomb, Bu Halima's Tomb also stands within a walled garden. Almost half of the western side of the enclosure walls (comprising almost 15% of the total length of walls) were however demolished in the early 20th century to make a road. Garden levels have since also been considerably altered leading to the gateway flooring being almost 50 cm lower than the garden on its west leading to immense water-logging, besides altering original relationship.

(Above) Early 20th century British-era carriageway which disfigured the historic character of Bu Halima's Tomb - Garden and the entrance zone of the World Heritage Site has been demolished and original landscape restored

- As part of the landscaping works, the levels of the area on the west of the gateway were lowered to ensure the historically appropriate relationship between the gateway and its settings restored. Retaining walls in brick masonry were erected on the either side to minimise earth removal in view of large trees.
- Planting layout was carried out in the Bu-Halima's Garden Tomb, after the complete reconstruction of the missing wall in 2012. Orchards of peach trees are now grown in the complex.
- Sandstone pathways have been laid in the garden and as plinth protection along the entire internal length of the enclosure wall.

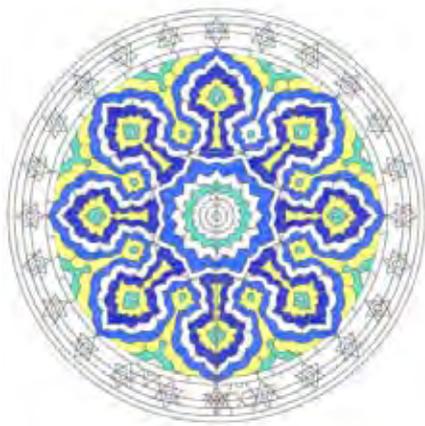
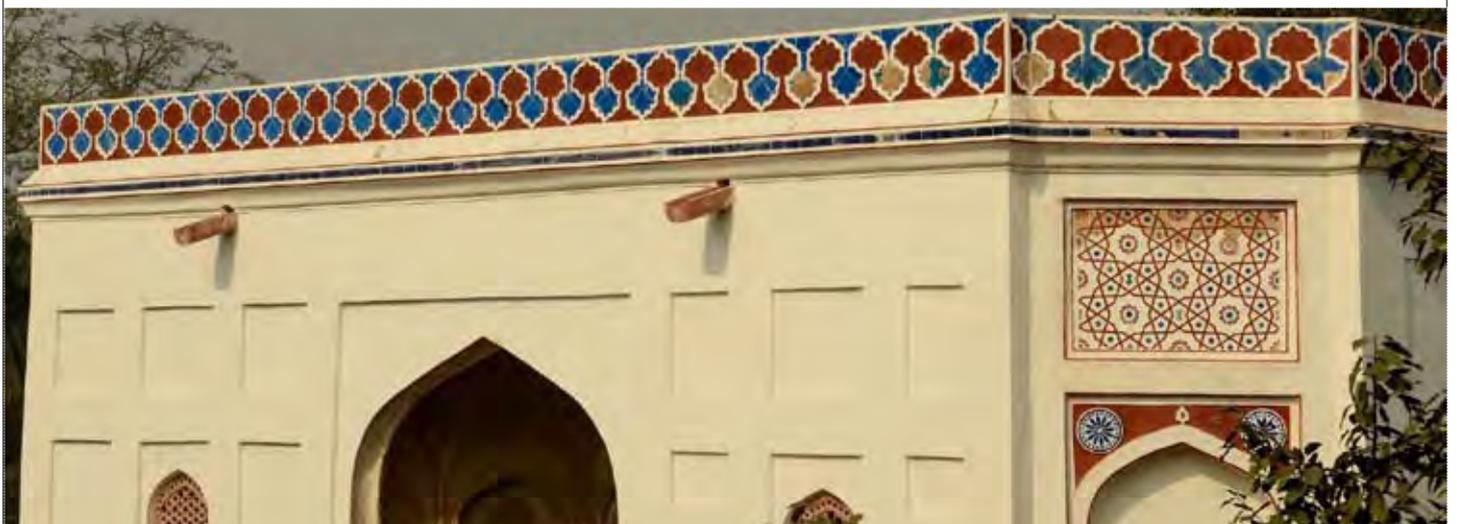
(Above) Tilework and polychromy works at Bu Halima's Gateway suffered deterioration; (Left) Following detailed architectural documentation and condition assesment, tilework, where missing was restored (Below)

- Portions of exquisite glazed tile work on the Bu-Halima Gateway (Above) were still present on the eastern façade in the form of tiled medallions in the spandrels of the central large recessed arch, tile inlay work in the panels of chamfered surfaces and on the parapet.
- The extensive documentation of the tile remains, of the large medallions comprising of small pieces of tiles beautifully put together, were carried out and the shapes and sizes of missing tiles were comprehended.
- The tiles were then prepared using the original materials and techniques.
- The tiles were then arranged in the original position by the craftsmen and now tile restoration work is completed on the Bu-Halima Gateway.
- The spandrels of all the arches and parapet were then finished with the Red polychromy work.

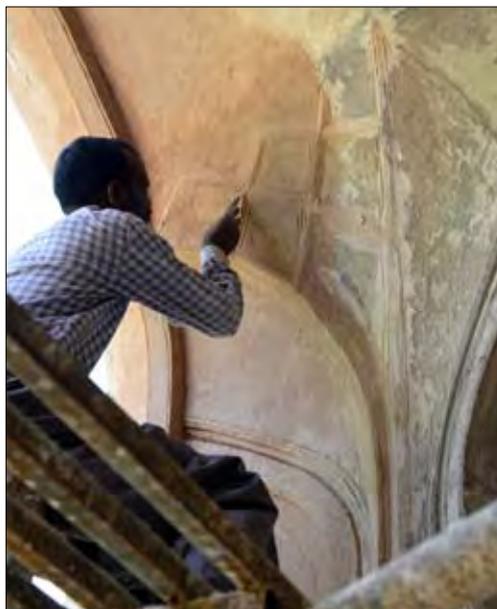
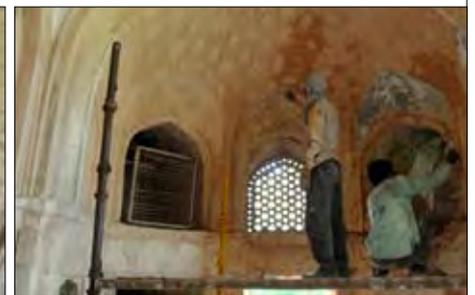
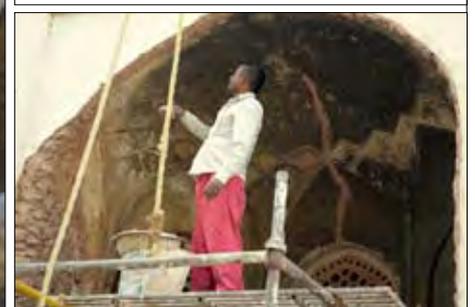
- The plaster on the lower half of the façade was mostly lost and has been re-plastered in cement on at least two occasions since 2001. This inappropriate conservation work on the monumental gateway first required the cement and other modern plastered portions on the façade and the interior spaces to be carefully removed.

(Above) The Gateway walls had been covered with cement plaster which was required to be removed; (Right) Restoration of historic lime plaster on the walls and arches

- After completely removing the added cement layers, the plastering works were commenced. The plastering layers included coarse lime mortar for the base layer and fine lime mortar for the top layer. The plastering works were then finished using a coat of 1 mm fine layer of Lime punning comprising of 1:1 ratio of lime and marble dust.

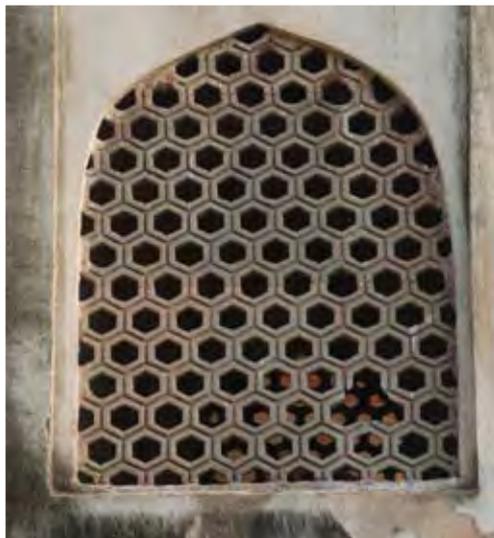
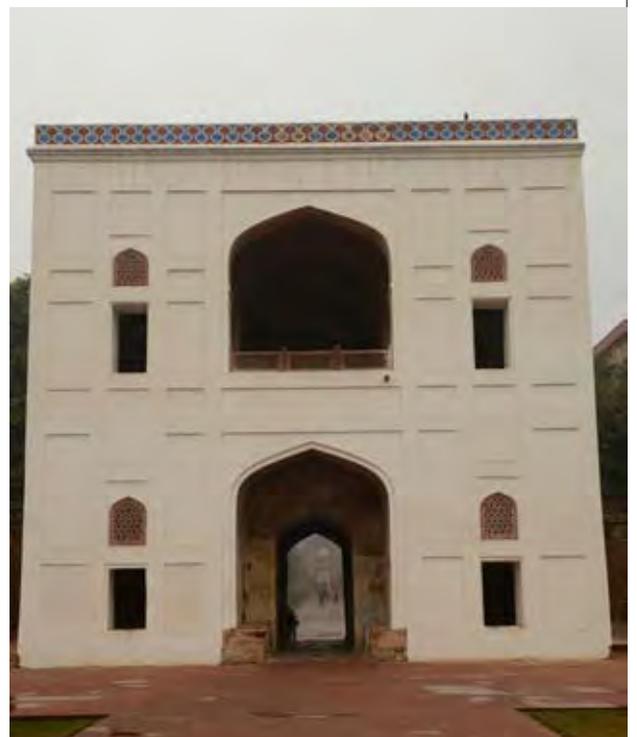
- After the inspection of the building it was found that in the earlier conservation attempt the sandstone screens have been replaced with cement screens. Such interventions have severely disfigured the historical significance of the structure.

(Above) Sandstone jaalis which were replaced with concrete jaalis (Bottom Left), were re-installed after a detailed documentation. Bu Halima's gateway after restoration of sandstone jaalis (Bottom Right).

- The careful documentation of all the opening sizes and shapes was carried out and the lattice screens were then hand crafted by the master craftsmen.

- All the lattice screens are now prepared and installed in the arched openings of the structure.
- After the inspection of the building it was found that most of the beautifully carved sandstone lattice screen parapets were missing from the structure which severely disfigured the historical significance of the structure and made it unsafe.

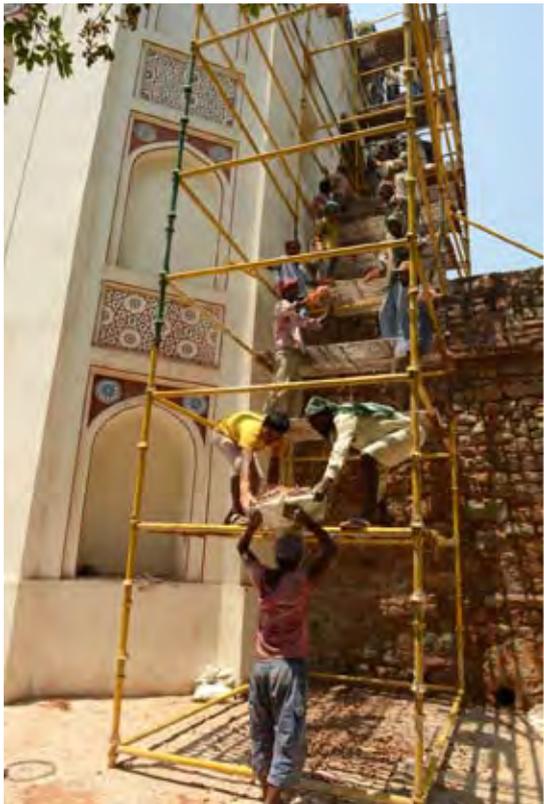
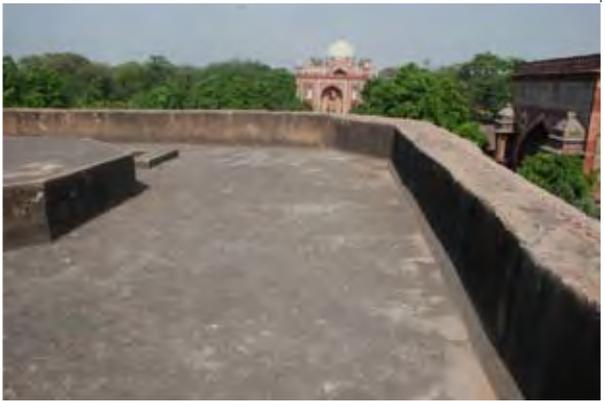
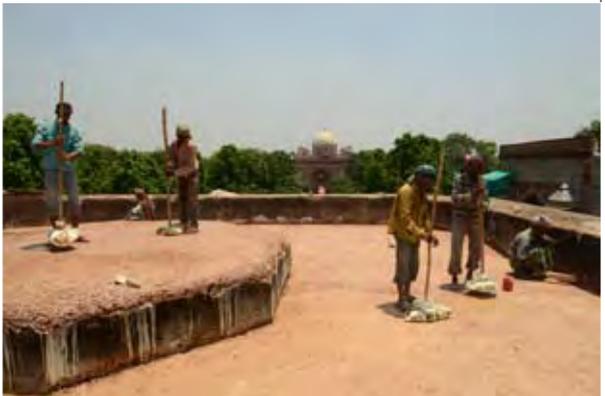
(Above) A detailed condition assesment of the structure was carried out as a precursor to conservation works and included listing all works required to be carried out; (Below) Cement concrete from the roof was manually removed and replaced with a traditional lime concrete based flooring. This required over 100 cu. ft. of lime concrete to be lifted to the roof.

- After completely removing the added cement layers from the terrace, the terracing work started using the lime concrete comprising lime mortar and brick aggregate. Traditional organic additives such as Bael Fruit pulp, jaggery were added to make the surface water tight and as per original slopes and details.
- The terracing works are now complete.

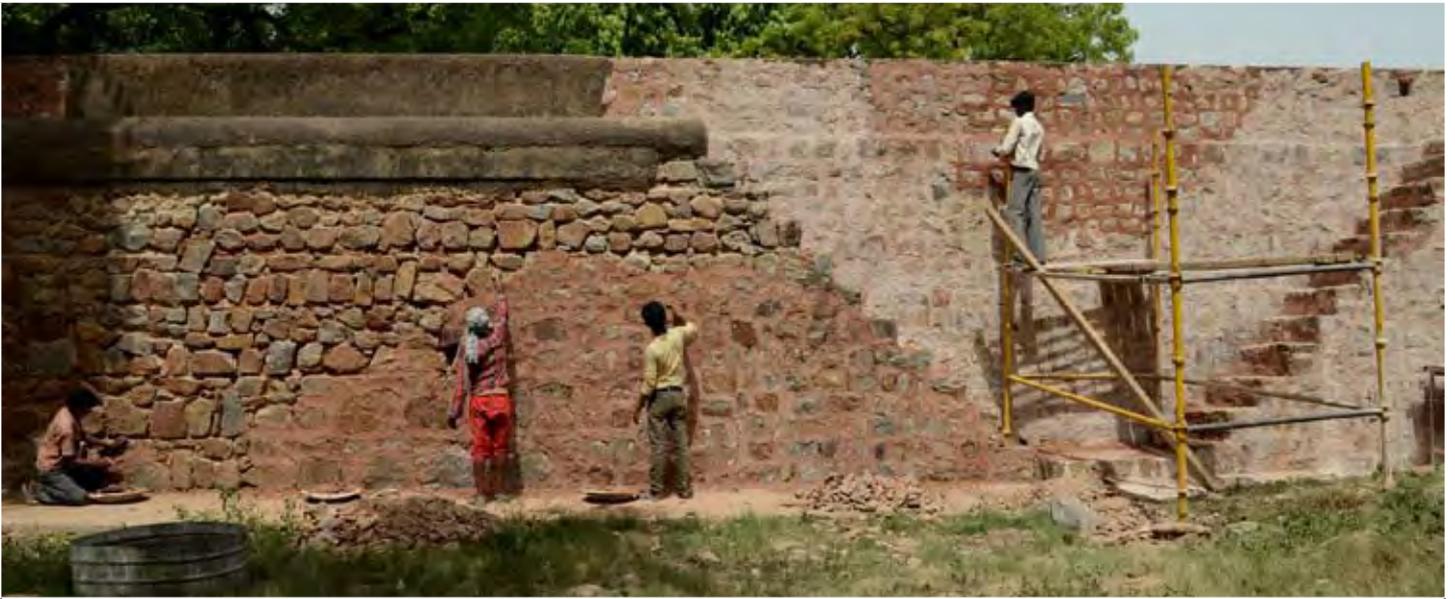
(Above) Removal of dead cement pointing and stitching the cracks in the enclosure wall and bastion chambers was followed by pointing with lime mortar.

- The enclosure wall and the chambers in the Bastion suffered from deep structural cracks due to neglect over the years.
- The cracks are repaired with the help of grouting
- It was also found that the arched entrances in the Bastion chambers were in an advanced state of disrepair. These arches were repaired with the help of brick shuttering which was made as per the original sizes.
- The walls and ceilings of the Bastion chamber are then finished with the application of base and fine layer of lime.

- After raking out the cement from the joints in the enclosure wall, they were then re-pointed in lime. The wall surfaces were cured with clean water after the re-pointing works dried.
- The plinth protection of the enclosure wall was finished in cement as a previous intervention.
- The cement concrete was removed from the plinth protection of enclosure wall and the conservation works were finished with the restoration of the sandstone plinth protection along the entire length of the enclosure wall.
- The works on the enclosure wall are now complete.
