PROJECT CONSERVATION

Nizamuddin Urban Renewal Initiative

a People Public | Private Partnership

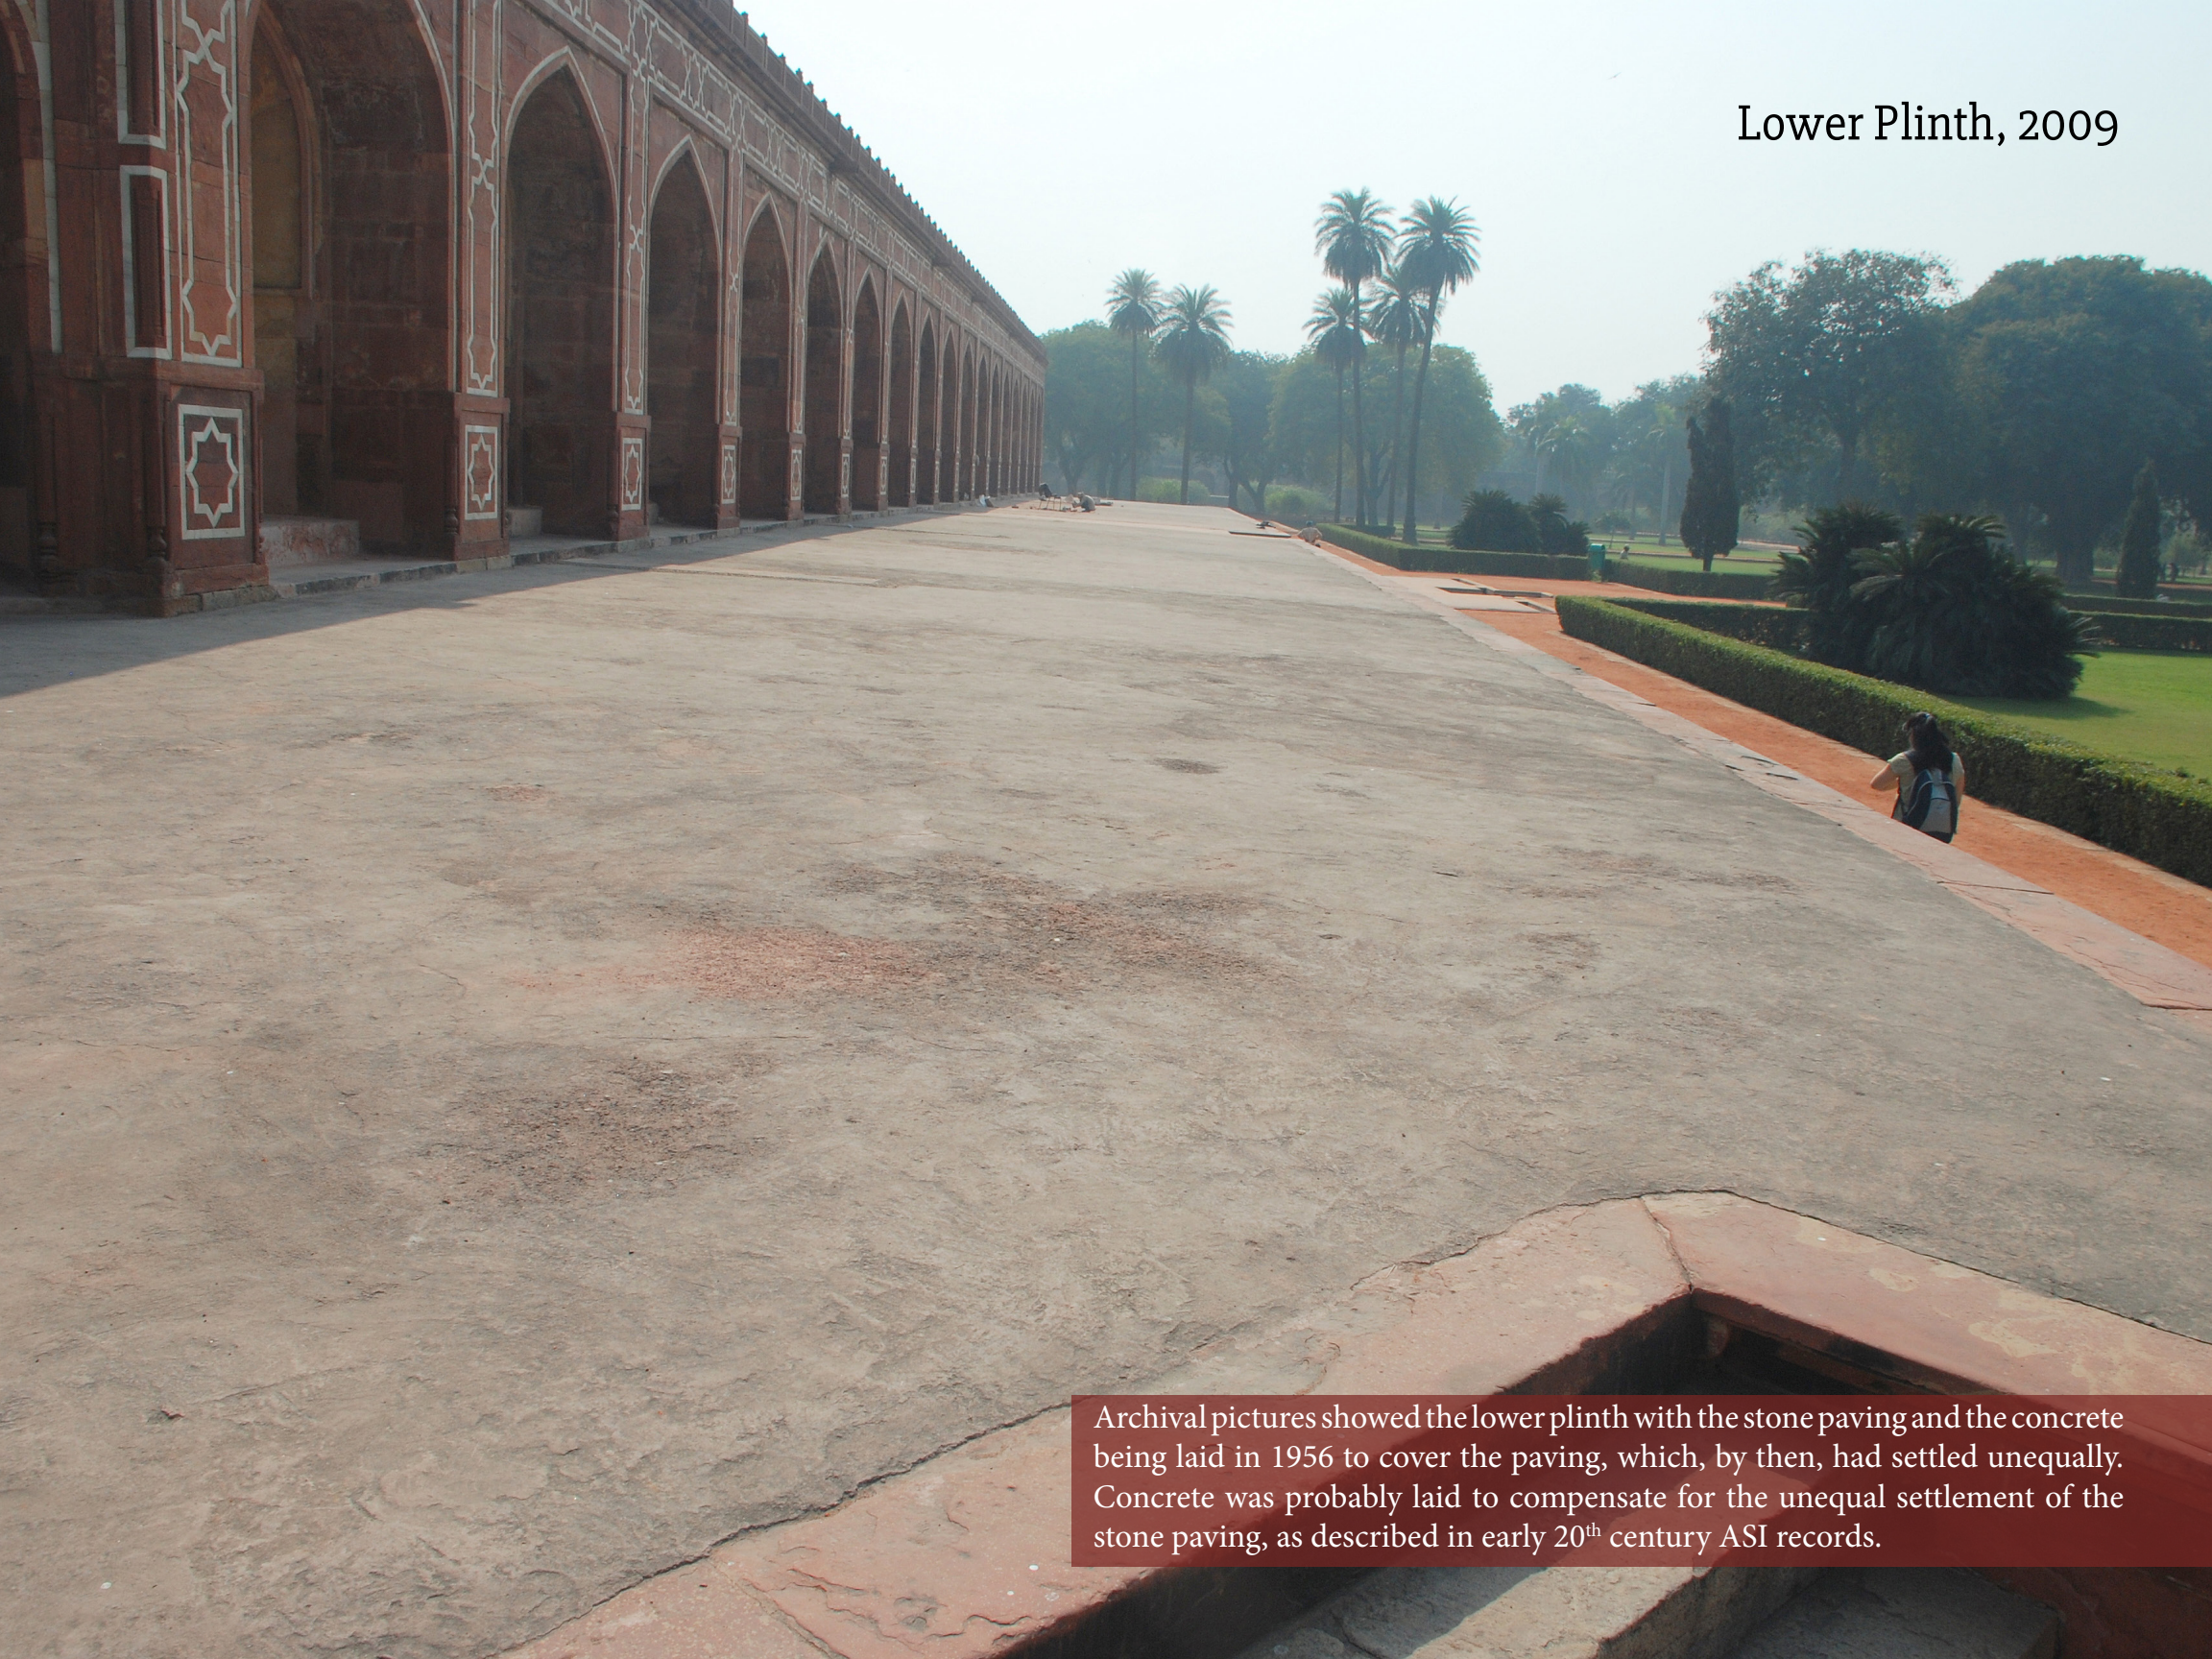
Lower Plinth, 2009

Archival pictures showed the lower plinth with the stone paving and the concrete being laid in 1956 to cover the paving, which, by then, had settled unevenly. Concrete was probably laid to compensate for the unequal settlement of the stone paving, as described in early 20th century ASI records.

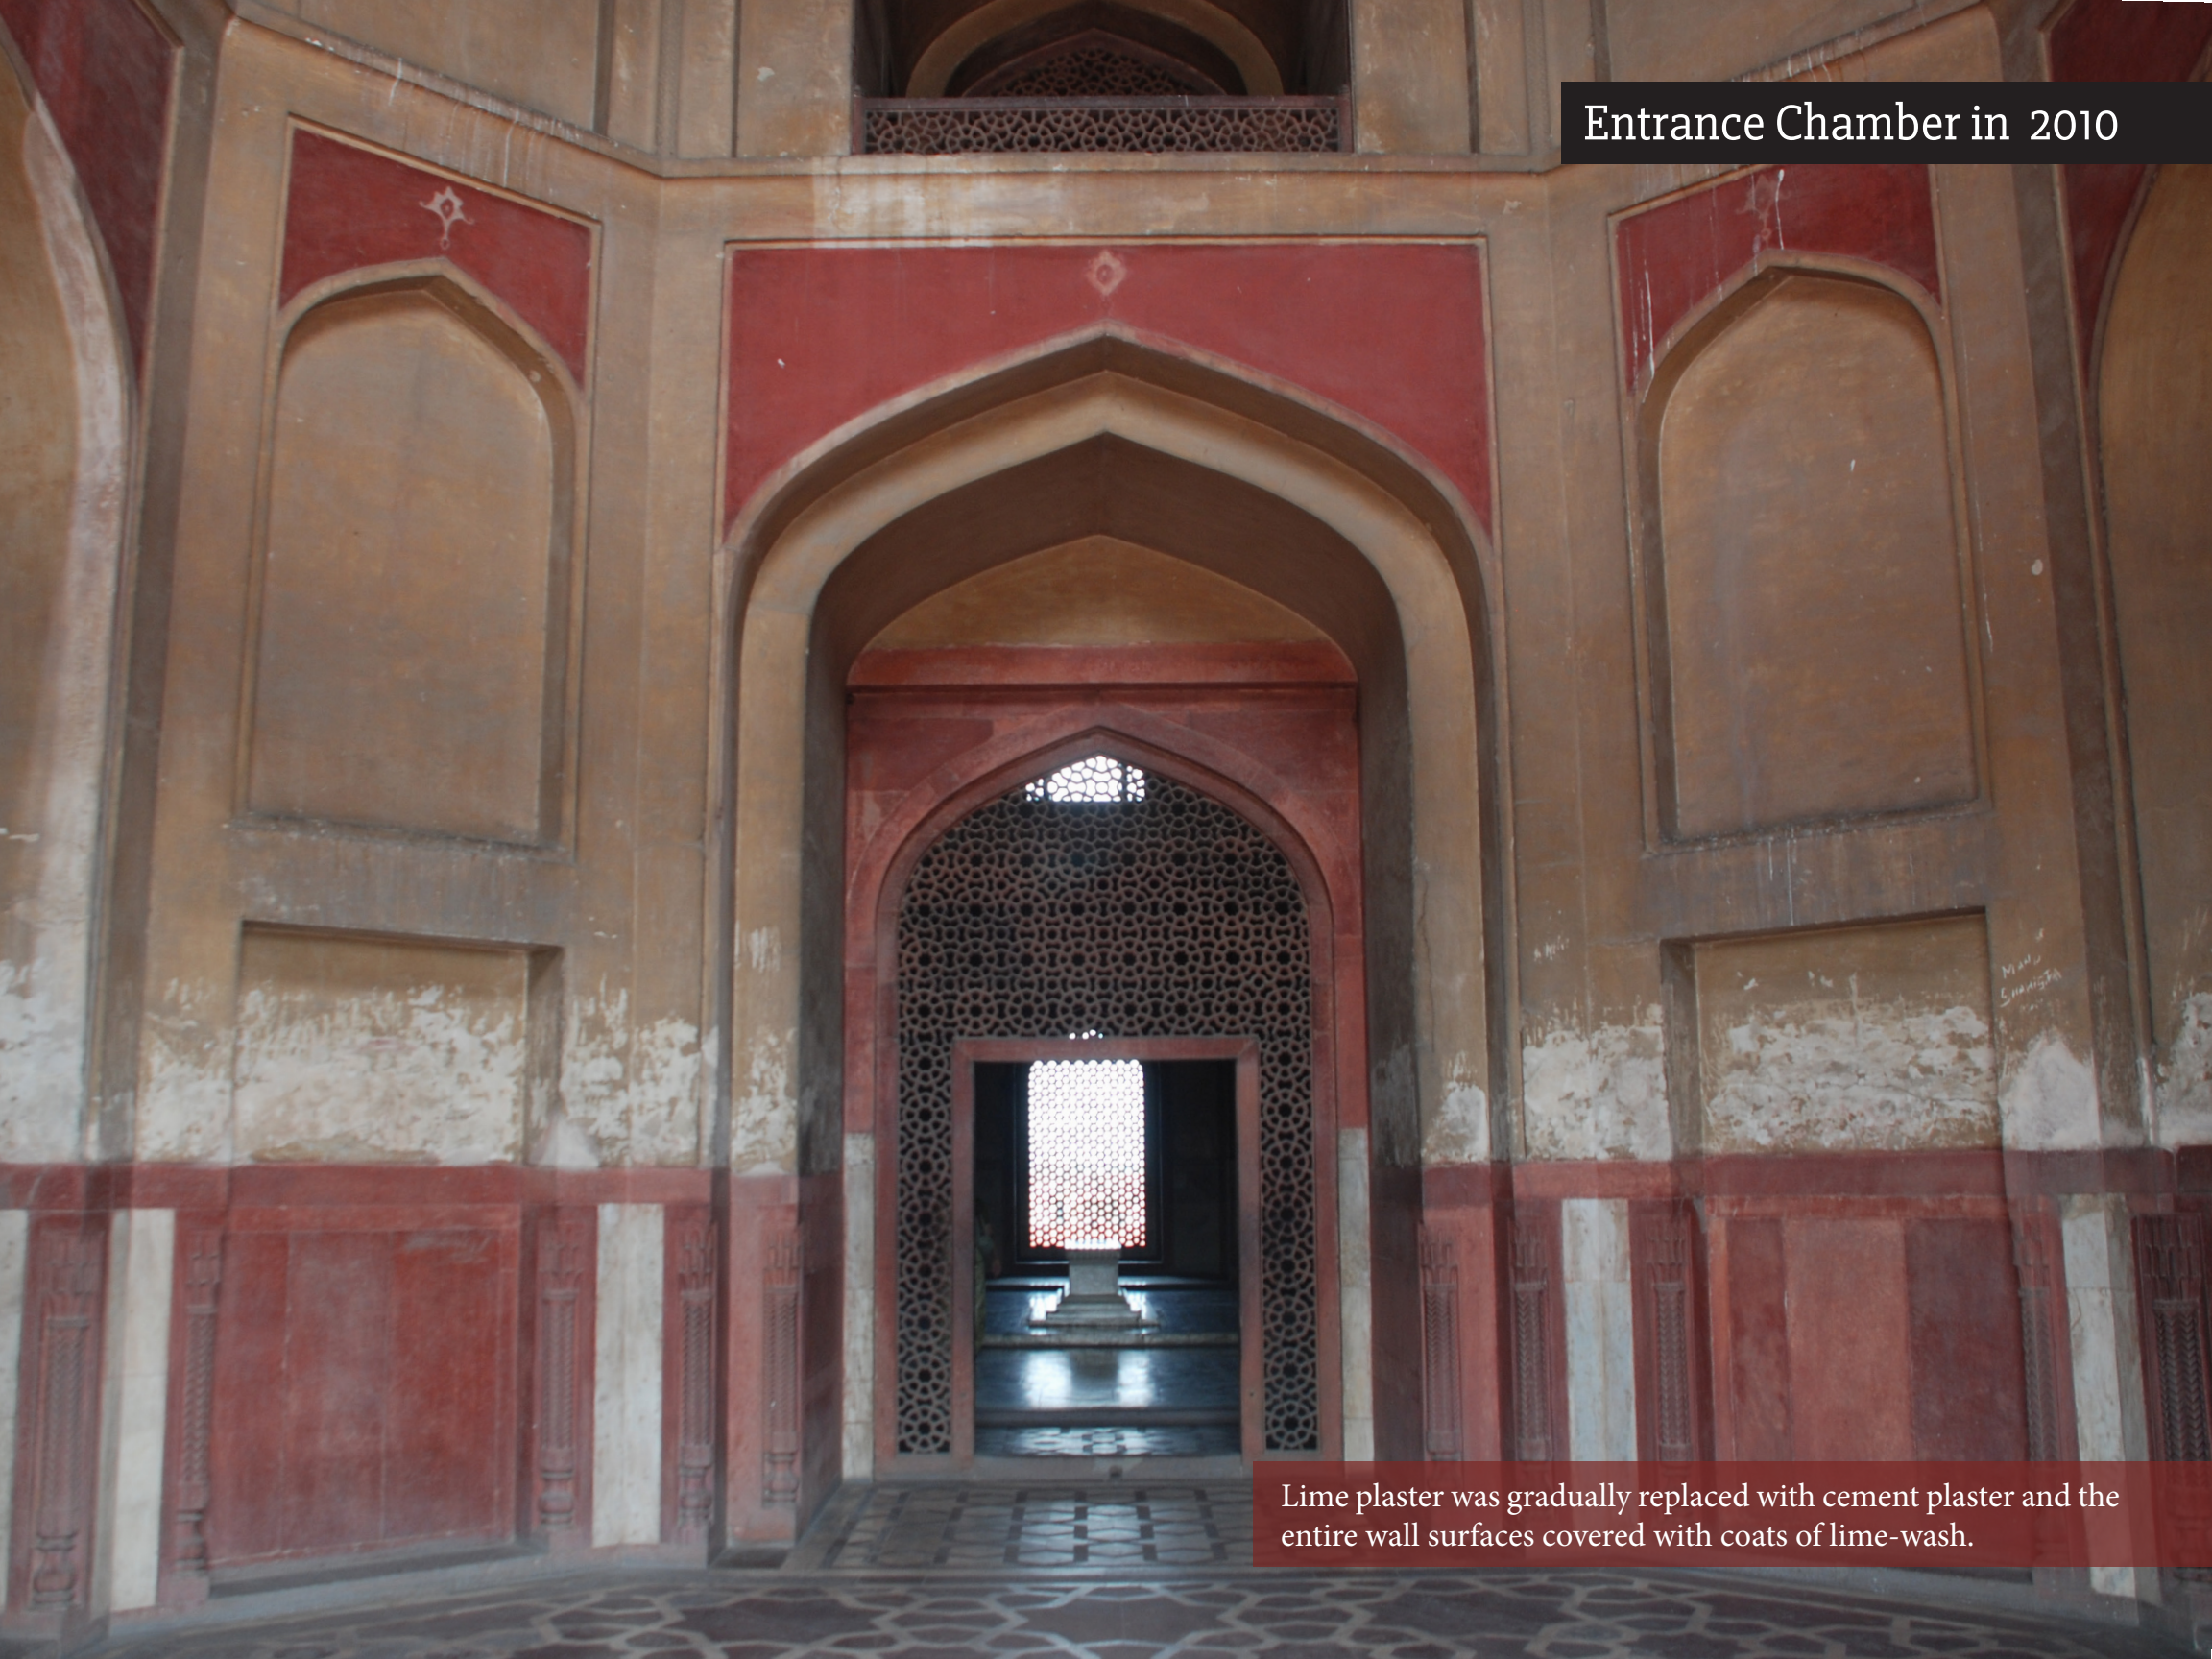
Entrance Chamber in 2010

Lime plaster was gradually replaced with cement plaster and the entire wall surfaces covered with coats of lime-wash.

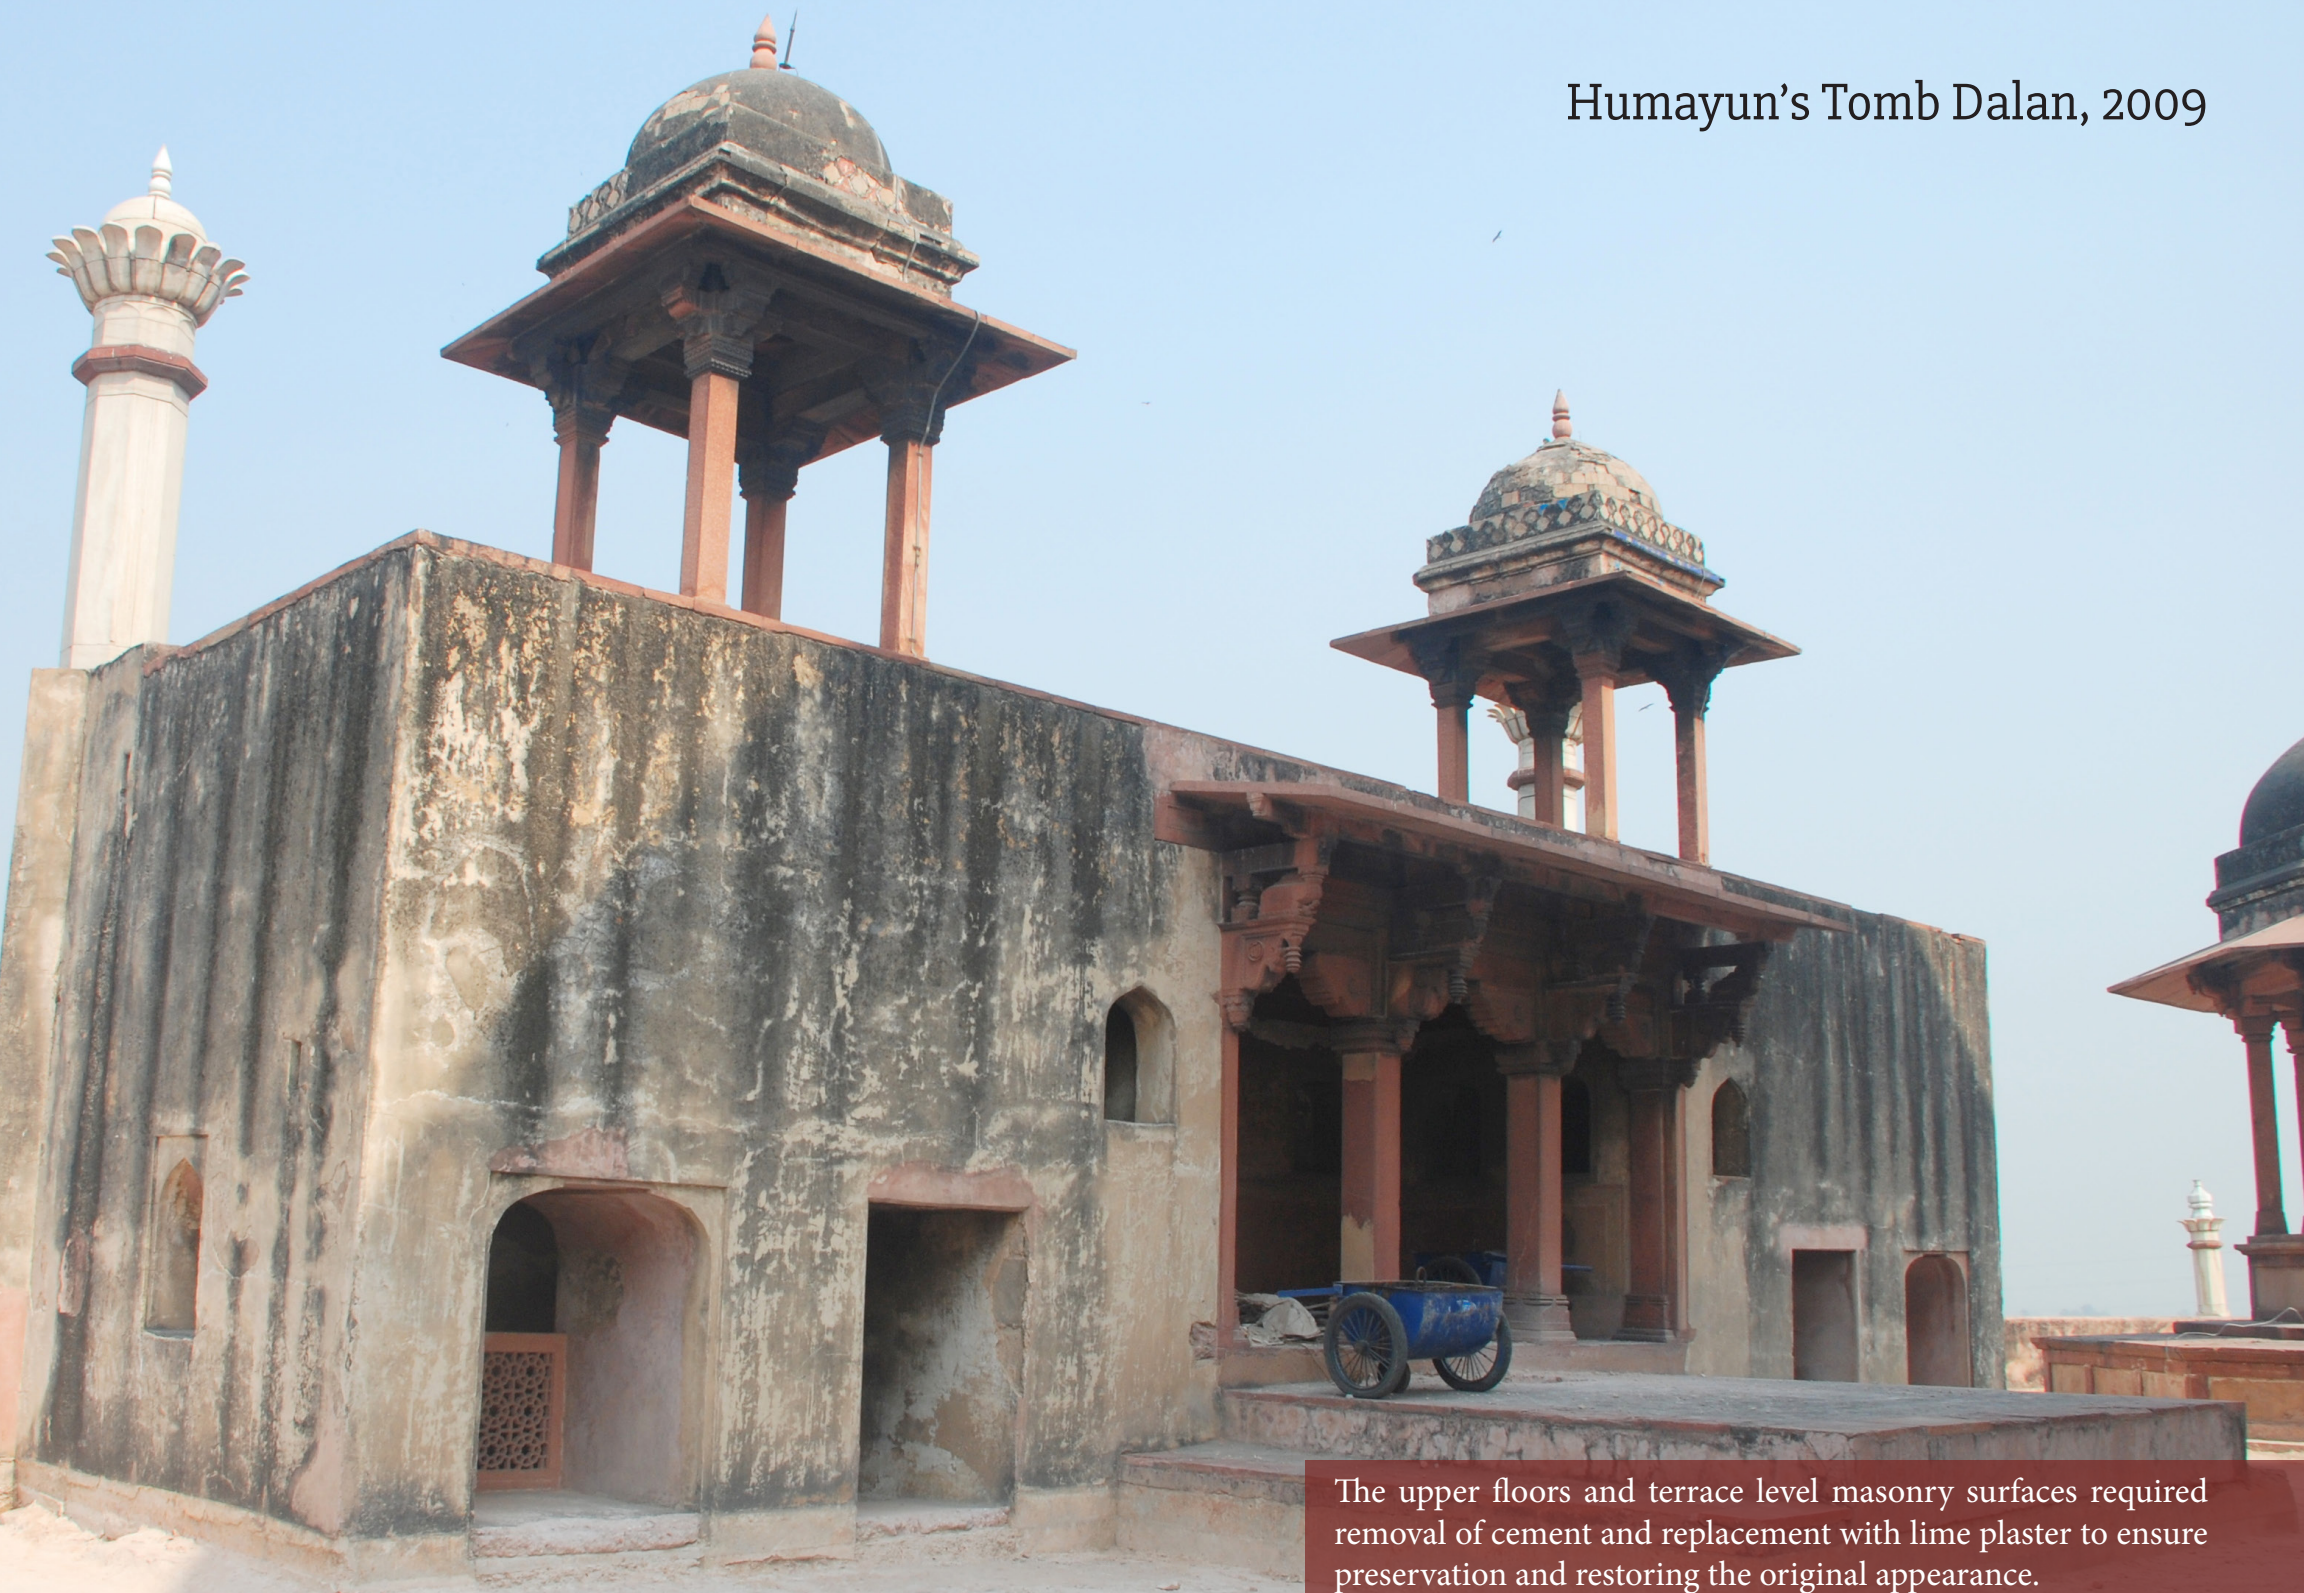
Humayun's Tomb Dalan, 2009

The upper floors and terrace level masonry surfaces required removal of cement and replacement with lime plaster to ensure preservation and restoring the original appearance.

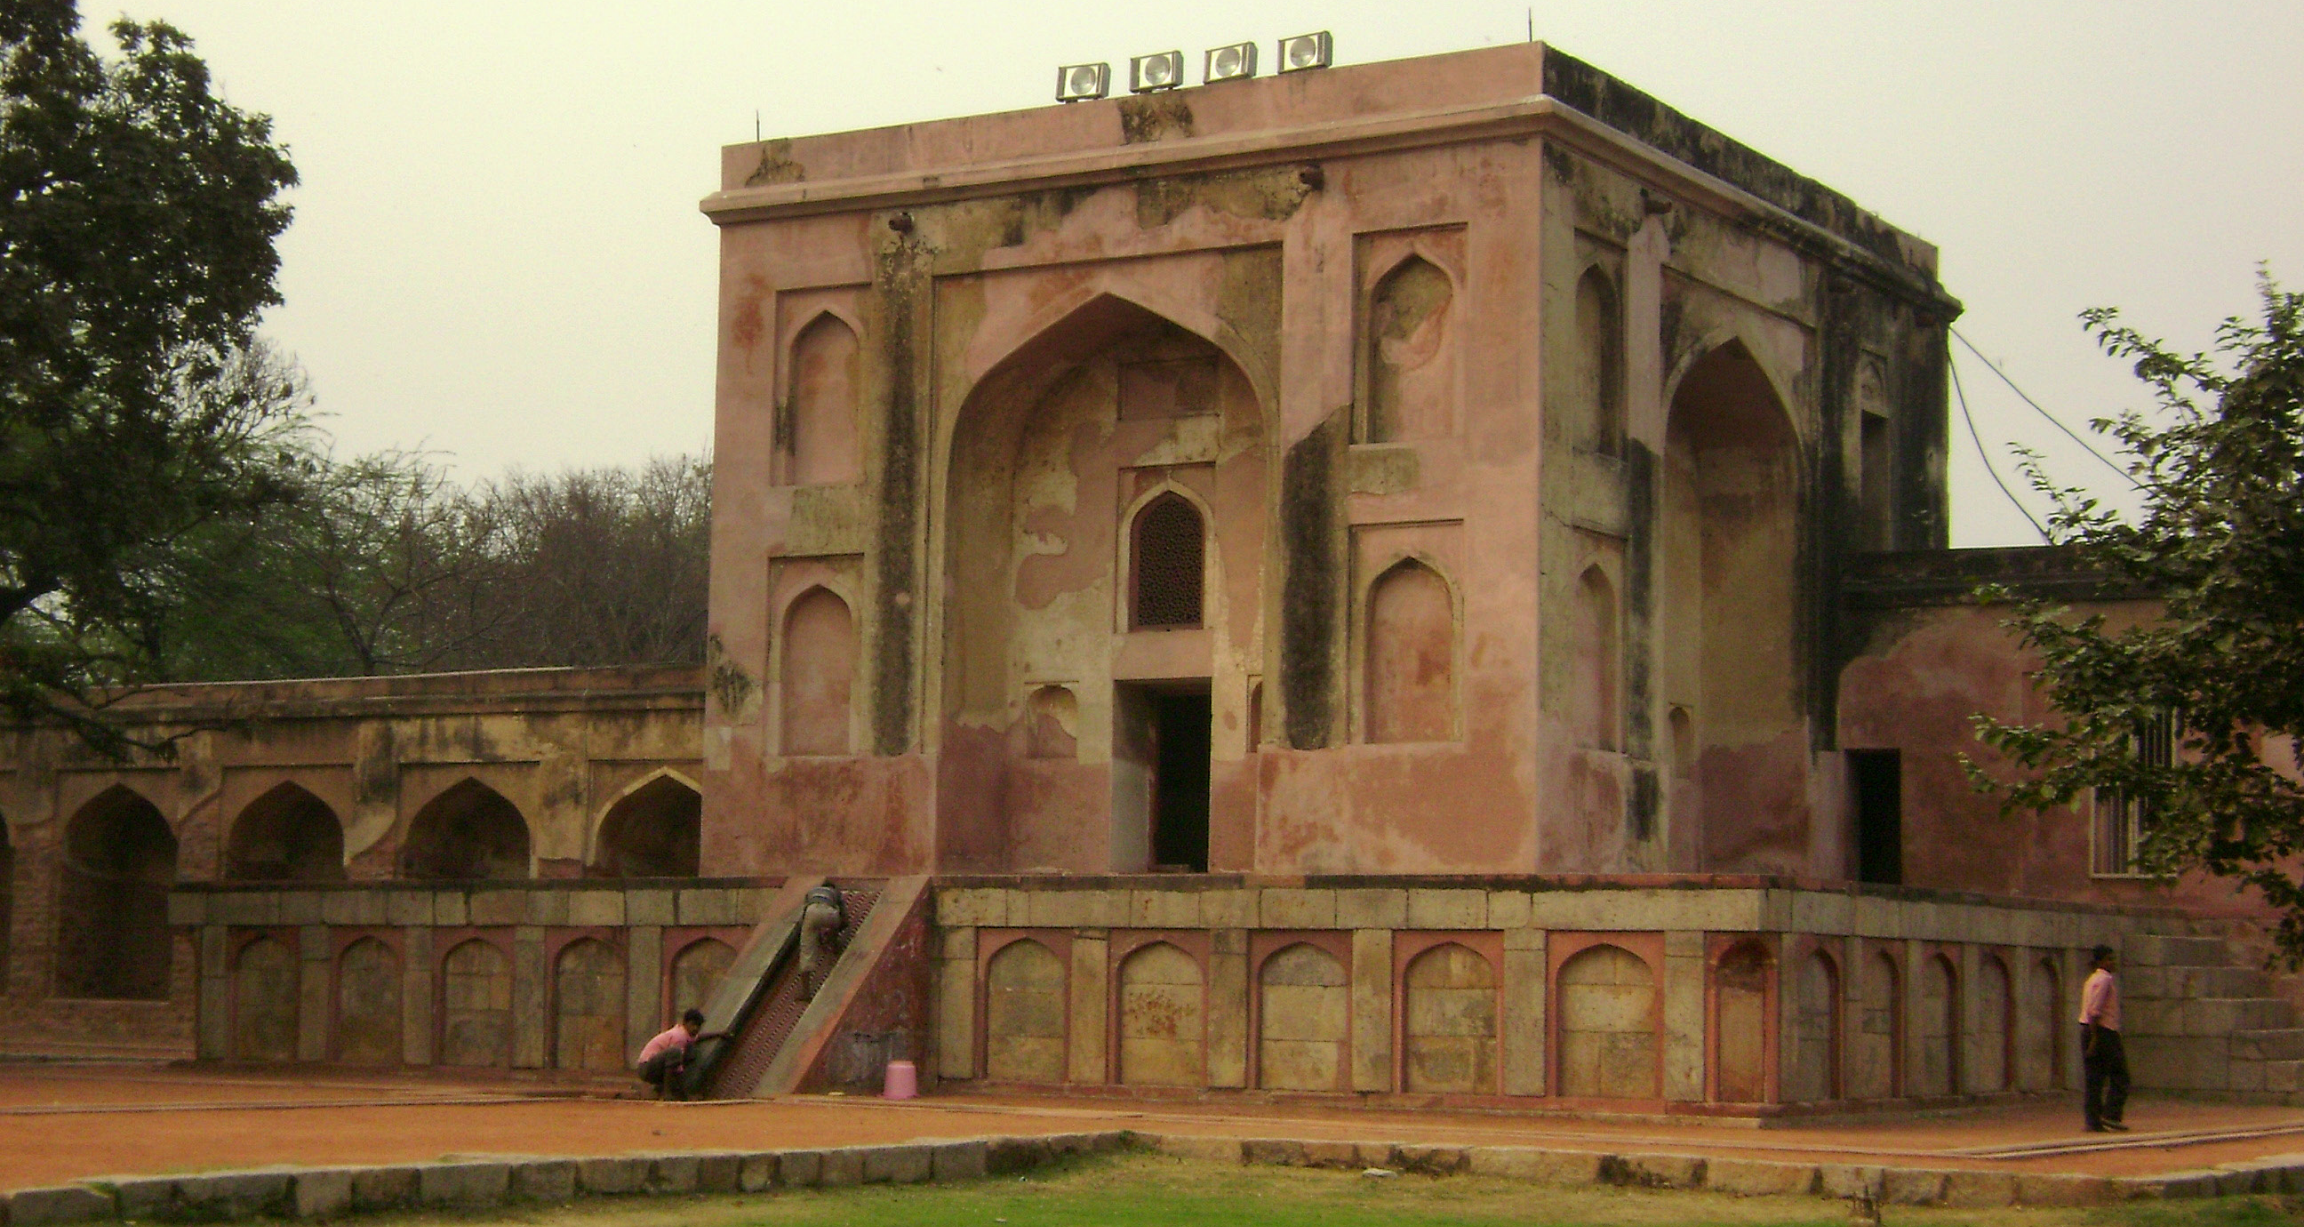
North Pavilion (2008)

Neglect and inappropriate repairs had significantly disfigured the architectural homogeneity and historical character of the north pavilion.

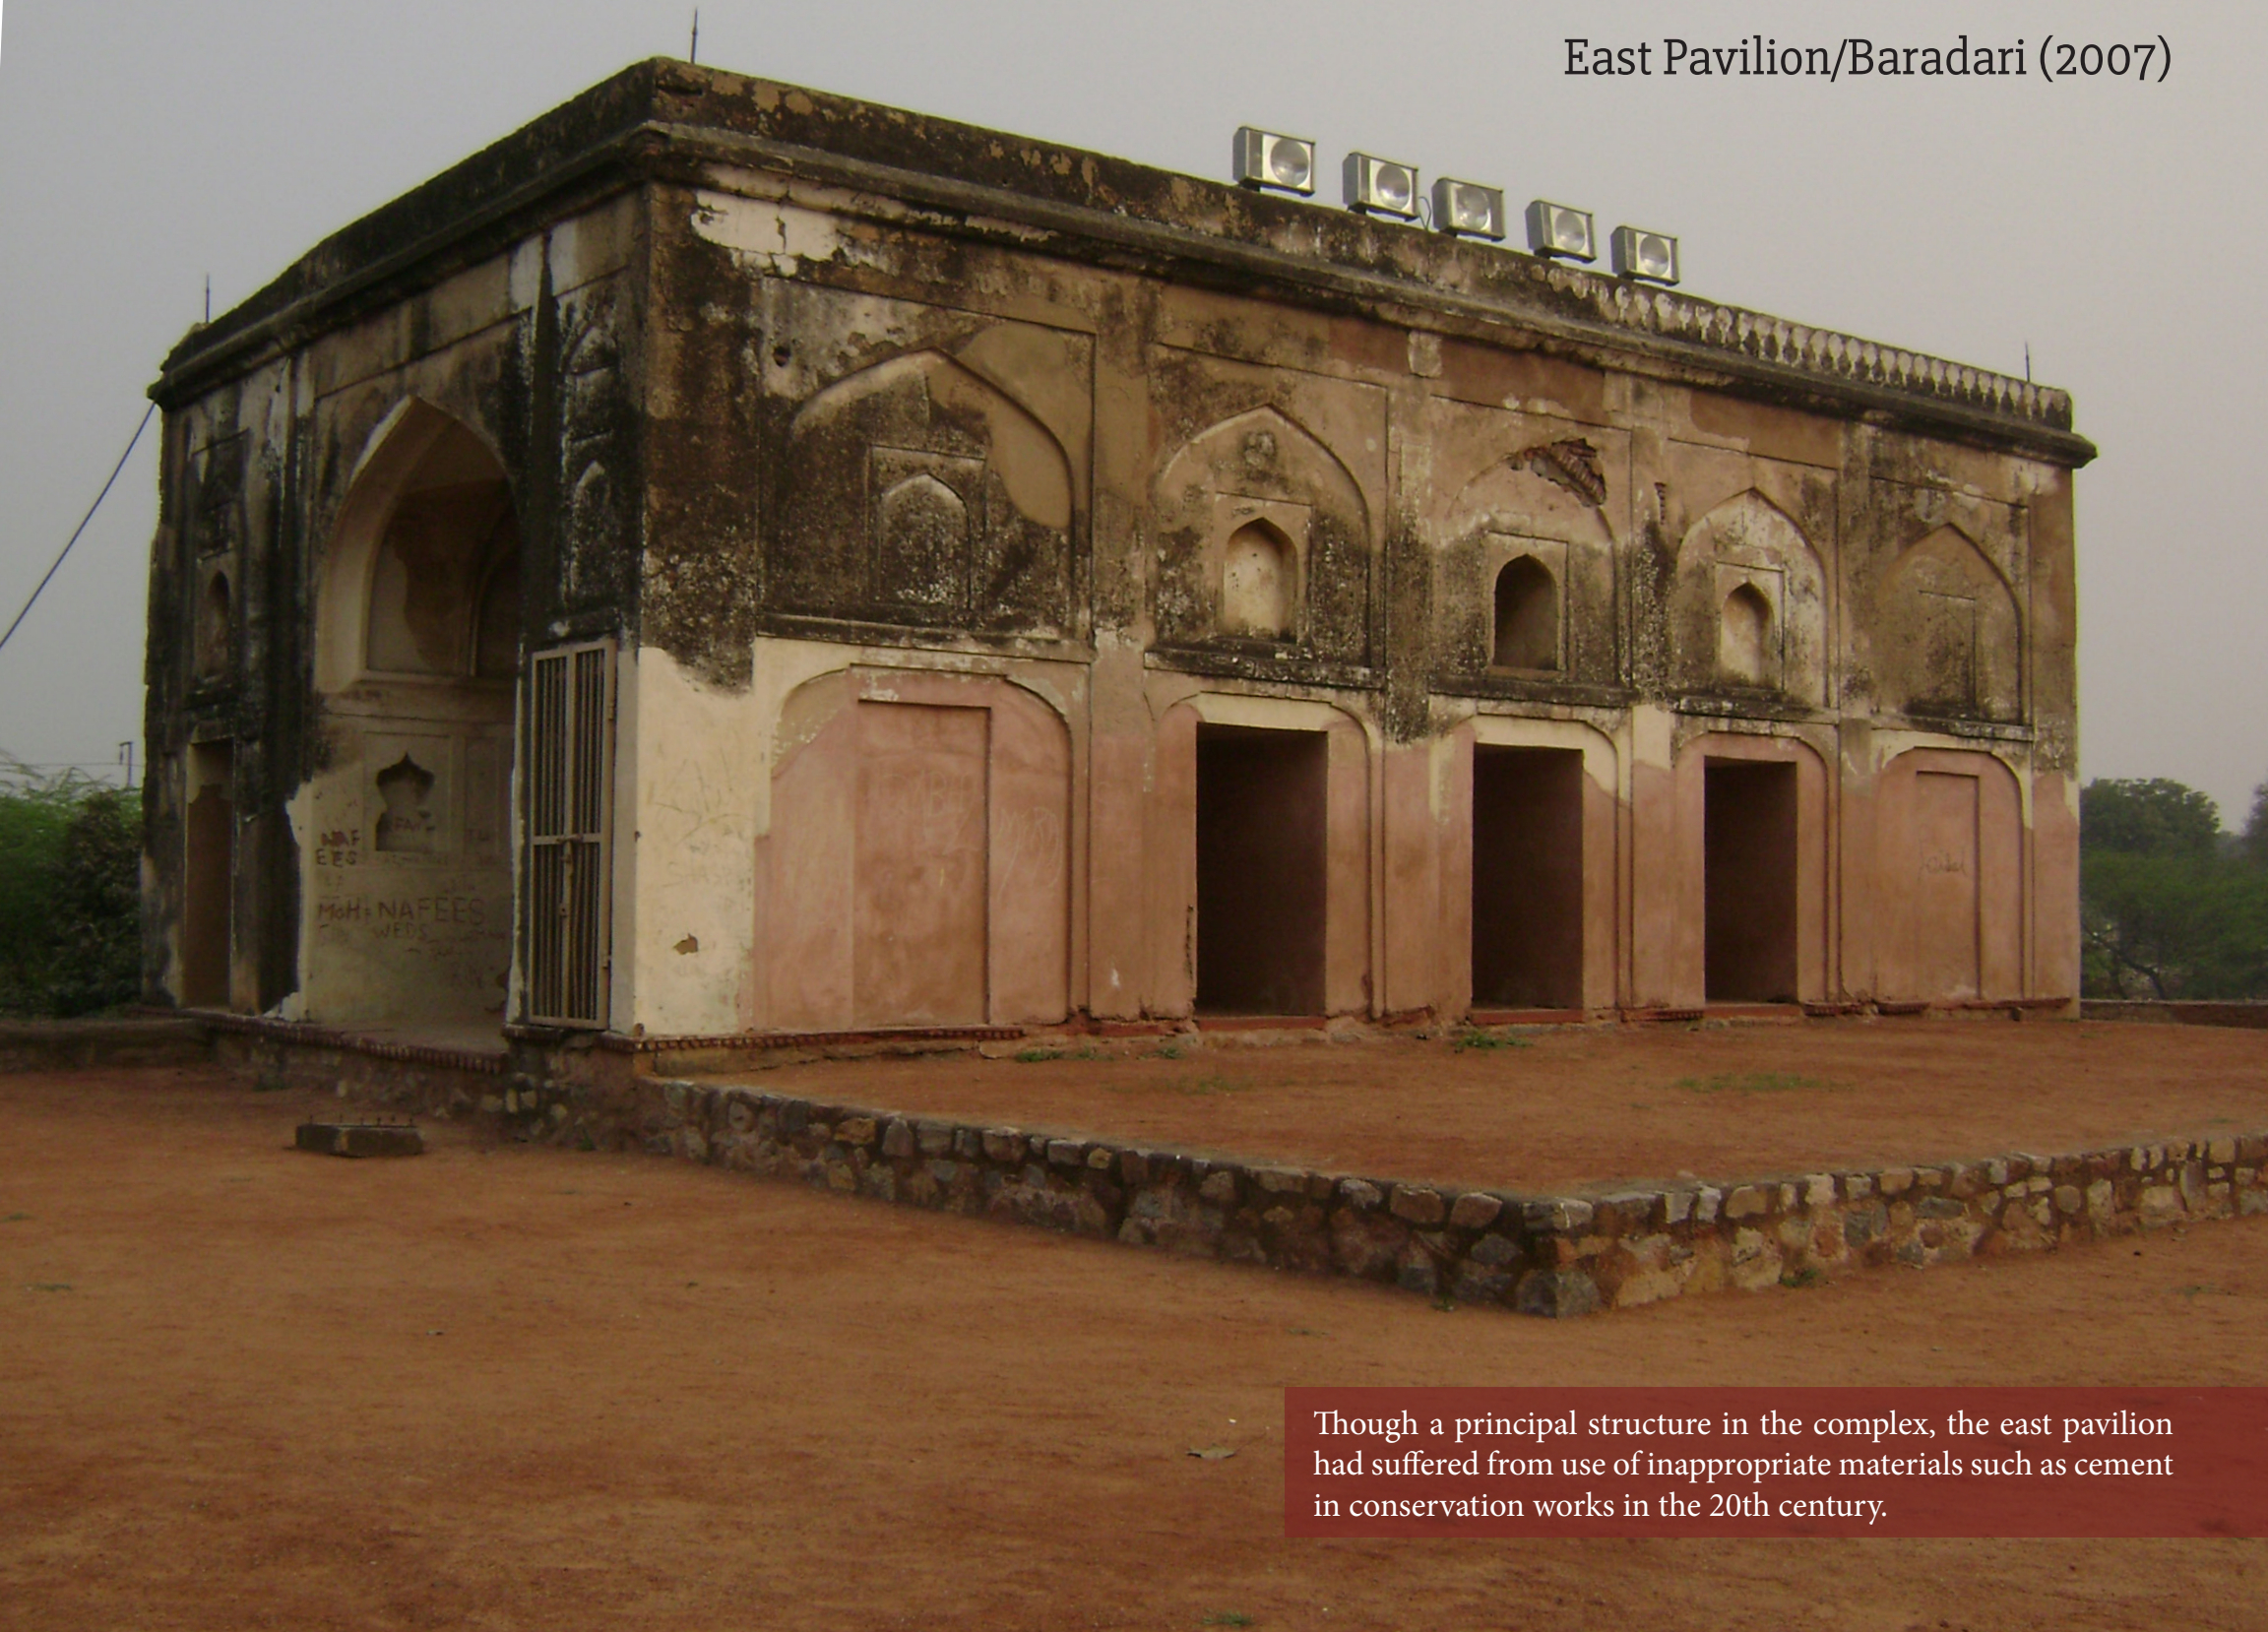
East Pavilion/Baradari (2007)

Though a principal structure in the complex, the east pavilion had suffered from use of inappropriate materials such as cement in conservation works in the 20th century.

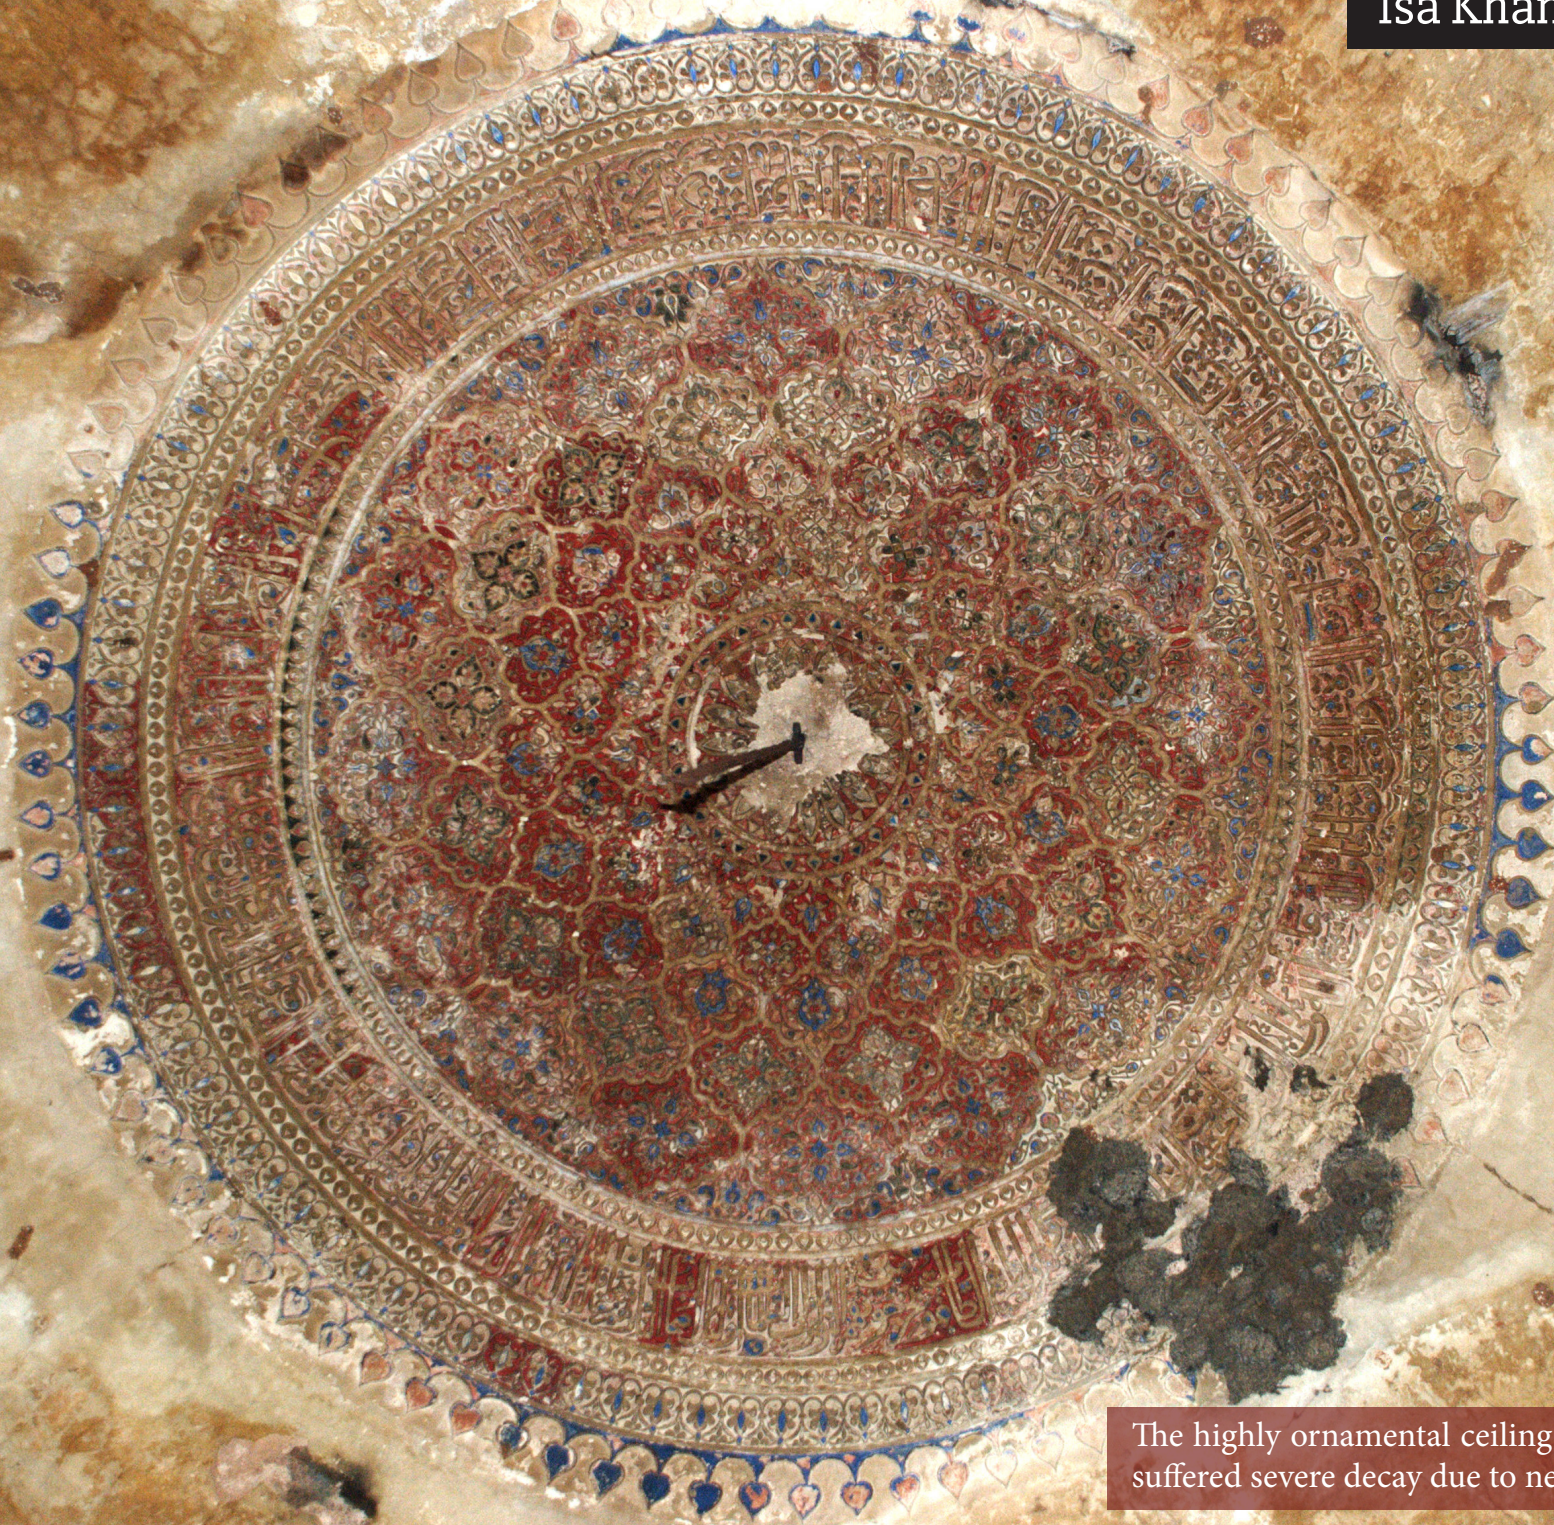
Isa Khan's Ceiling (2010)

The highly ornamental ceiling of Isa Khan's Tomb had suffered severe decay due to neglect and water ingress.
