ABOUT THE PROJECT

Nizamuddin Urban Renewal Initiative

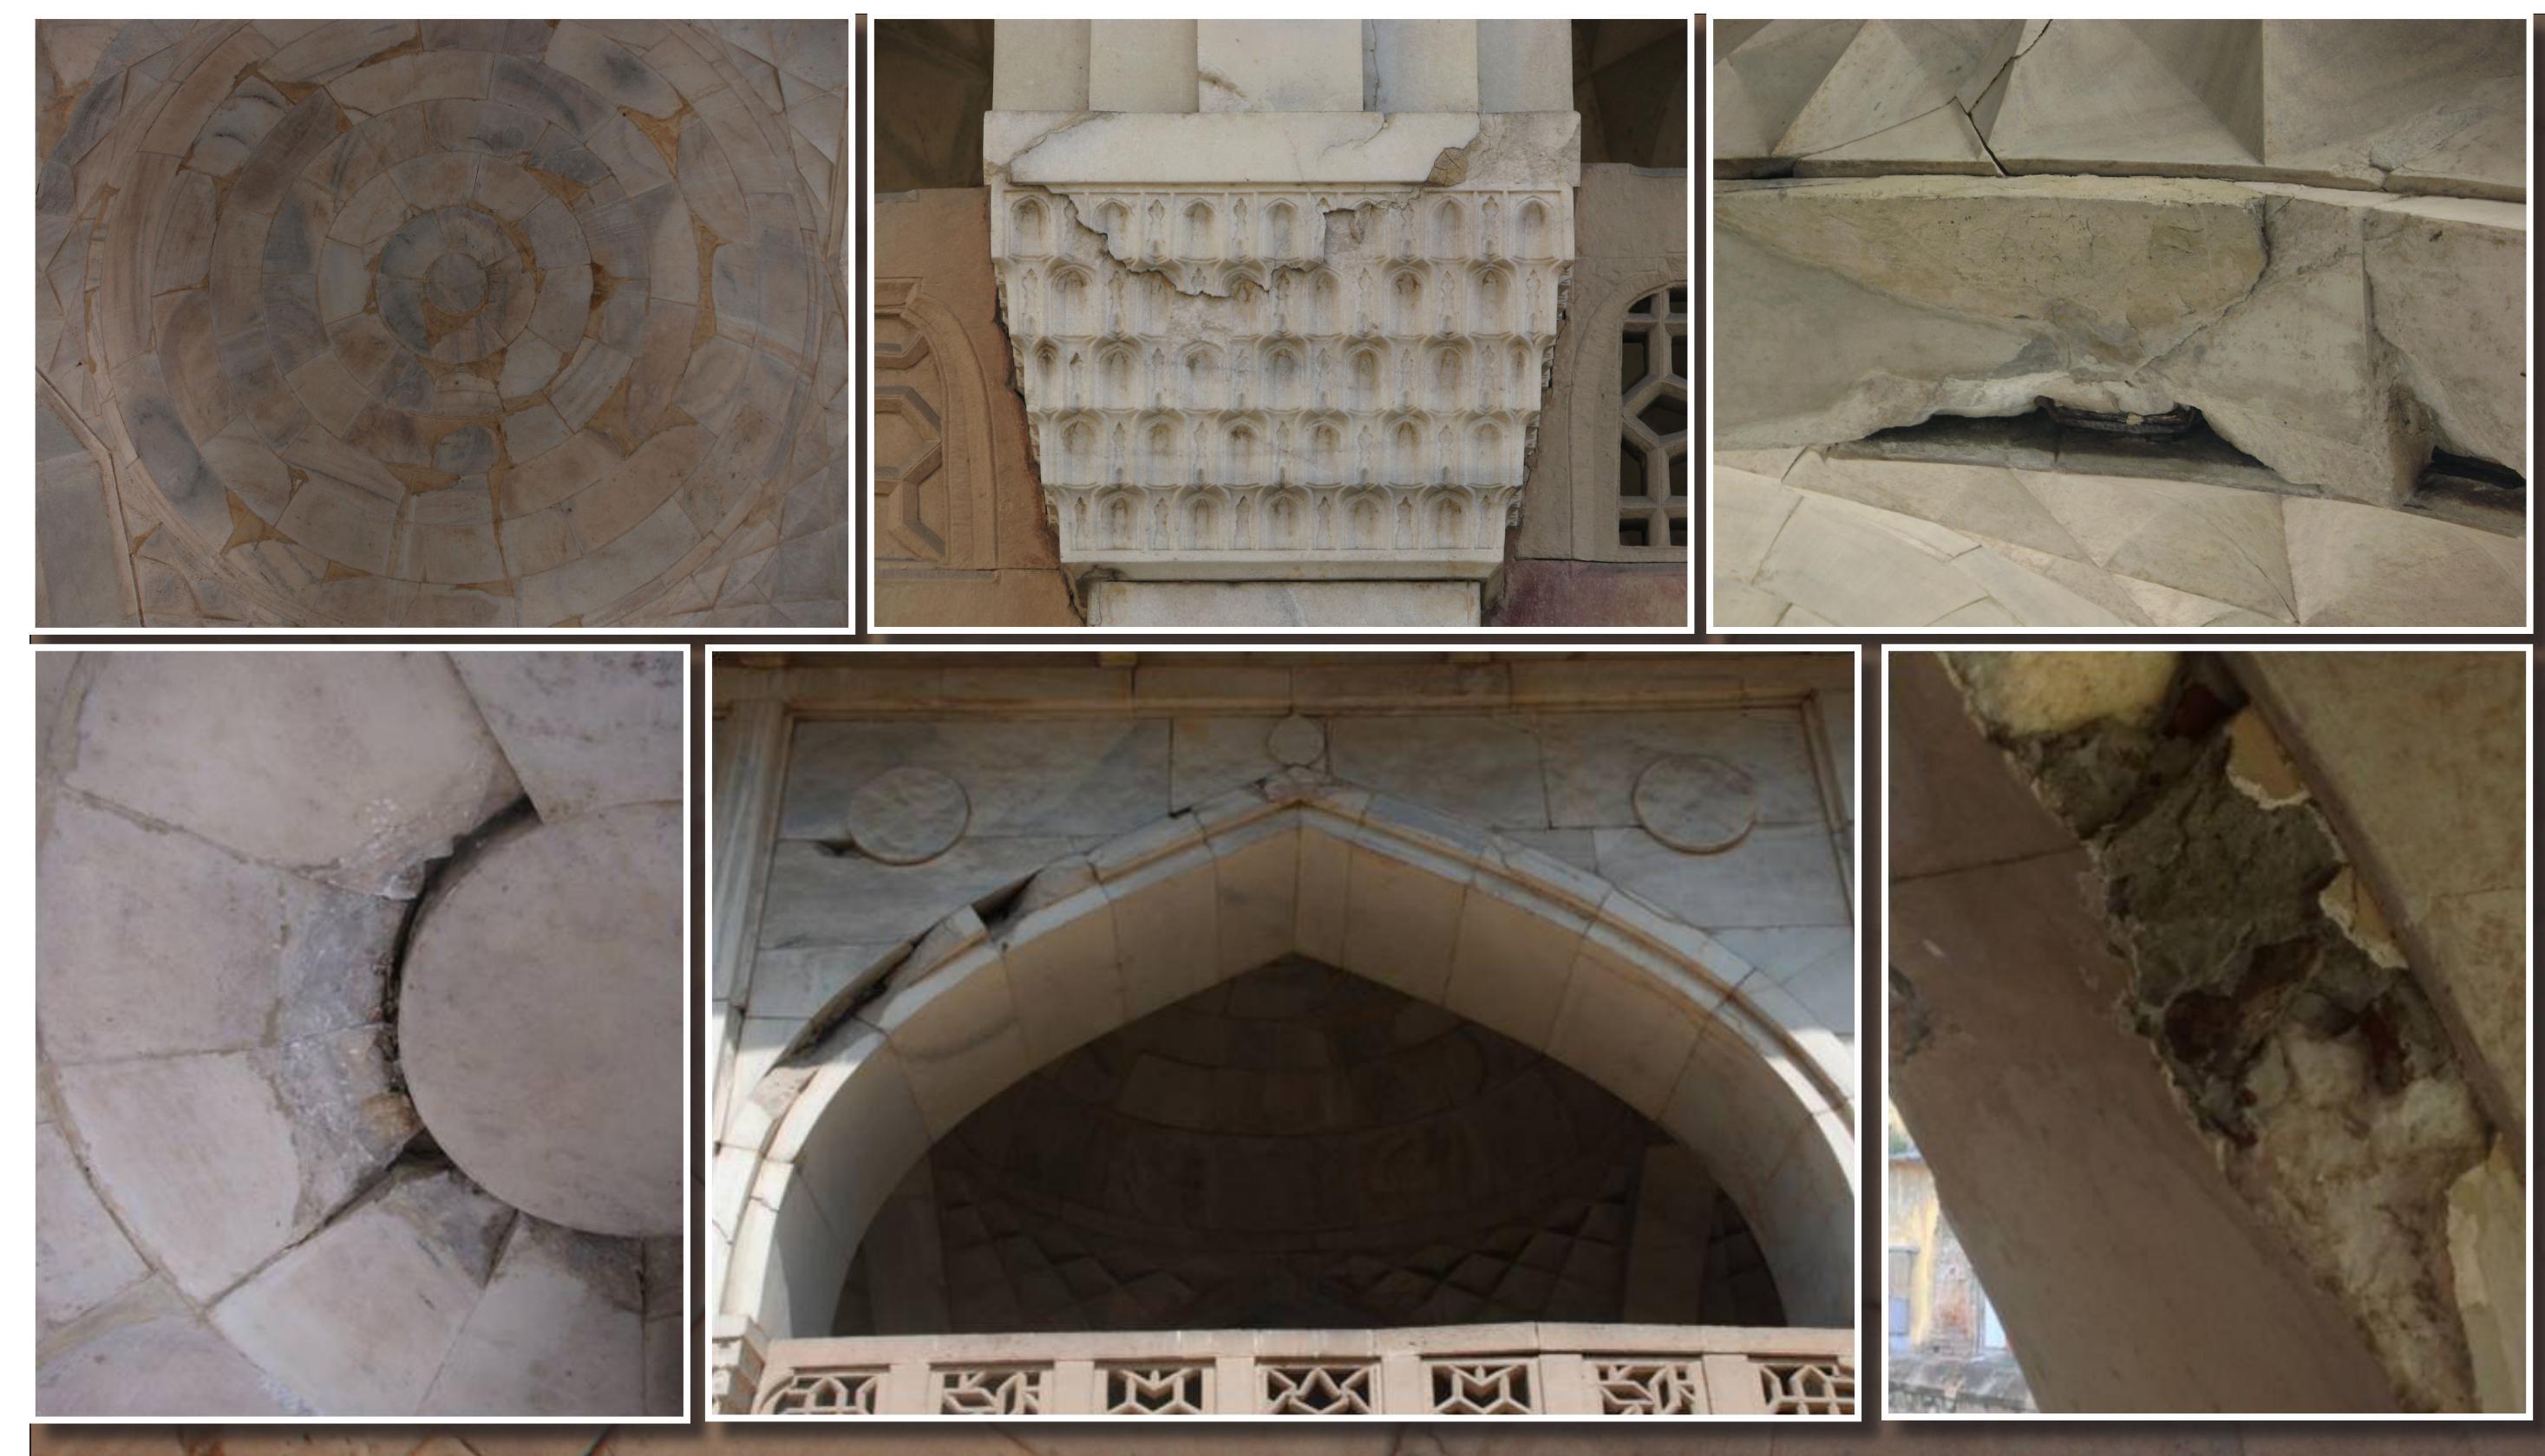
Material Deterioration due to past repairs in white cement masking the damage but allowing the deterioration to accelerate

Chipping of Marble elements like domes, arches, facade, pendentives, jaalis and column capitals

Rusting of iron dowel due to water seepage led to bursting of the marble

The marble blocks of the 25 domes were tied to one-another and embedded in the brick masonry over the domes with iron dowels. The rain water spouts from the inaccessible roof got blocked resulting in large quantities of rain water collecting on roof. This resulted in the rapid deterioration of the roof and large scale water ingress from the roof leading to the corrosion, rusting and expansion of the iron dowels. The significant pressure from the expanding iron dowel led to bursting of the marble blocks in all parts of the mausoleum – domes, arches, facade, pendentives and even the column capitals – threatening structural failure and collapse of the structure.

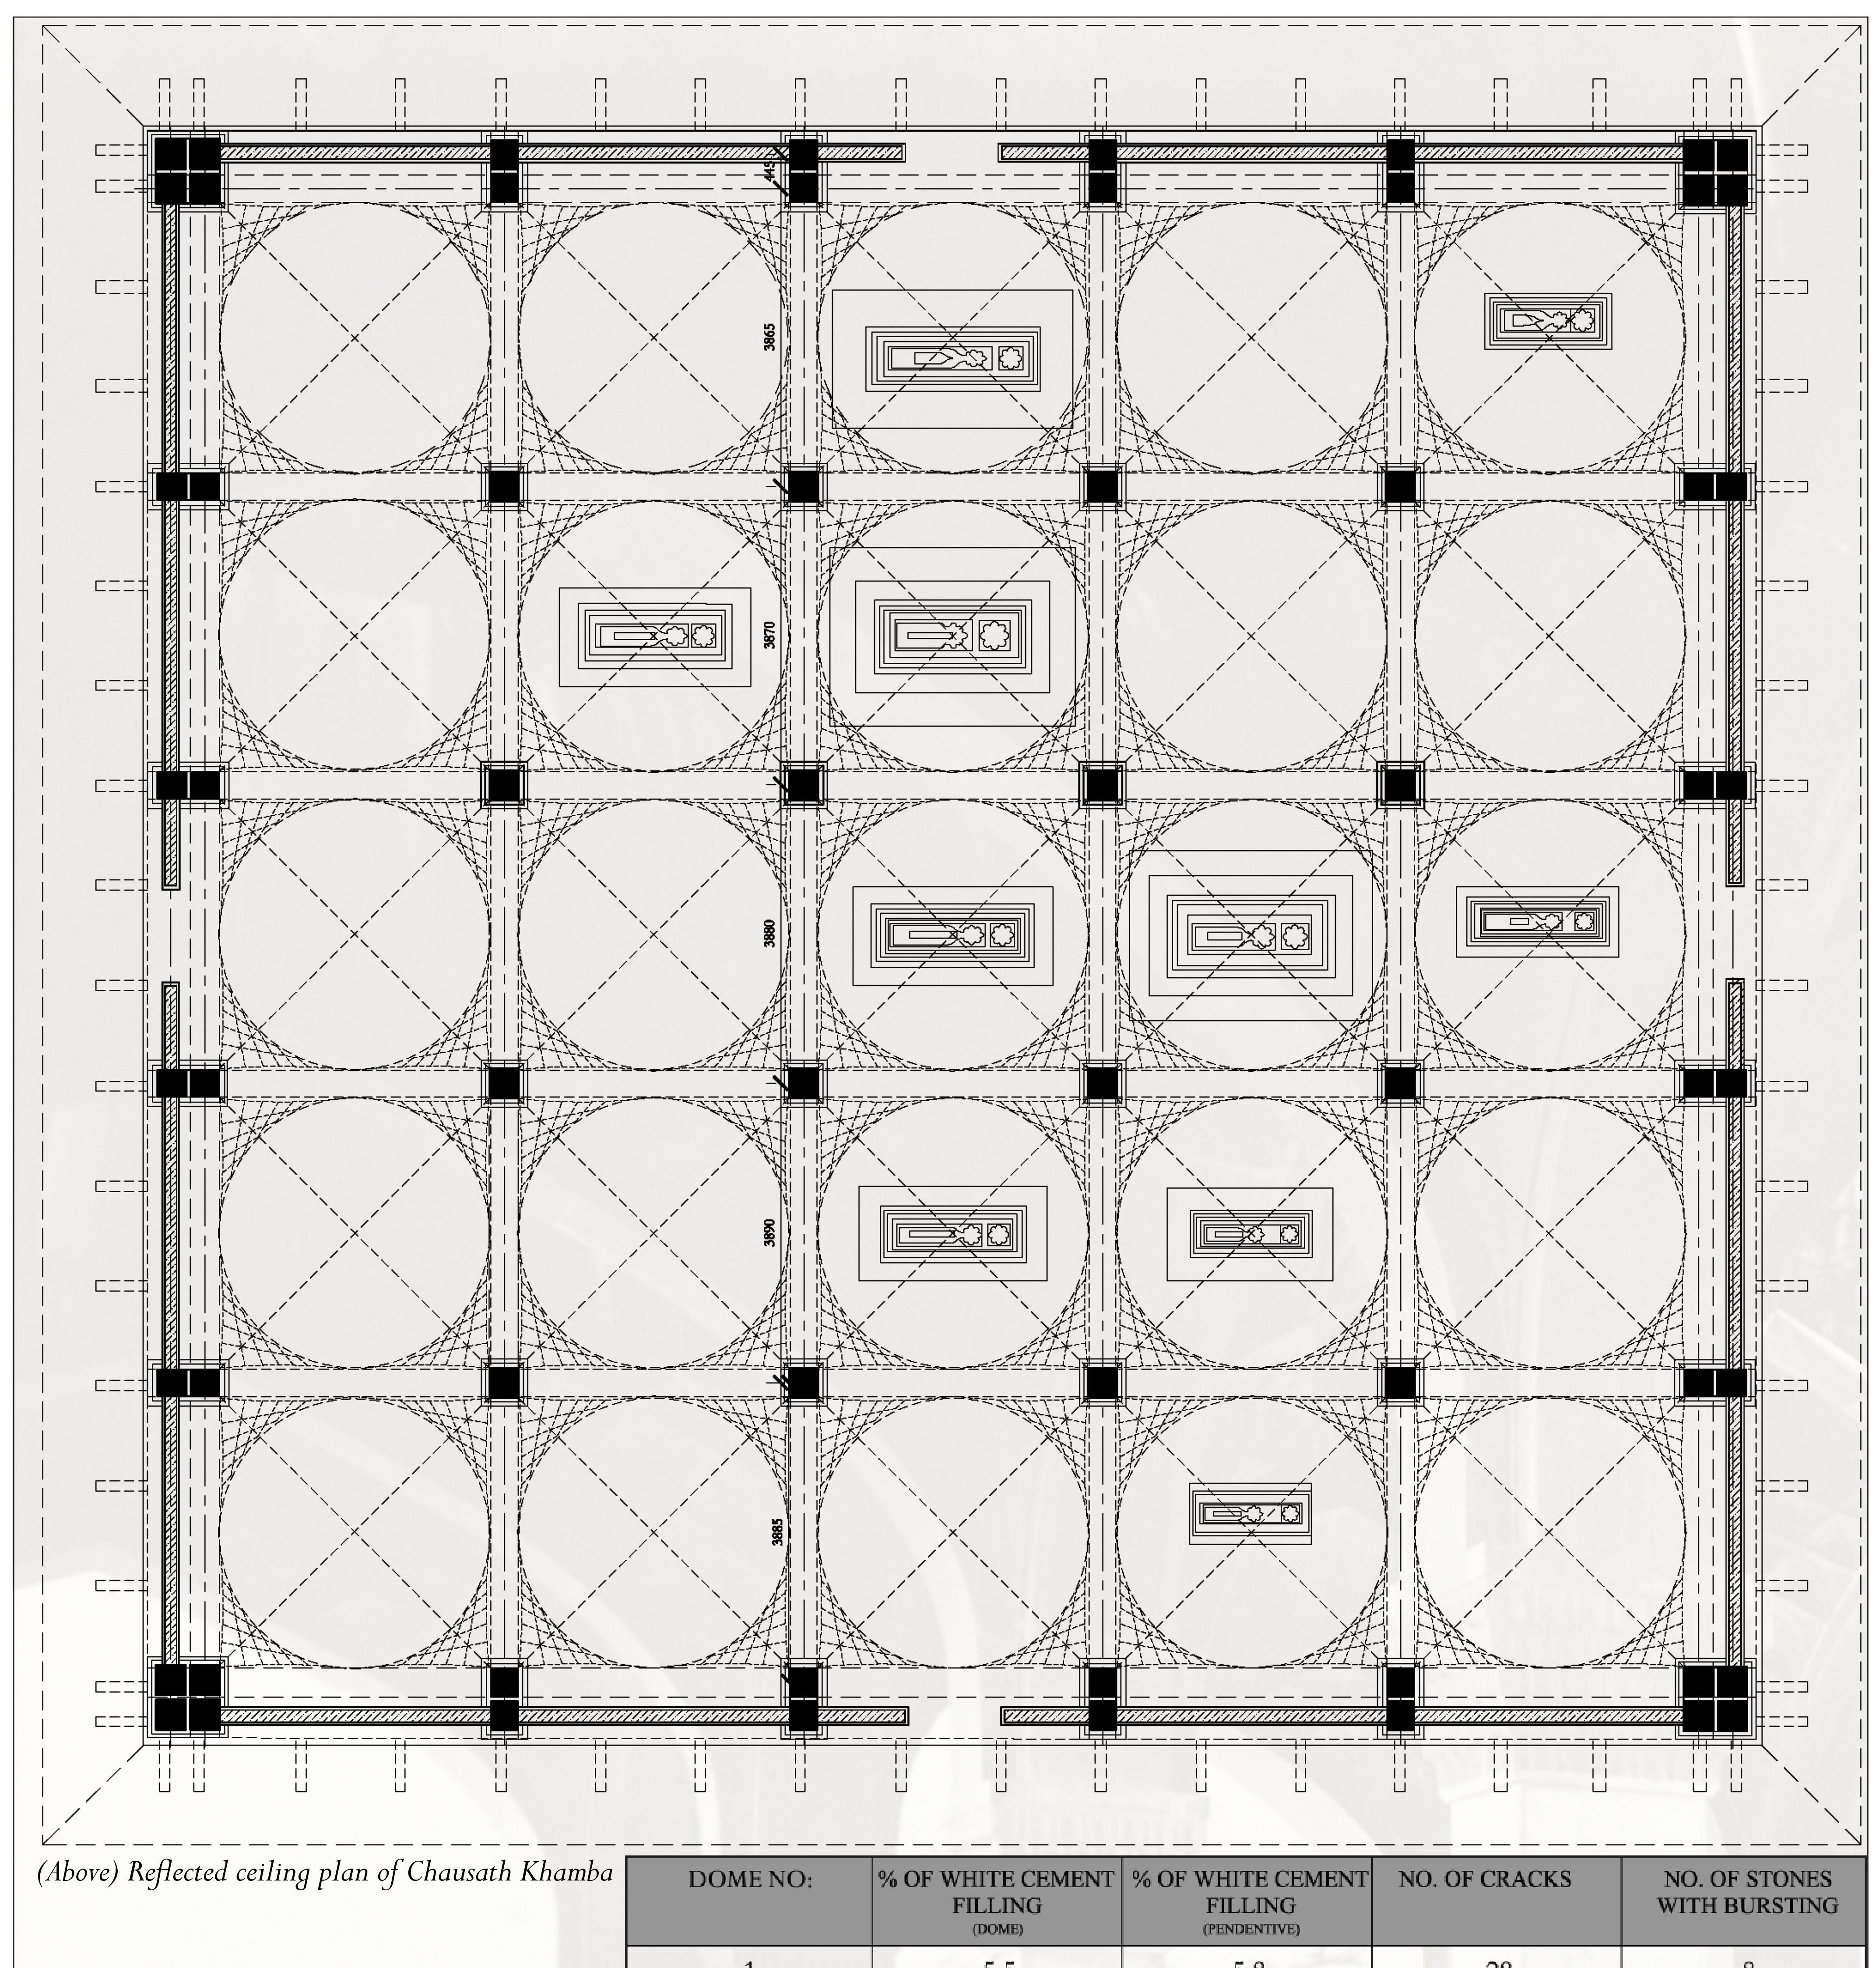
1	5.5	5.8	28	8
and the second second and the second s	2	4.4	2.2	18	2
Stone-by-Stone condition	3	3.2	2.4	4	6
assessment of the domes, exterior	4	2.9	5	9	3
and interior façades of the	5	2.8	5.4	4	-
monument was done manually on	6	4.1	3.1	1	-
the images by visual inspection	7	4.1	2.2	3	1
of each stone its defects and its	8	1.5	1	3	2
causes. Past, yet recent, repairs	9	5.12	2.7	13	3
at Chausath Khamba included	10	2.9	2.8	25	7
filling cavities created by broken	11	3.3	1	23	15
marble edges with white cement.	12	6.4	3.1	4	3
This needed to be carefully	13	2.8	1.6	3	2
removed.	14	2.6	1.3	2	2
	15	4.1	4	4	3
Each stone was closely inspected	16	3.5	1	3	-
to list required repairs by	17	1	1.1	2	-
indenting or to assess if it is not	18	2.8	1.3	7	
possible to repair and requires	19	3.1	1.7	5	6 -
replacement.	20	1.5	2	8	4
	21	2.3	1	9	8
	22	1.1	1	2	5
	23	2.2	2	2	3
	24	2.4	1	3	1
	25	1.1	1	7	1

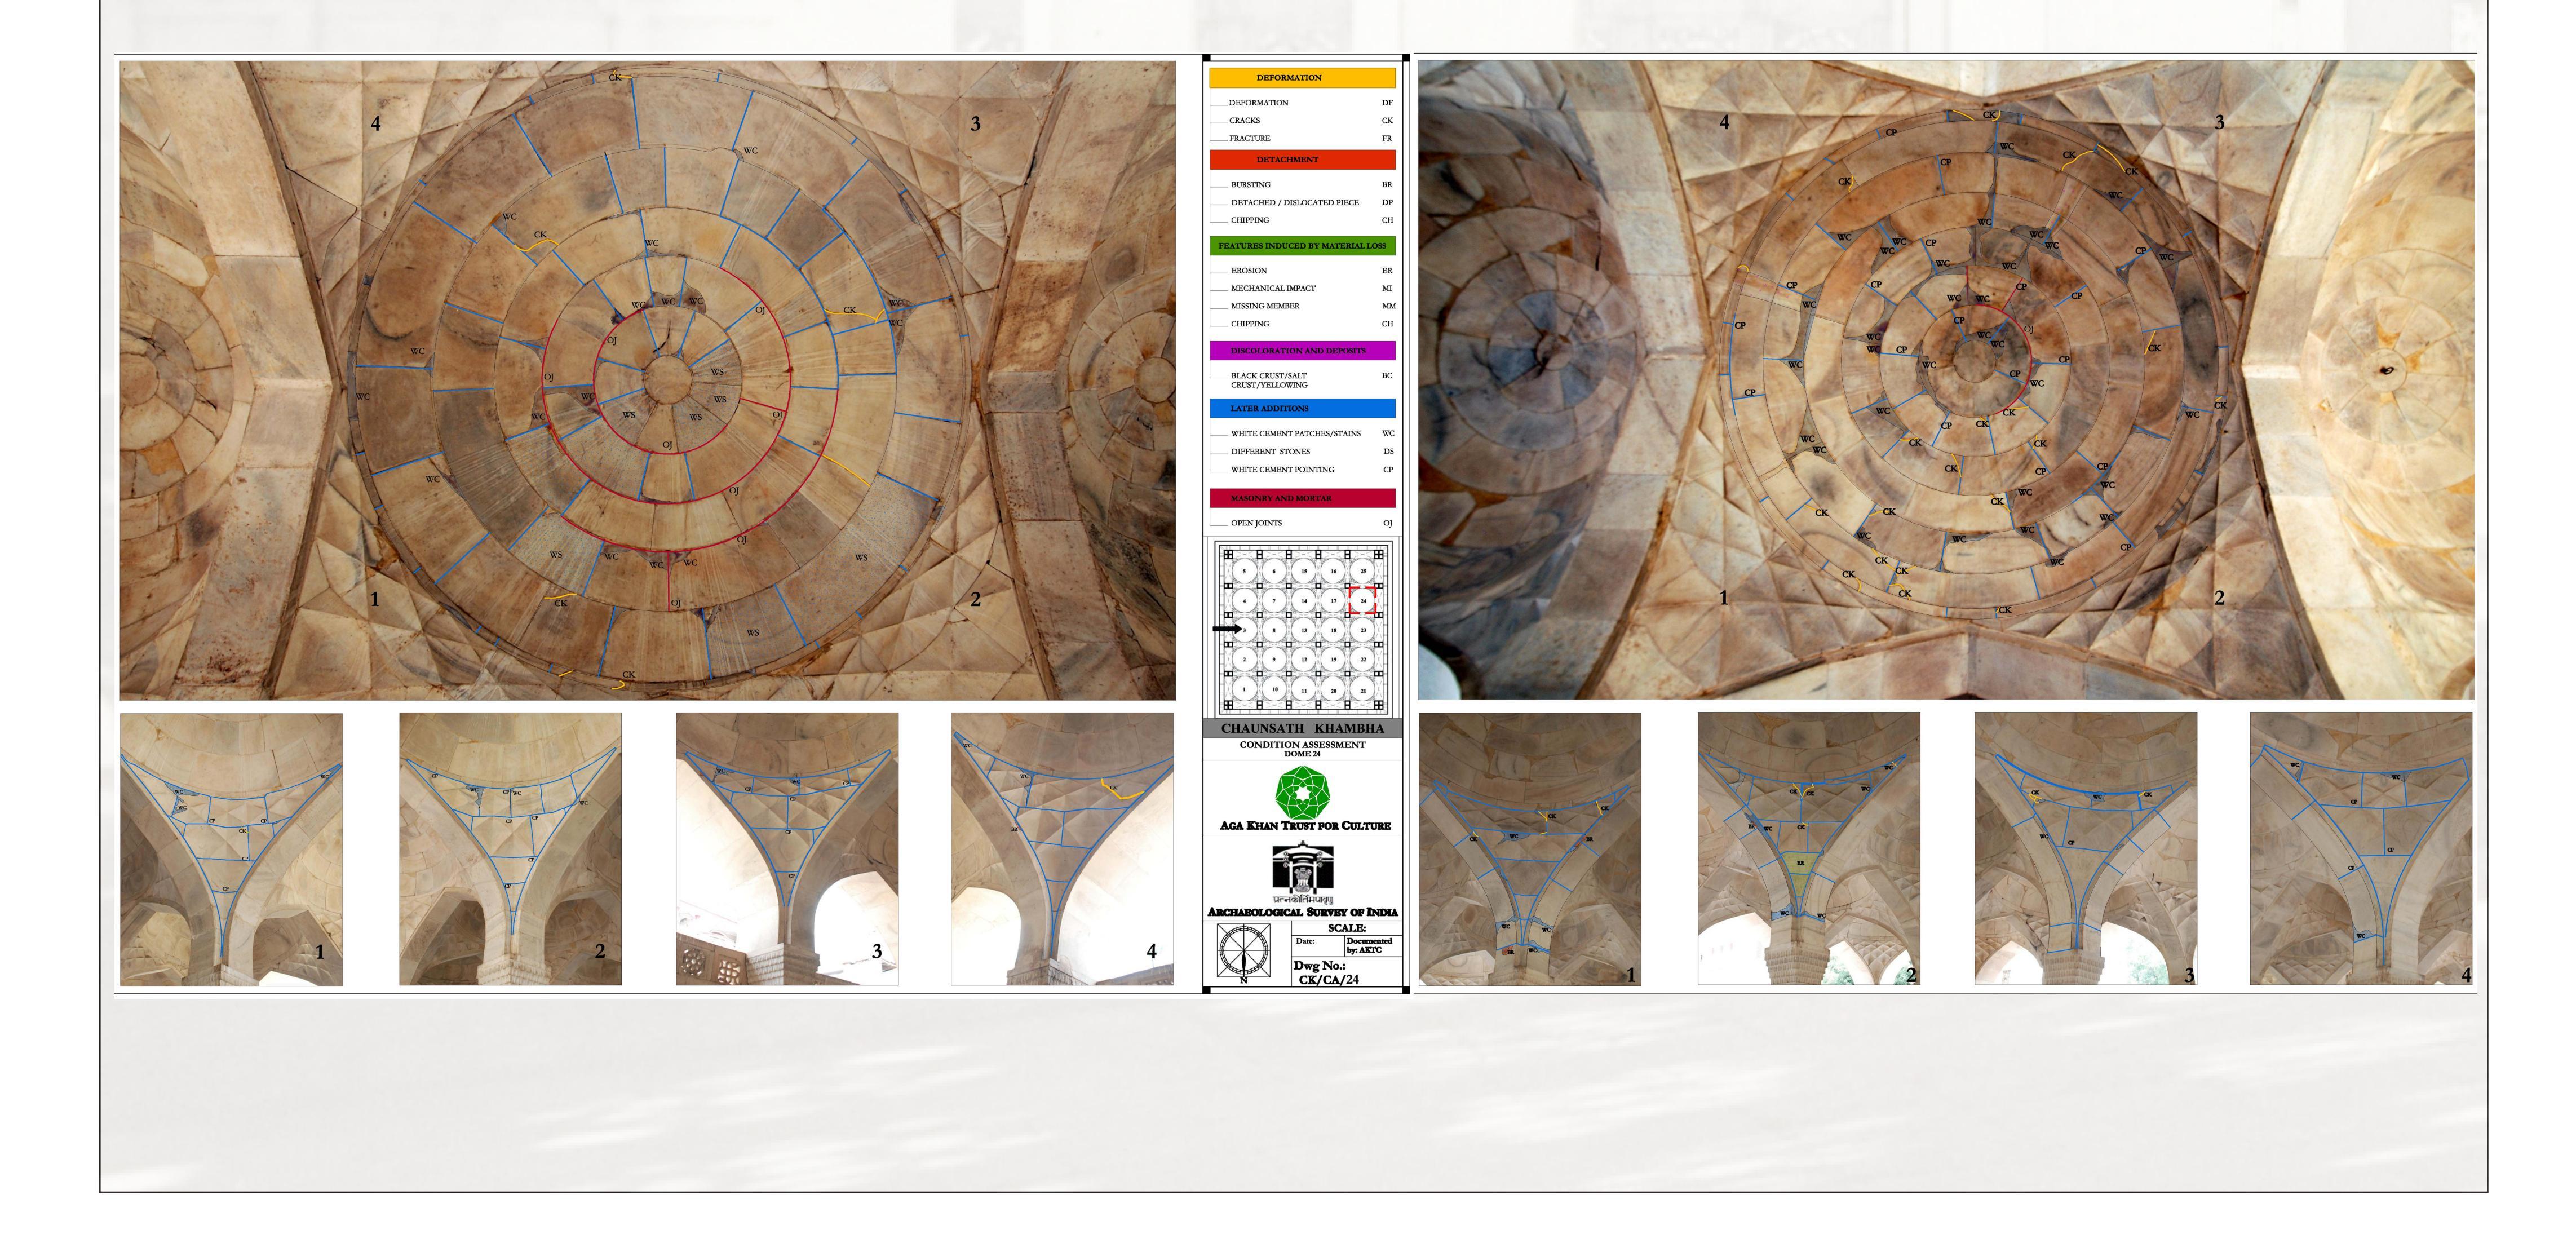
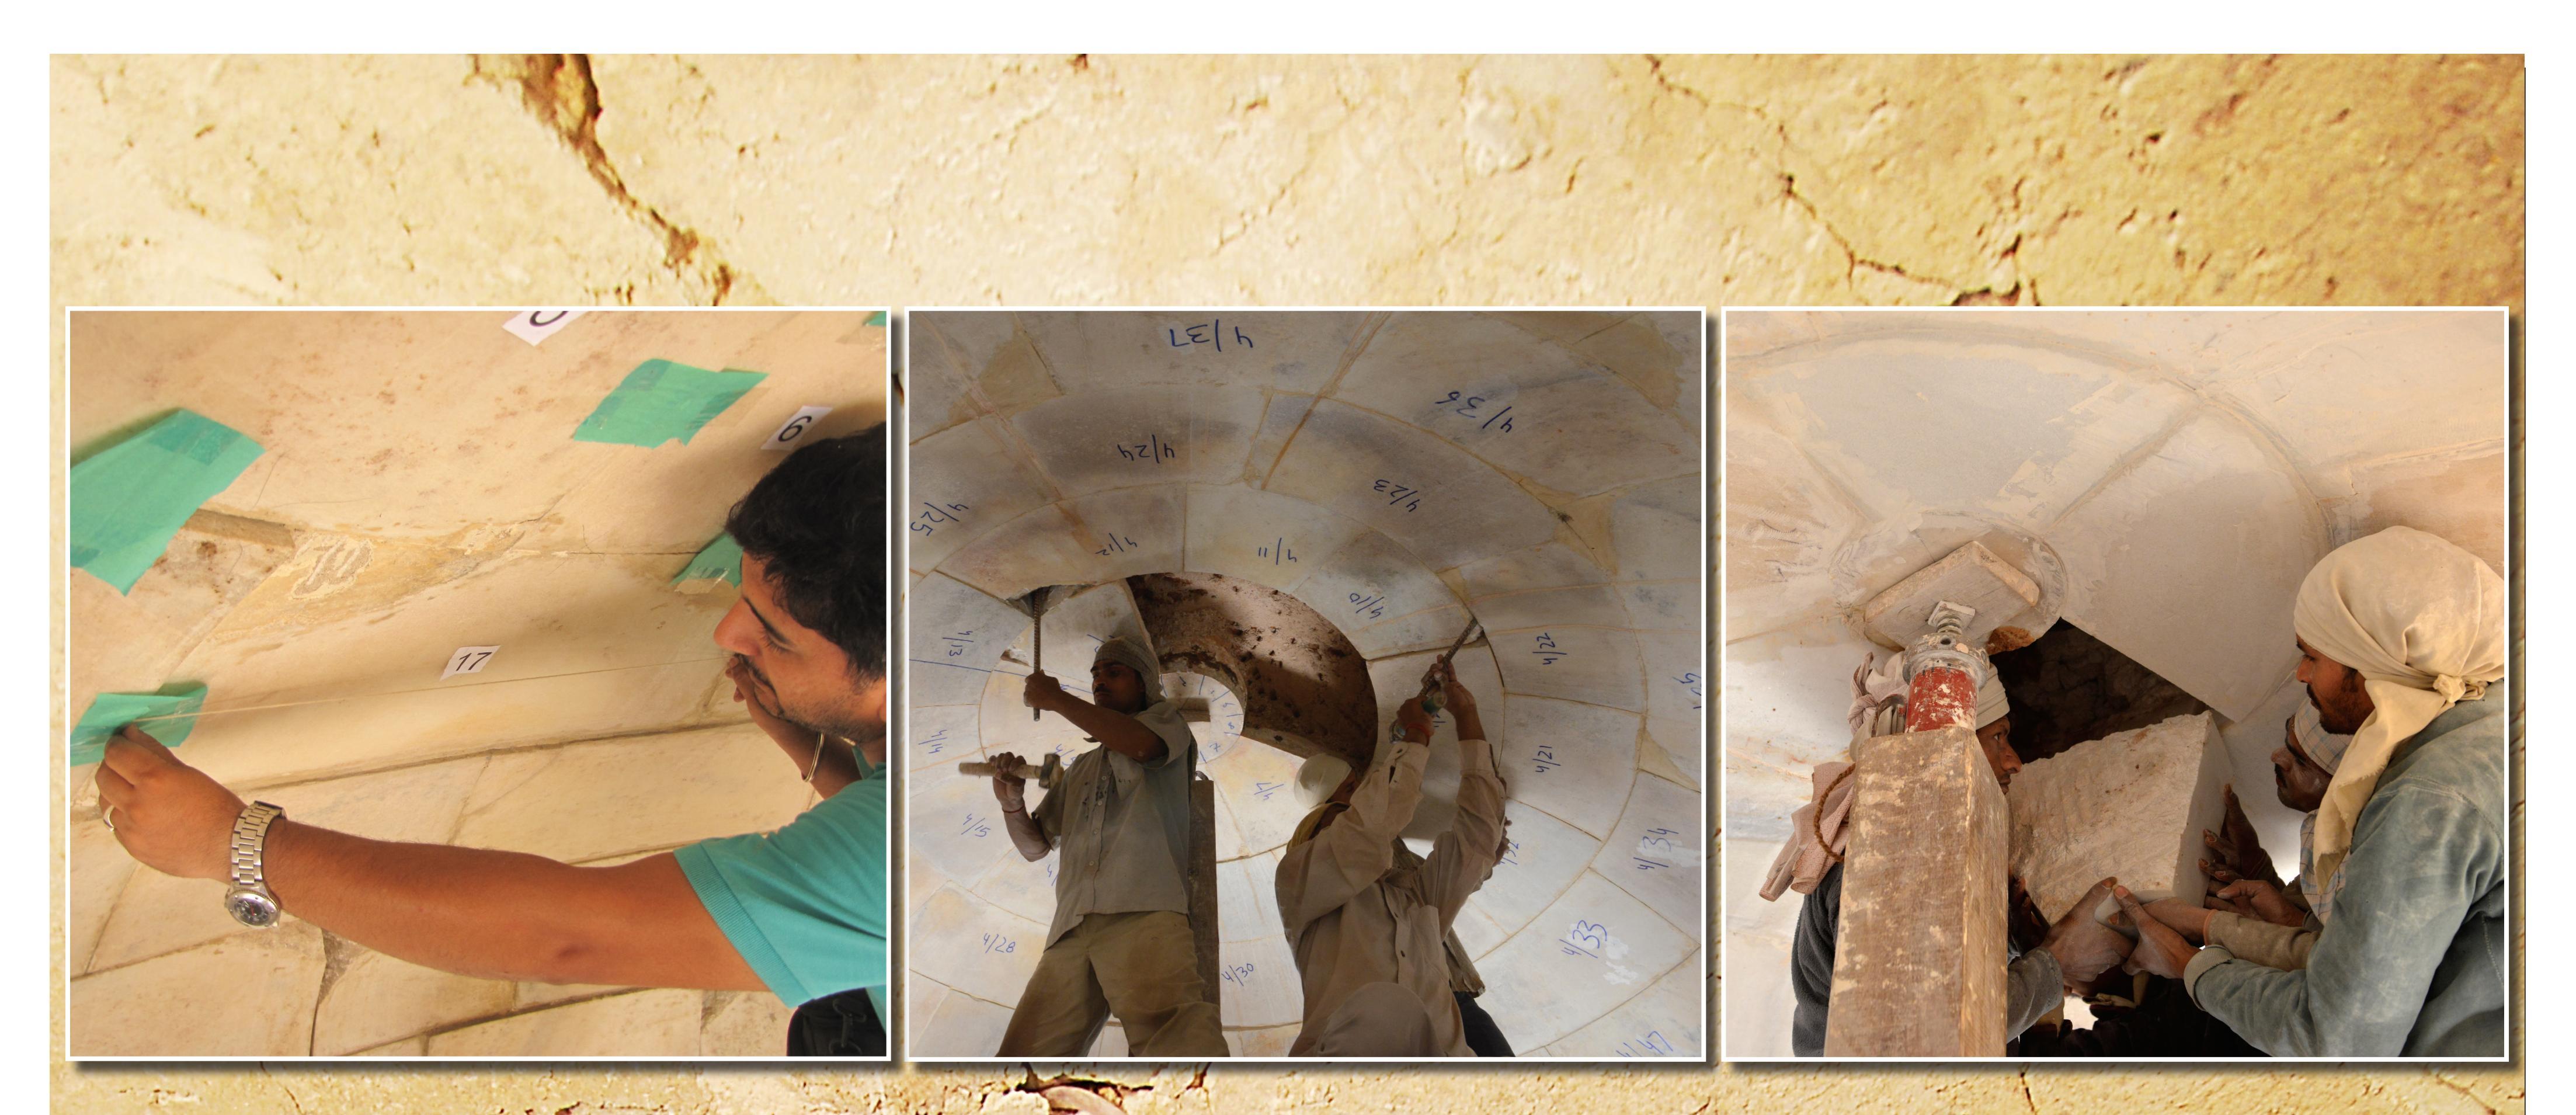
Various stages of conservation of one dome: Numbering each stone; Dismantling the marble blocks and repairing

of cracks in the masonry; and Repair of marble blocks with indents of matching stone where these had burst by master craftsmen using tools, techniques used by the original builders and Re-installation of marble blocks in the original location.

> After removing the white cement from the broken joints, tell tails were fixed over the joints for structural monitoring for further observation by trained conservation architect and engineers. Each stone weighs from 200 to 350 kilograms and requires 4 to 5 persons to remove and stack the stone. The stones being structural stones and are interlocked with each other. Proper precision needs to follow while removing the stone without damaging the stone. Shifting of stones from the scaffolding has to be done with great care with the help of rope and requires 4-5 persons without damaging the edges of the stone. The corroded Iron dowels are then removed carefully without damaging the stone and then replaced with

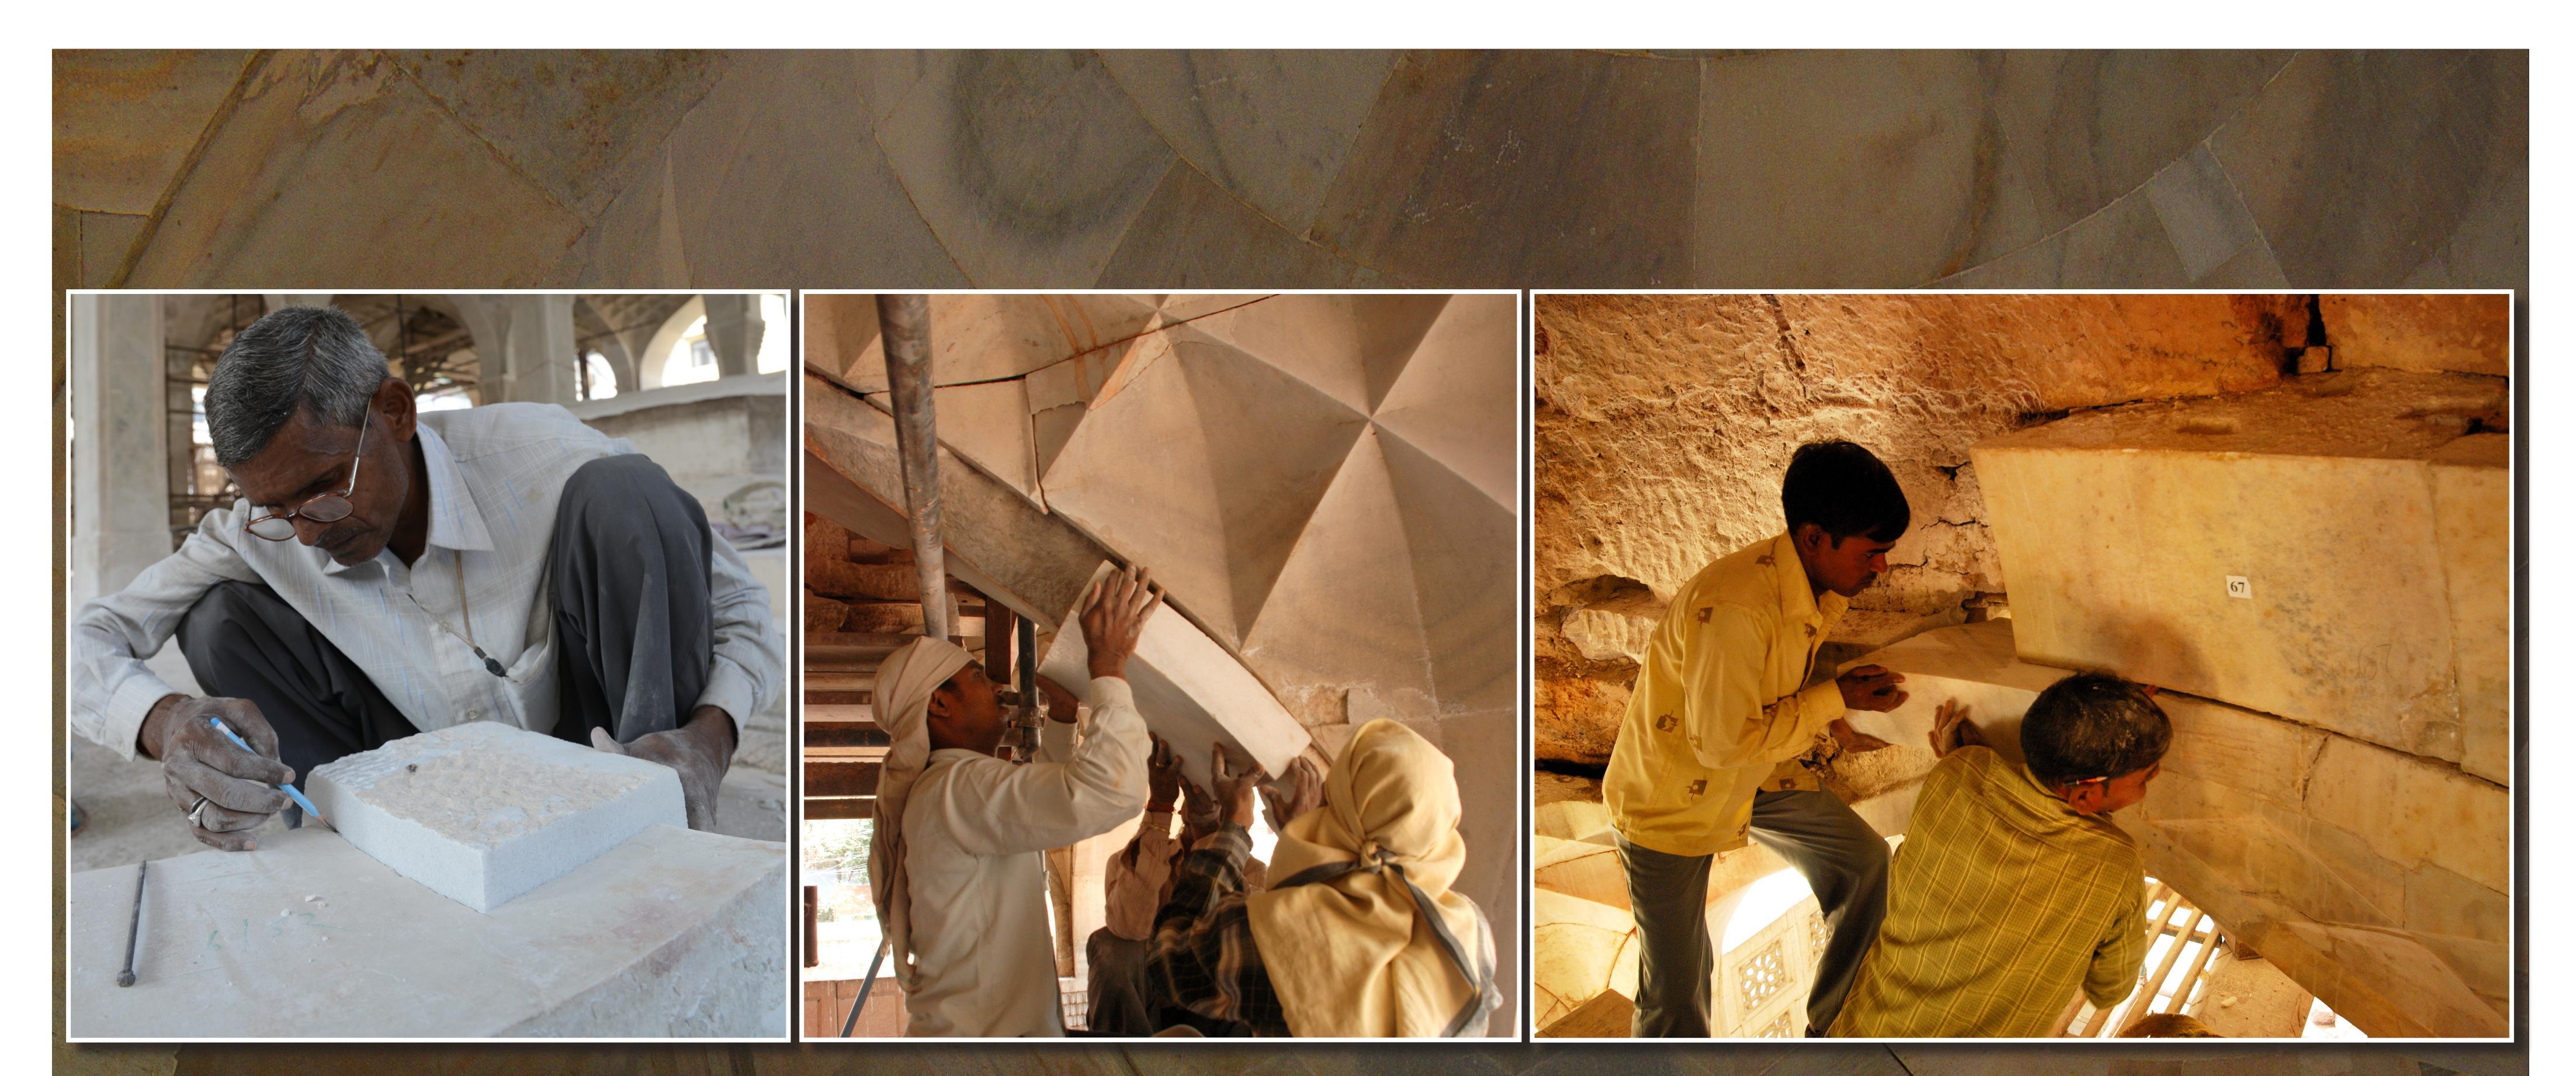
The removed stones are further closely inspected before indenting repair. After examining, the stone decision on repair methodology

is taken. The process is time consuming as each stone is unique in terms of its size and curvature on both the axis.
