CROWNING GLORY

Humayun's Tomb - Sundar Nursery - Hazrat Nizamuddin Basti **URBAN RENEWAL INITIATIVE**

RESTORING THE GOLD FINIAL with funding and technical supervision of the **Titan Company** and in partnership with the Archaeological Survey of India

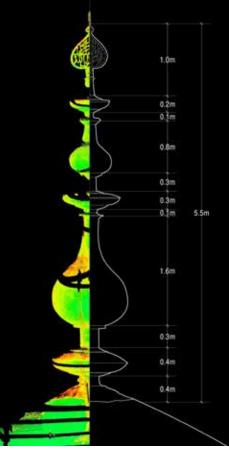
3D Laser Scanning and detailed physical documentation was carried out in 2009 providing an accurate record of each vessel (top); Following the collapse, immediate site inspections were carried out by senior officials of ASI and AKTC and a repair strategy was finalized (centre); A team of architects, engineers, scientists and traditional craftsmen – carpenters, copper-smiths (bottom), gilders – worked towards this mammoth restoration effort.

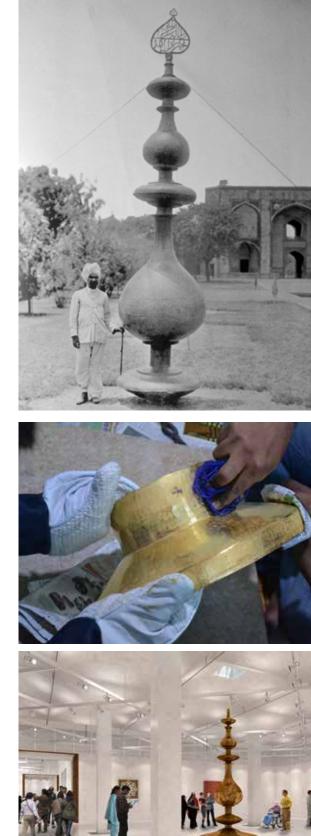
Past repairs to the finial included one in 1912, when the finial was taken down in an attempt to insert a lightening conductor on the finial (top); Gilding work on the copper vessel was carried out after each vessel underwent series of scientific tests like the gold density test, thermal shock test in the Titan lab (centre); The original finial will be repaired and showcased as a centrepiece of the Humayun's Tomb Interpretation Centre (bottom).
