CHAUNSATH KHAMBA

Chausath Khamba

CHAUSATH KHAMBHA

CHAUSATH KHAMBA CONSERVATION

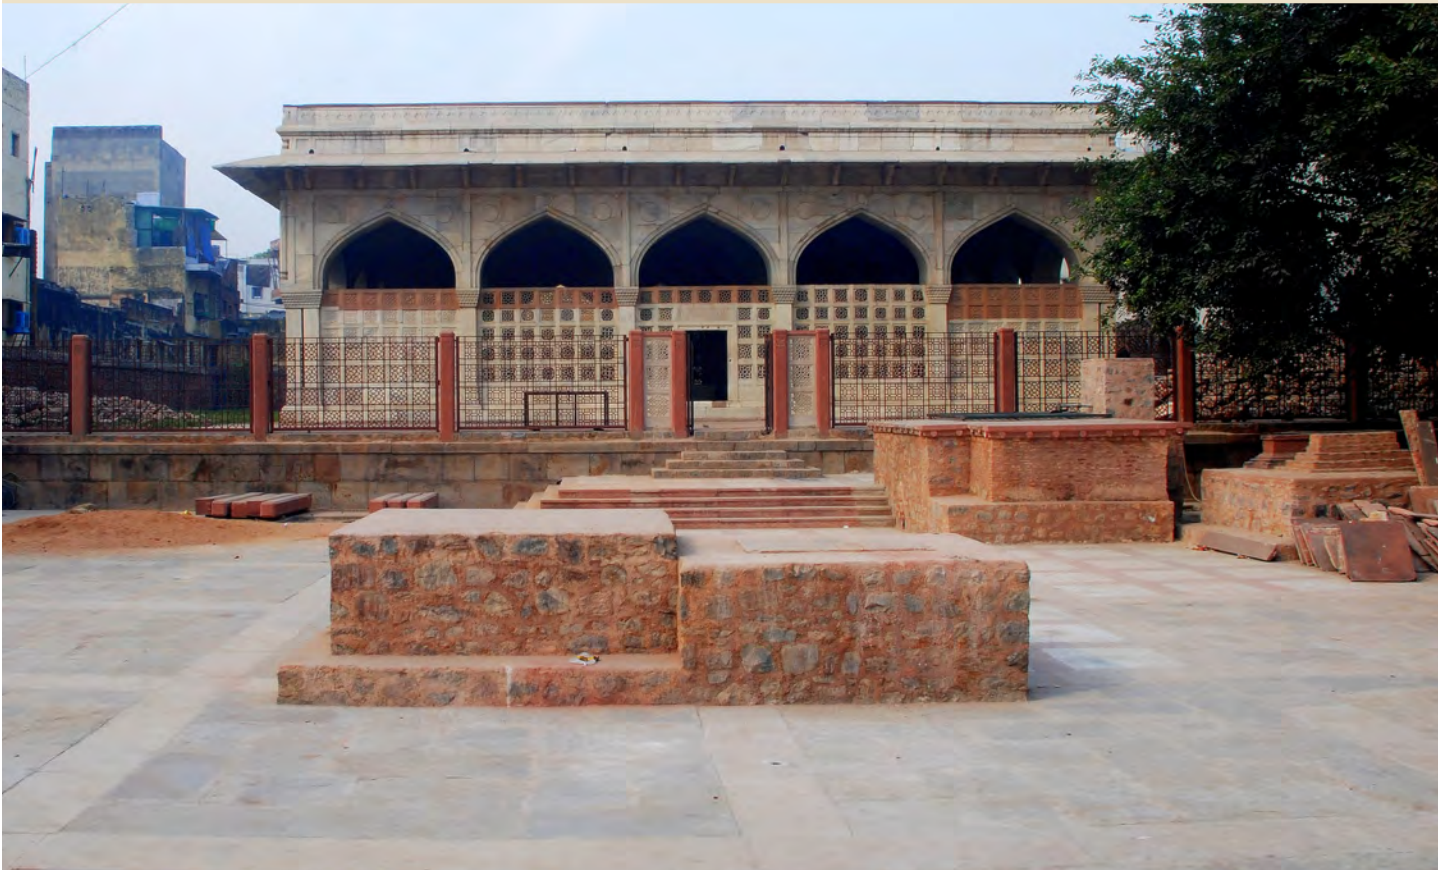
The area comprising of Chausanth Khamba, Urs Mahal courtyard and Mirza Ghalib Tomb, form the largest open space in Nizamuddin Basti. The three presently segregated sites will be integrated by the landscape design thereby enhancing the cultural significance of the place and allow appropriate community usage.

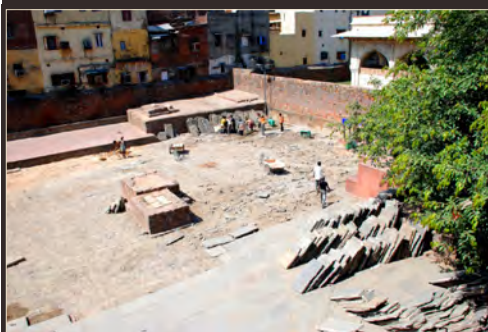
The large forecourt has been paved, in a formal design, reflective of Mughal style. This required the existing paving to be removed though portions of the stonework could eventually be re-used in the new design.

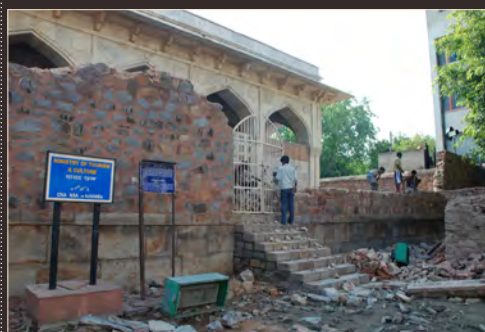
The random rubble masonry wall built in the 1960's, disfigured the historic relationship of the monument to its forecourt. This wall has now been demolished and replaced with a protective metal fence that allows visibility of the monument

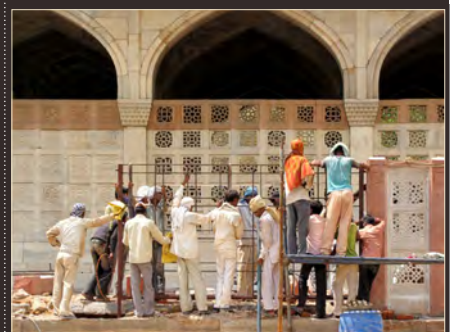
Craftsmen install the sandstone pillars that support the metal fencing.

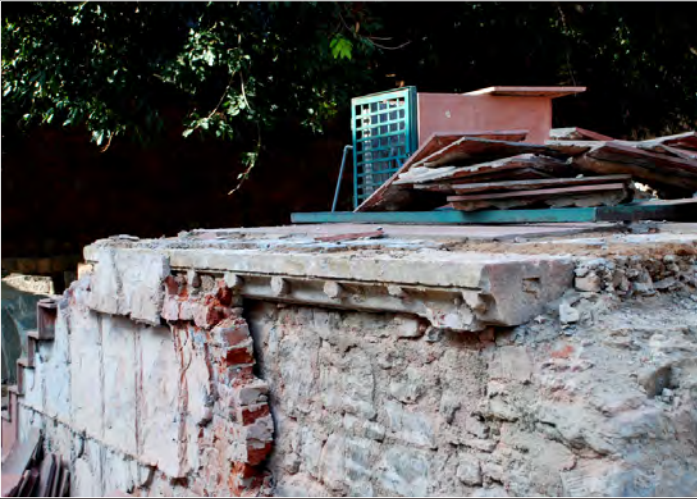
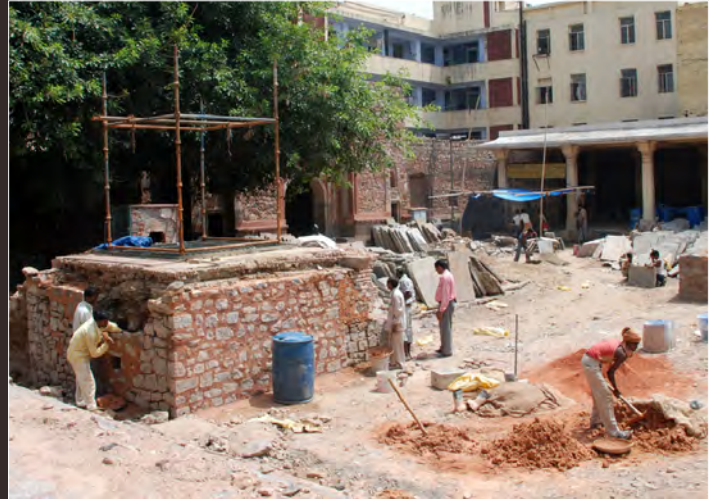
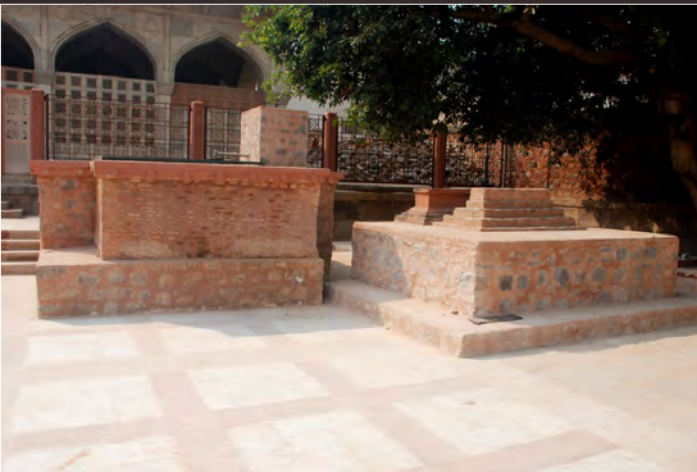
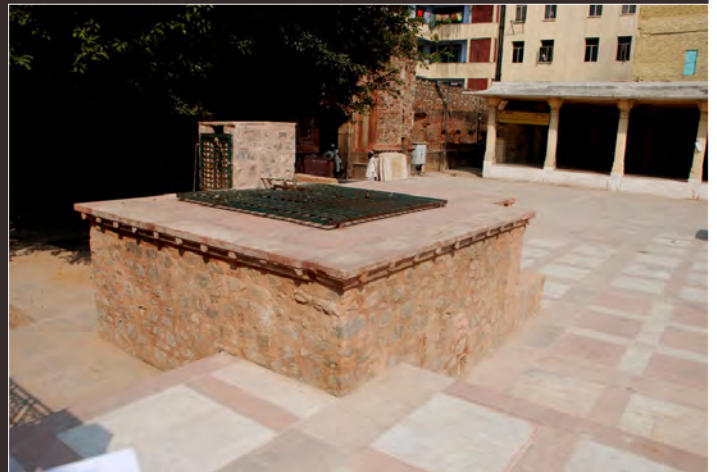
The historic well - during conservation works

The historic well in the Chaunsath Khambha courtyard was clad in brick masonry and sandstone cladding – disfiguring its architectural and historical character. The modern layers have now been peeled away restoring the original stone masonry wall and sandstone edging

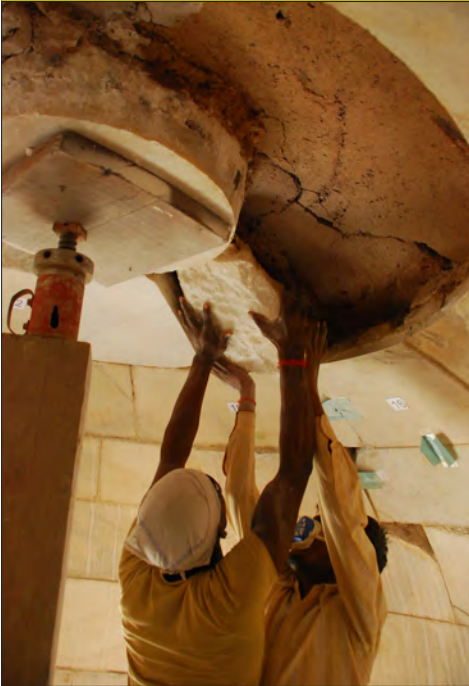
The structural stability of the tomb structure is threatened by the severe erosion of iron dowels and resulting in cracking of the marble elements.

- After careful investigation and trials it was agreed that repairs could only be carried out by dismantling the marble pieces of the dome to be followed by replacement of Iron dowels with stainless steel and carry out repairs to damaged stones prior to refixing.

- The corner south-east chamber of the monument has been taken up for repairs on an experimental basis in September 2011.
- After proper scaffolding and shuttering was installed the marble rings were dismantled one-by-one and carefully marked.

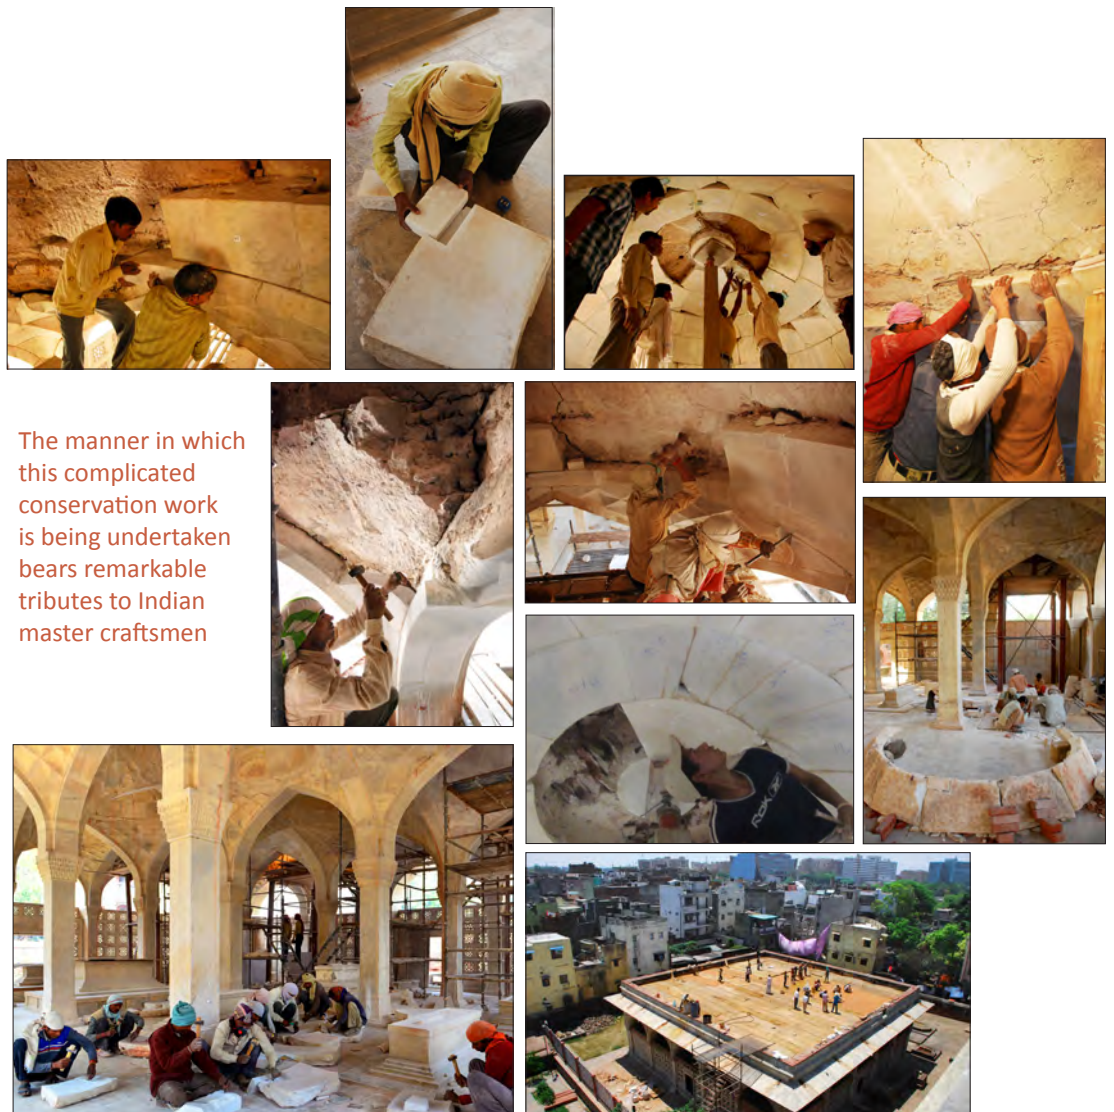
The plan of this unique 16th century marble building is inspired from Iranian garden palaces and in turn inspired the Emperor Shah Jahan's Diwan-i-khas of the Red Fort. In one of the most complex conservation efforts ever undertaken, each marble piece, most weighing over a 1000 kilos, from the 25 domed cells, is being dismantled to remove the 16th century iron dowels many of which have rusted and damaged the marble. The iron dowels are being replaced with non-corrosive stainless steel prior to fixing the marble back in its original position. In the process, meter deep cracks in the underlying masonry are being carefully stitched and repairs required to many of the marble pieces carried out.

The manner in which this complicated conservation work is being undertaken bears remarkable tributes to Indian master craftsmen

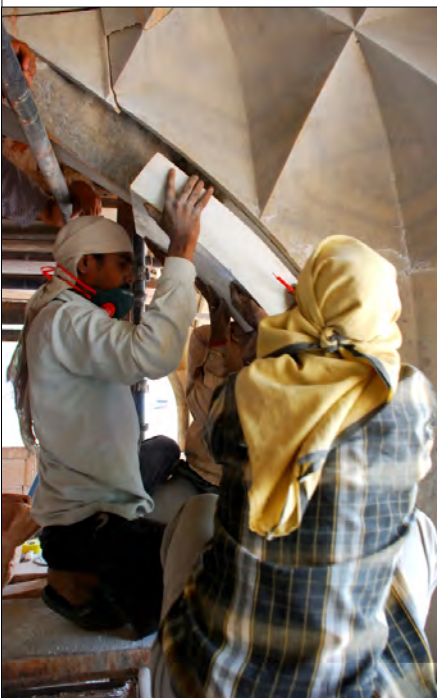
▲ Stone carvers fix the repaired marble elements back to their original location on the structure

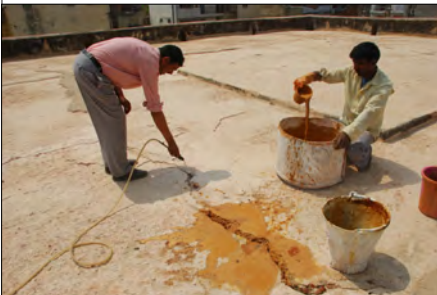
◀ The 230 mm thick layer of cement concrete from the roof was removed and pressure grouting was done to repair the network of cracks in the roof. New layer of lime concrete with additives like Jaggery and Bael fruit pulp (*Belgiri*) was laid maintaining the original slope levels. Clogged water spouts were opened to avoid rain water from stagnating.

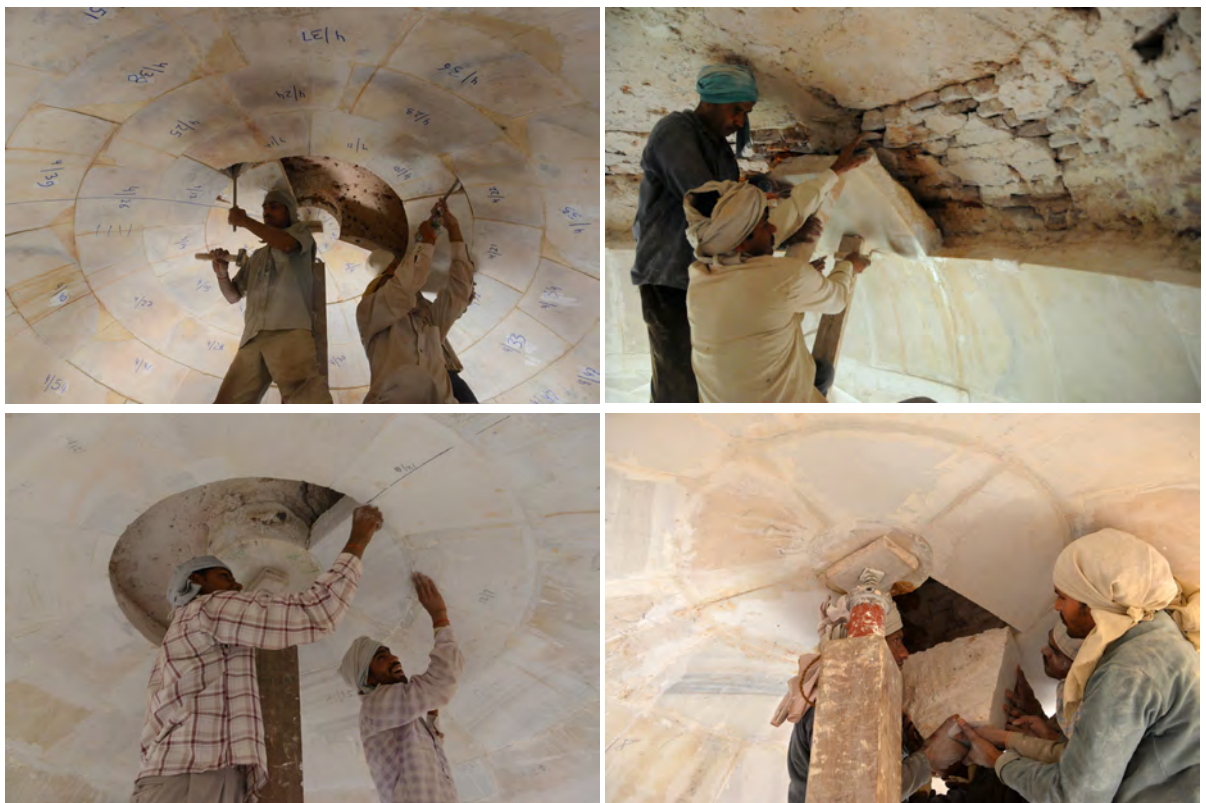
(Below) Various stages of conservation of one dome - in all 25 domes were restored in Chausath Khamba

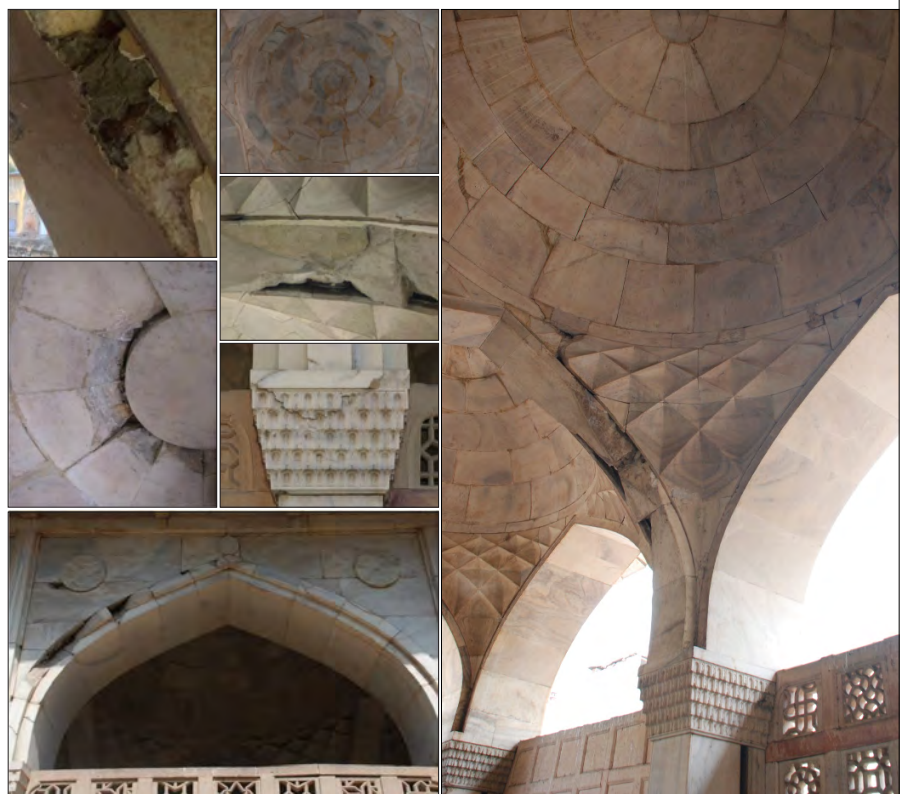
Material Deterioration due to past repairs in white cement – masking the damage but allowing the deterioration to accelerate; Chipping of Marble elements like domes, arches, facade, pendentive, jaalis and column capitals; Rusting of iron dowel due to water seepage led to bursting of the marble

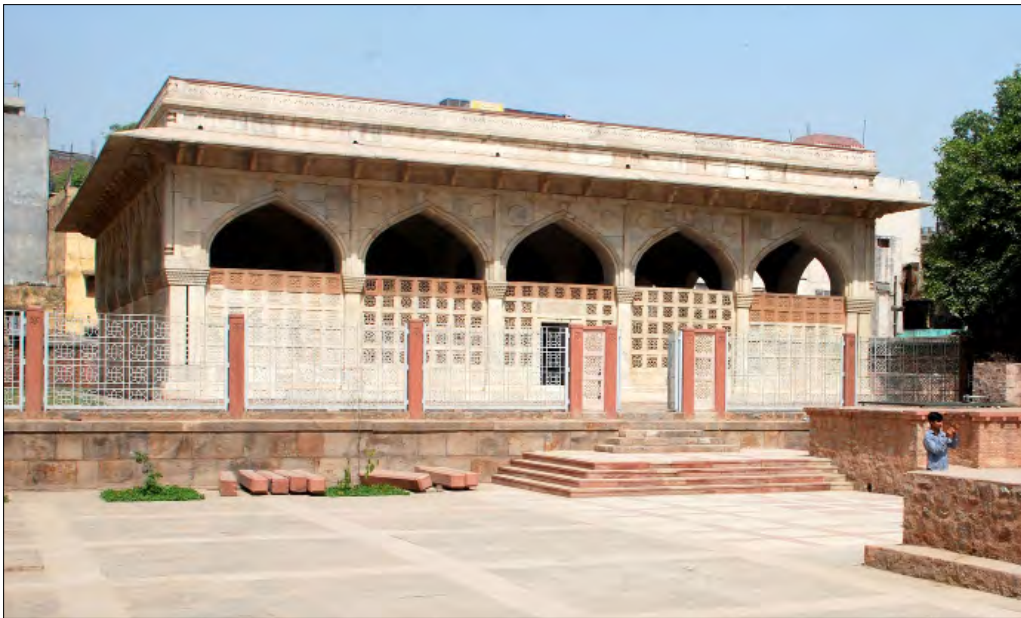
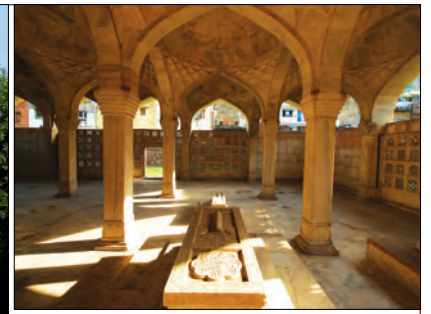
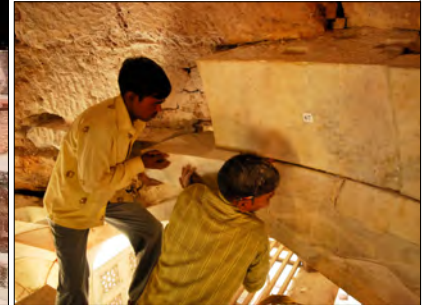
Each stone was closely inspected to list required repairs by indenting or to assess if it is not possible to repair and requires replacement.

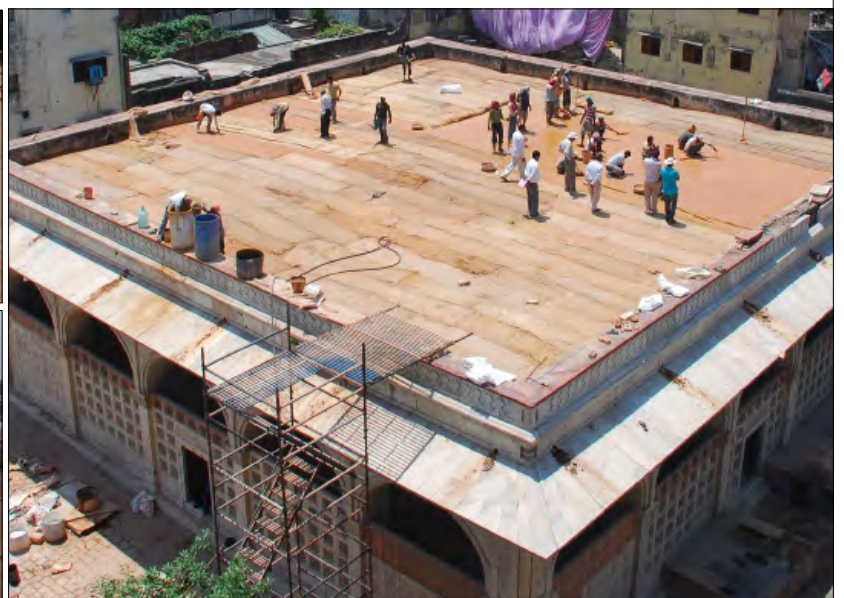
The masonry above the domes had 1 metre deep and 4" wide cracks through which the water was seeping inside the building. These cracks were required to be repaired urgently to stop further deterioration. The 230 mm thick layer of cement concrete from the roof was removed without disturbing the underneath structure and pressure grouting was done to repair the network of cracks in the roof which were approximately 2 meters in depth. A new layer of lime concrete with additives like Jaggery and Bael fruit pulp (Belgiri) was laid maintaining the original slope levels. Clogged water spouts were opened to avoid rain water from stagnating.

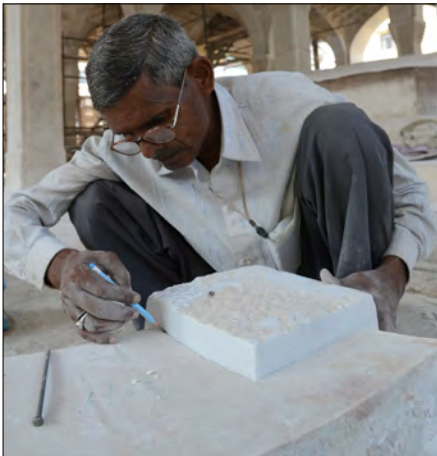
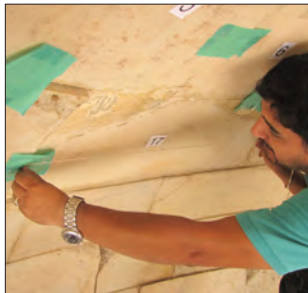
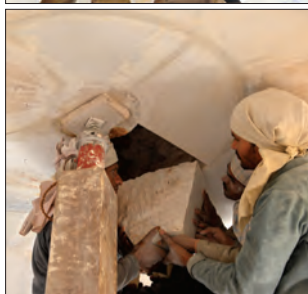
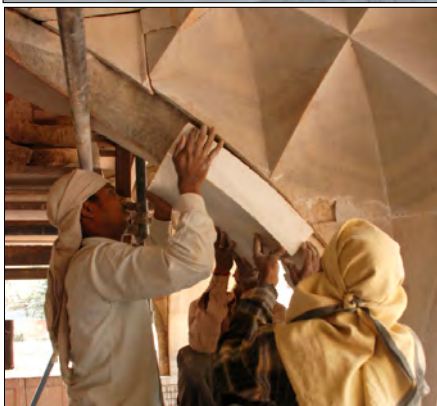
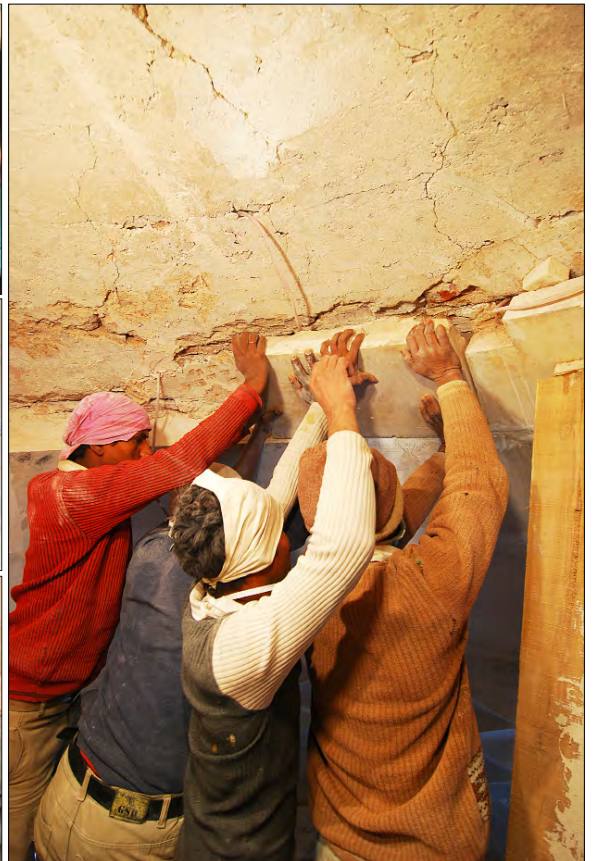
Various stages of conservation of one dome: Numbering each stone; Dismantling the marble blocks and repairing of cracks in the masonry; and Repair of marble blocks with indents of matching stone where these had burst by master craftsmen using tools, techniques used by the original builders and Re-installation of marble blocks in the original location.

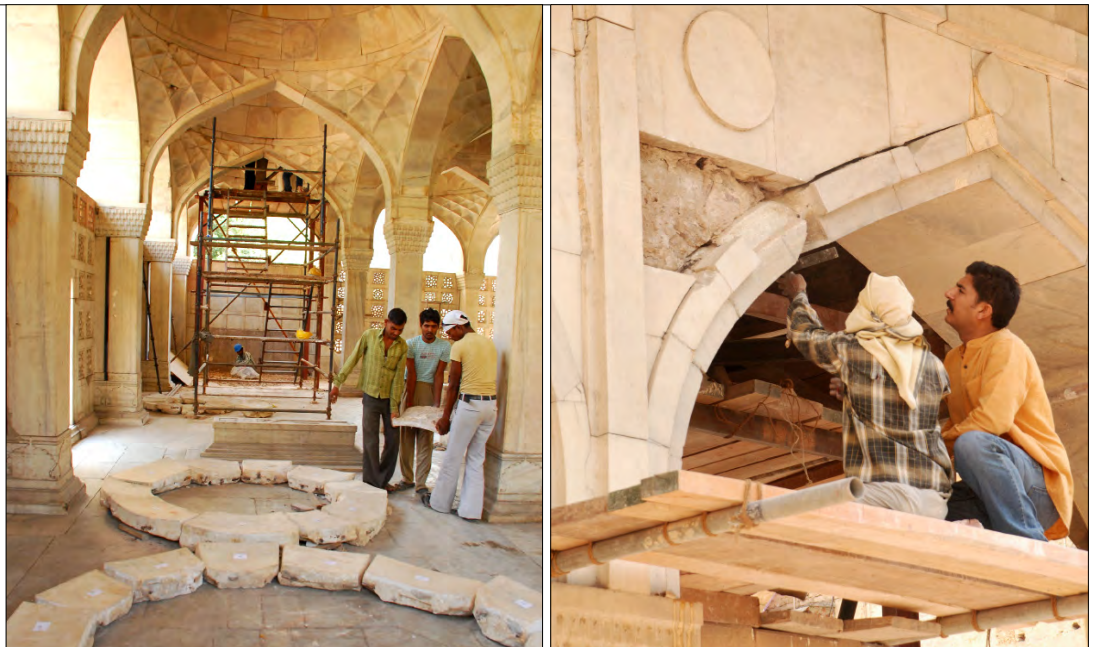
The removed stones are further closely inspected before indenting repair. After examining, the stone decision on repair methodology is taken. The process is time consuming as each stone is unique in terms of its size and curvature on both the axis.
