# Batashewala Complex

## CONSERVATION & LANDSCAPE RESTORATION

# BATASHEWALA ENCLOSURE

## Chota Batashewala

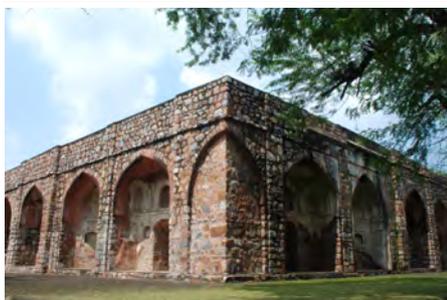
**Mirza Muzaffar Hussain's Tomb**  
*Before conservation in 2010*

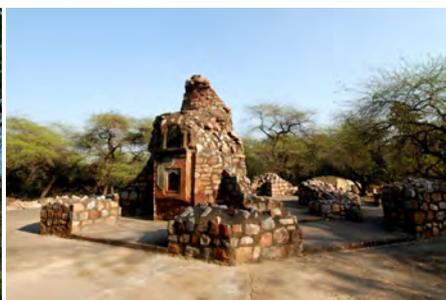
**Chota Batashewala**  
*Before conservation in 2010*

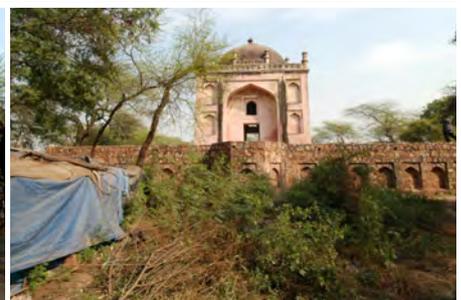
**Mughal Tomb**  
*Before conservation in 2010*

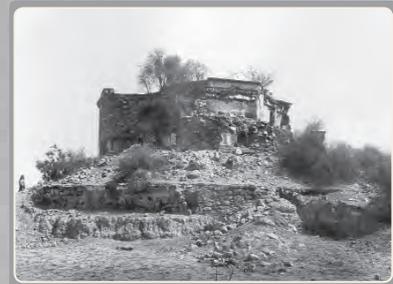
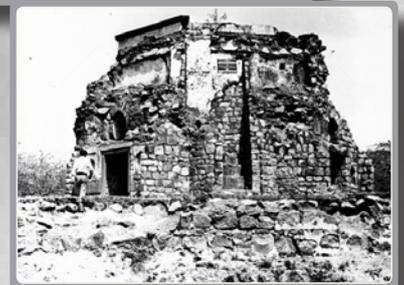
Chota Batashewala with Mughal Tomb  
in the background

1930 A.D. ▲

1955 A.D. ►

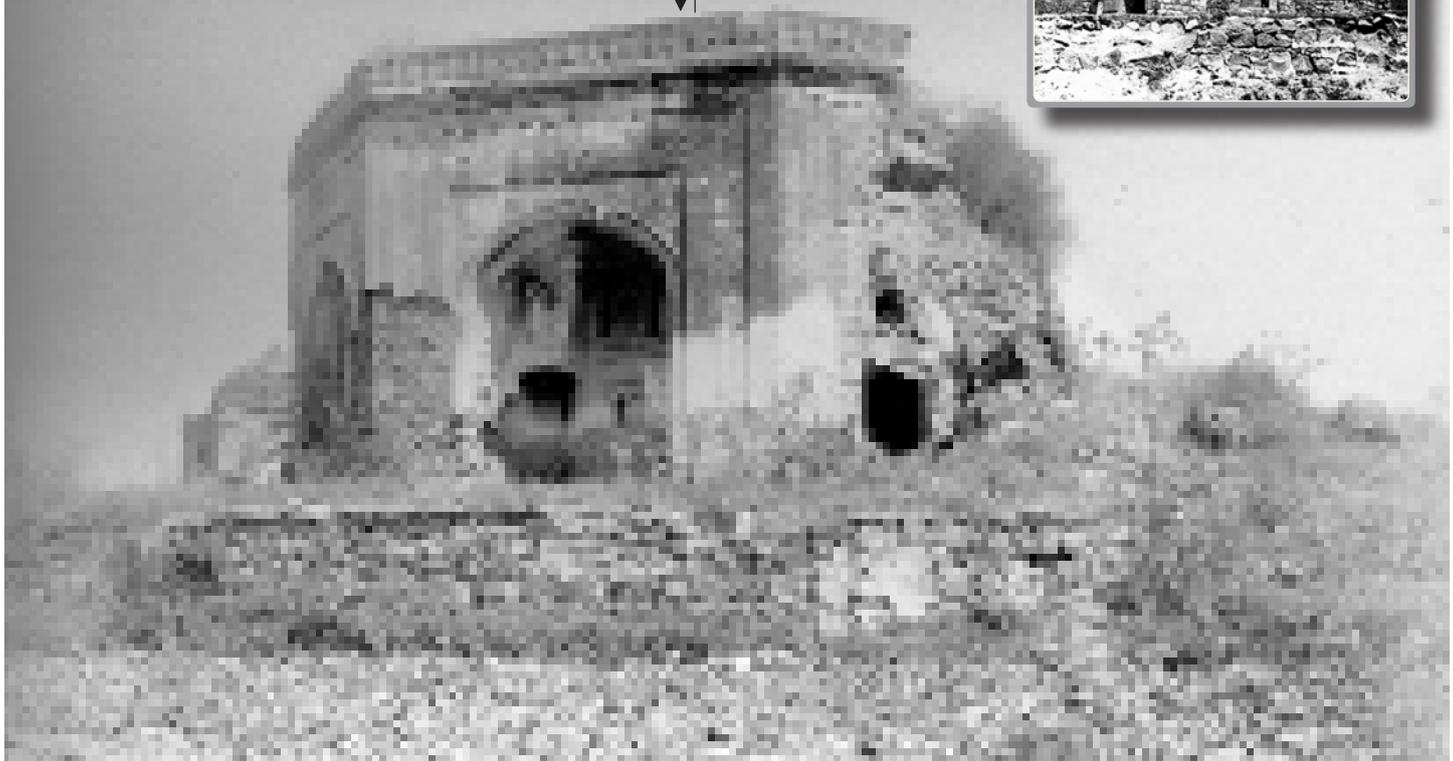
The ASI protected monument known as Chota Batashewala, seems to have largely collapsed following the leveling of land, by Bharat Scouts and Guides, in its immediate setting in 1989 to build the structures for the Bharatiyam event. This as the structure seems to have had no foundations and with the leveling of the mound on which it stood all its foundations were exposed.

- The remains on the site were found to be either raised or consolidated in cement concrete as past repair. It was also found that the entire surface area of the plinth was covered by 20 cm of cement concrete. The first conservation task was to remove all the cement concrete from the entire plinth and the remains of the walls of the tomb.

- During earthworks near the Chota Batasha, it was found that platform stood directly over the earth. The stabilization of the structure required a support from all the sides.

- To counter this problem, an earth mound is designed all around the structure which provides stability to the structure.
- The mound rises till 1M and has a 900 mm wide DQ masonry wall to a depth of 900 mm wrapping all around it.

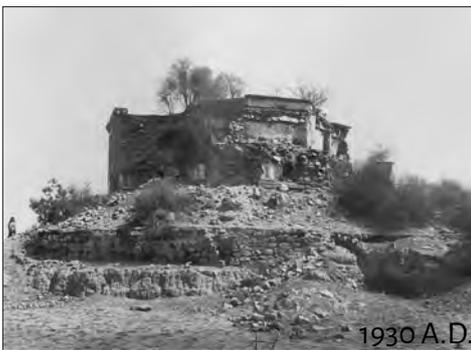
Using archival images, the effort here has been to raise standing portions of the structure to complete just one portion of the facade in order to indicate to visitors the original scale and profile.

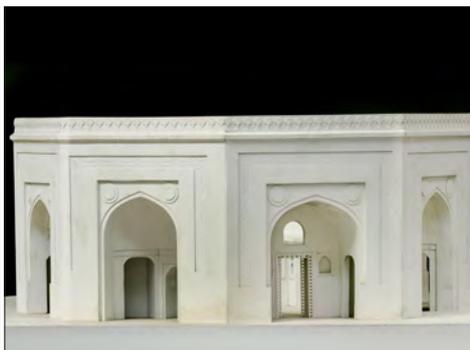
Architectural models created to understand the structure in detail

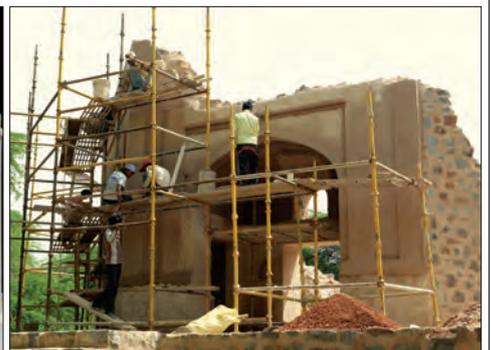
Restoration works on the structure as per the evidences, archival images found
