# Humayun's Tomb Complex

Conservation Works undertaken during 2008-14

**Nizamuddin Urban Renewal Initiative**

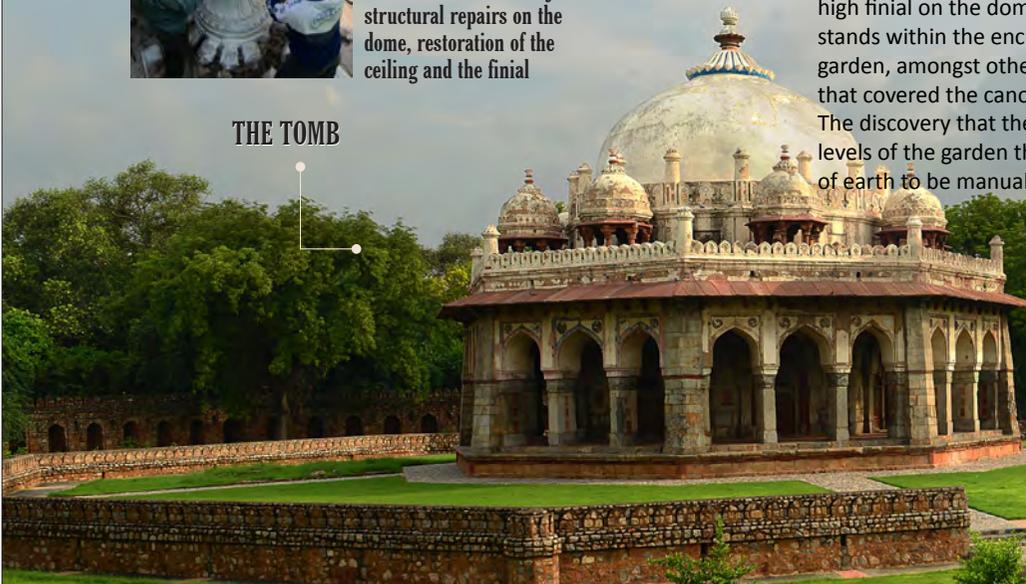
## THE TOMB

Conservation works on the tomb have included major structural repairs on the dome, restoration of the ceiling and the finial

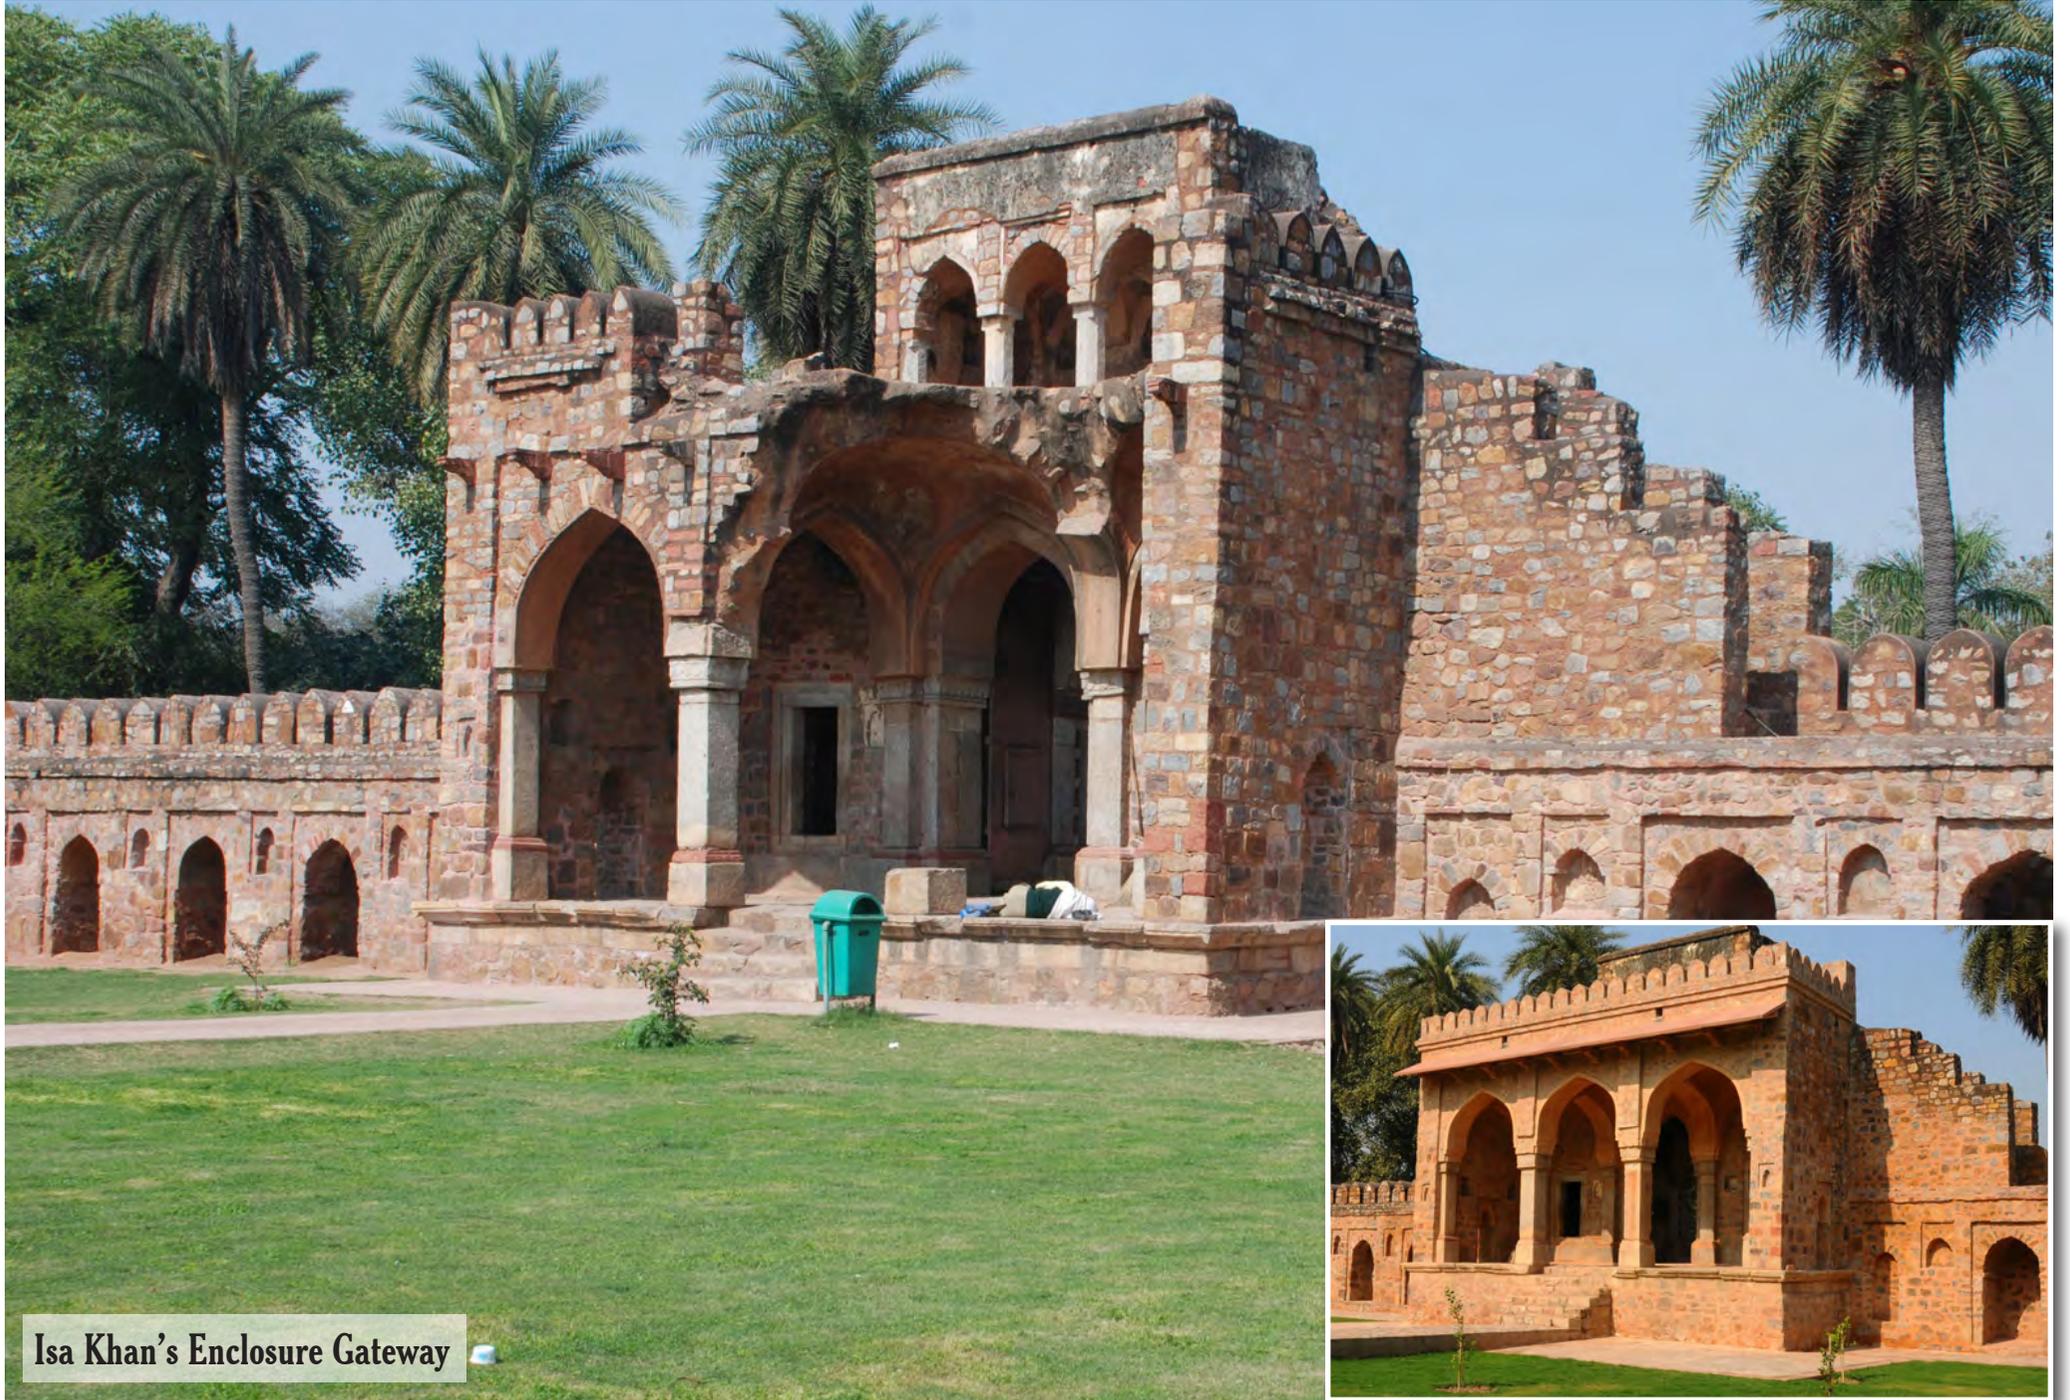
Isa Khan's Enclosure Gateway

Conservation works in the Isa Khan's garden tomb enclosure, have included reconstruction of the collapsed portions of the gateway; structural repairs to the garden retaining wall; restoration of the 2.5 m high finial on the dome; major structural repairs to the Mosque that stands within the enclosure; de-silting of a well discovered within the garden, amongst others. Stone finials to the canopies as well as the tiles that covered the canopy are to be restored.  
The discovery that the outer garden was originally four feet below the levels of the garden that surrounds the tomb required 125,000 cubic feet of earth to be manually removed to restore historic levels.

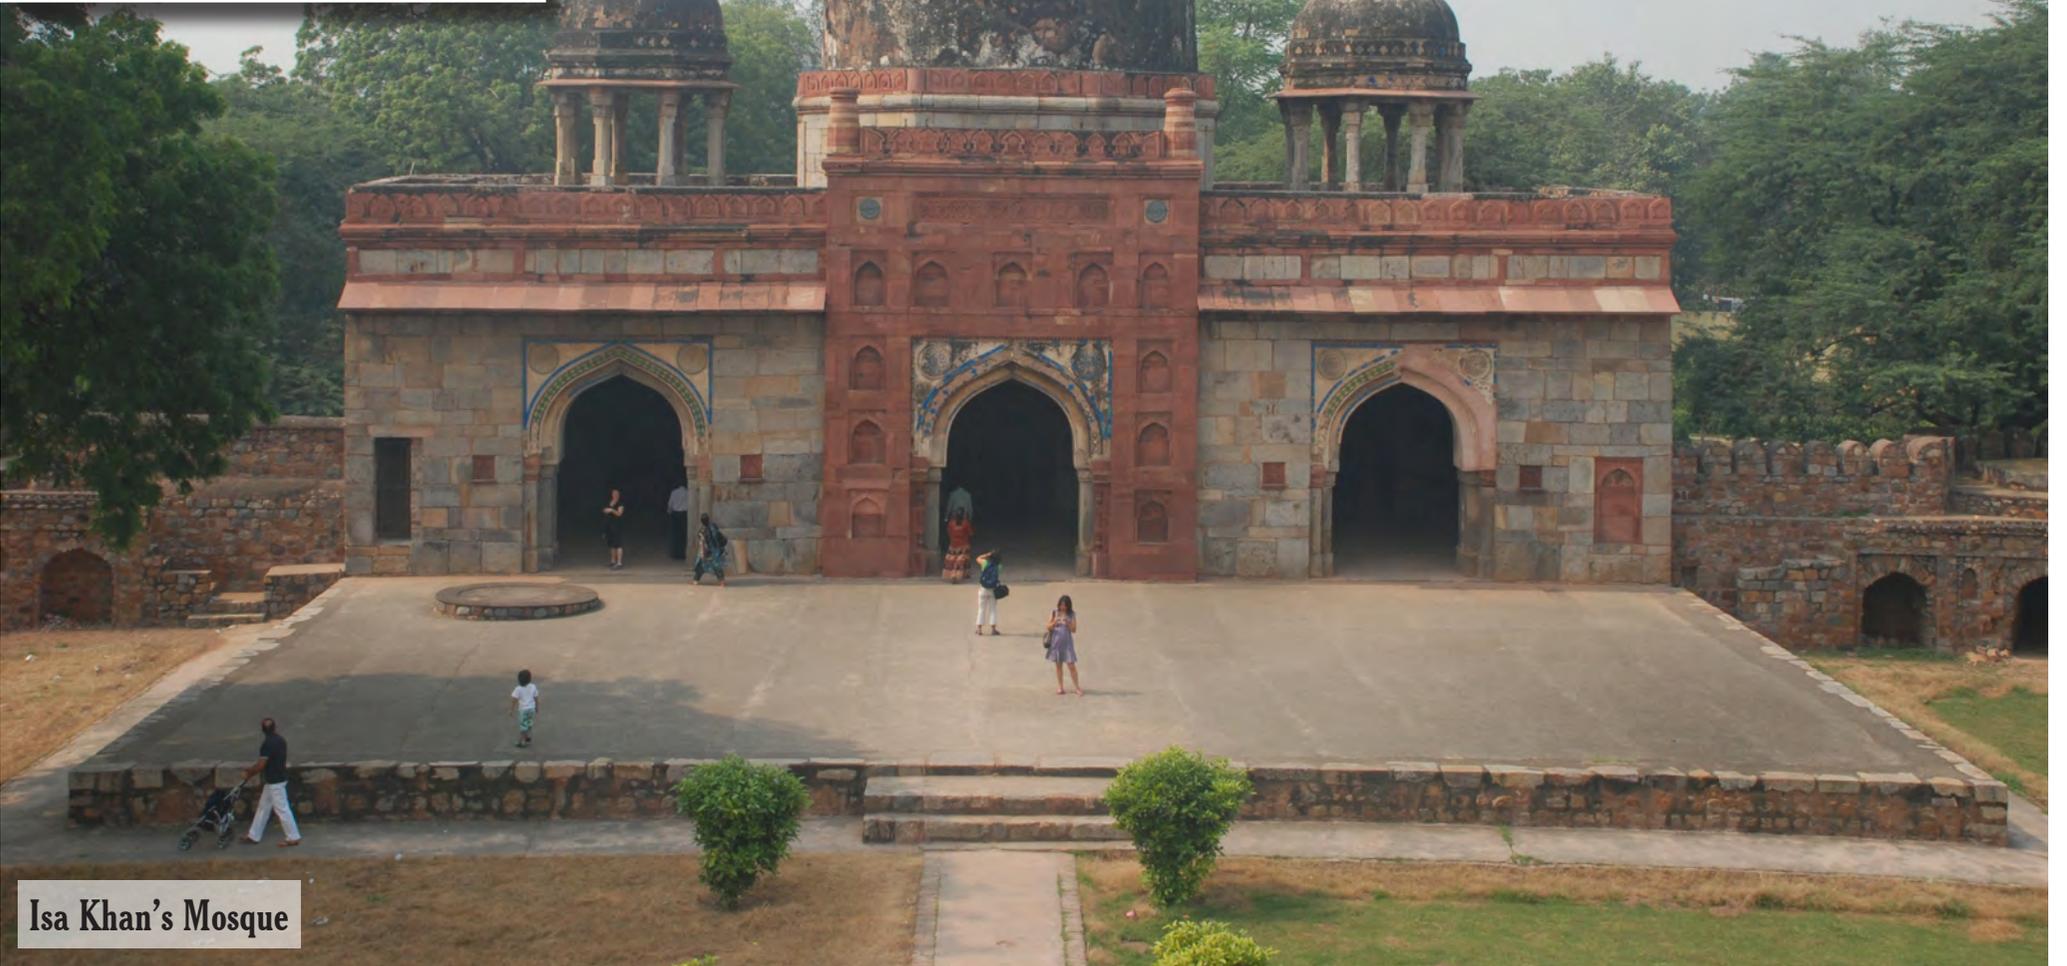
Isa Khan's Mosque

The interiors of the mosque also required cleaning of the stone surfaces and re-plastering with lime mortar following the removal of cement plaster

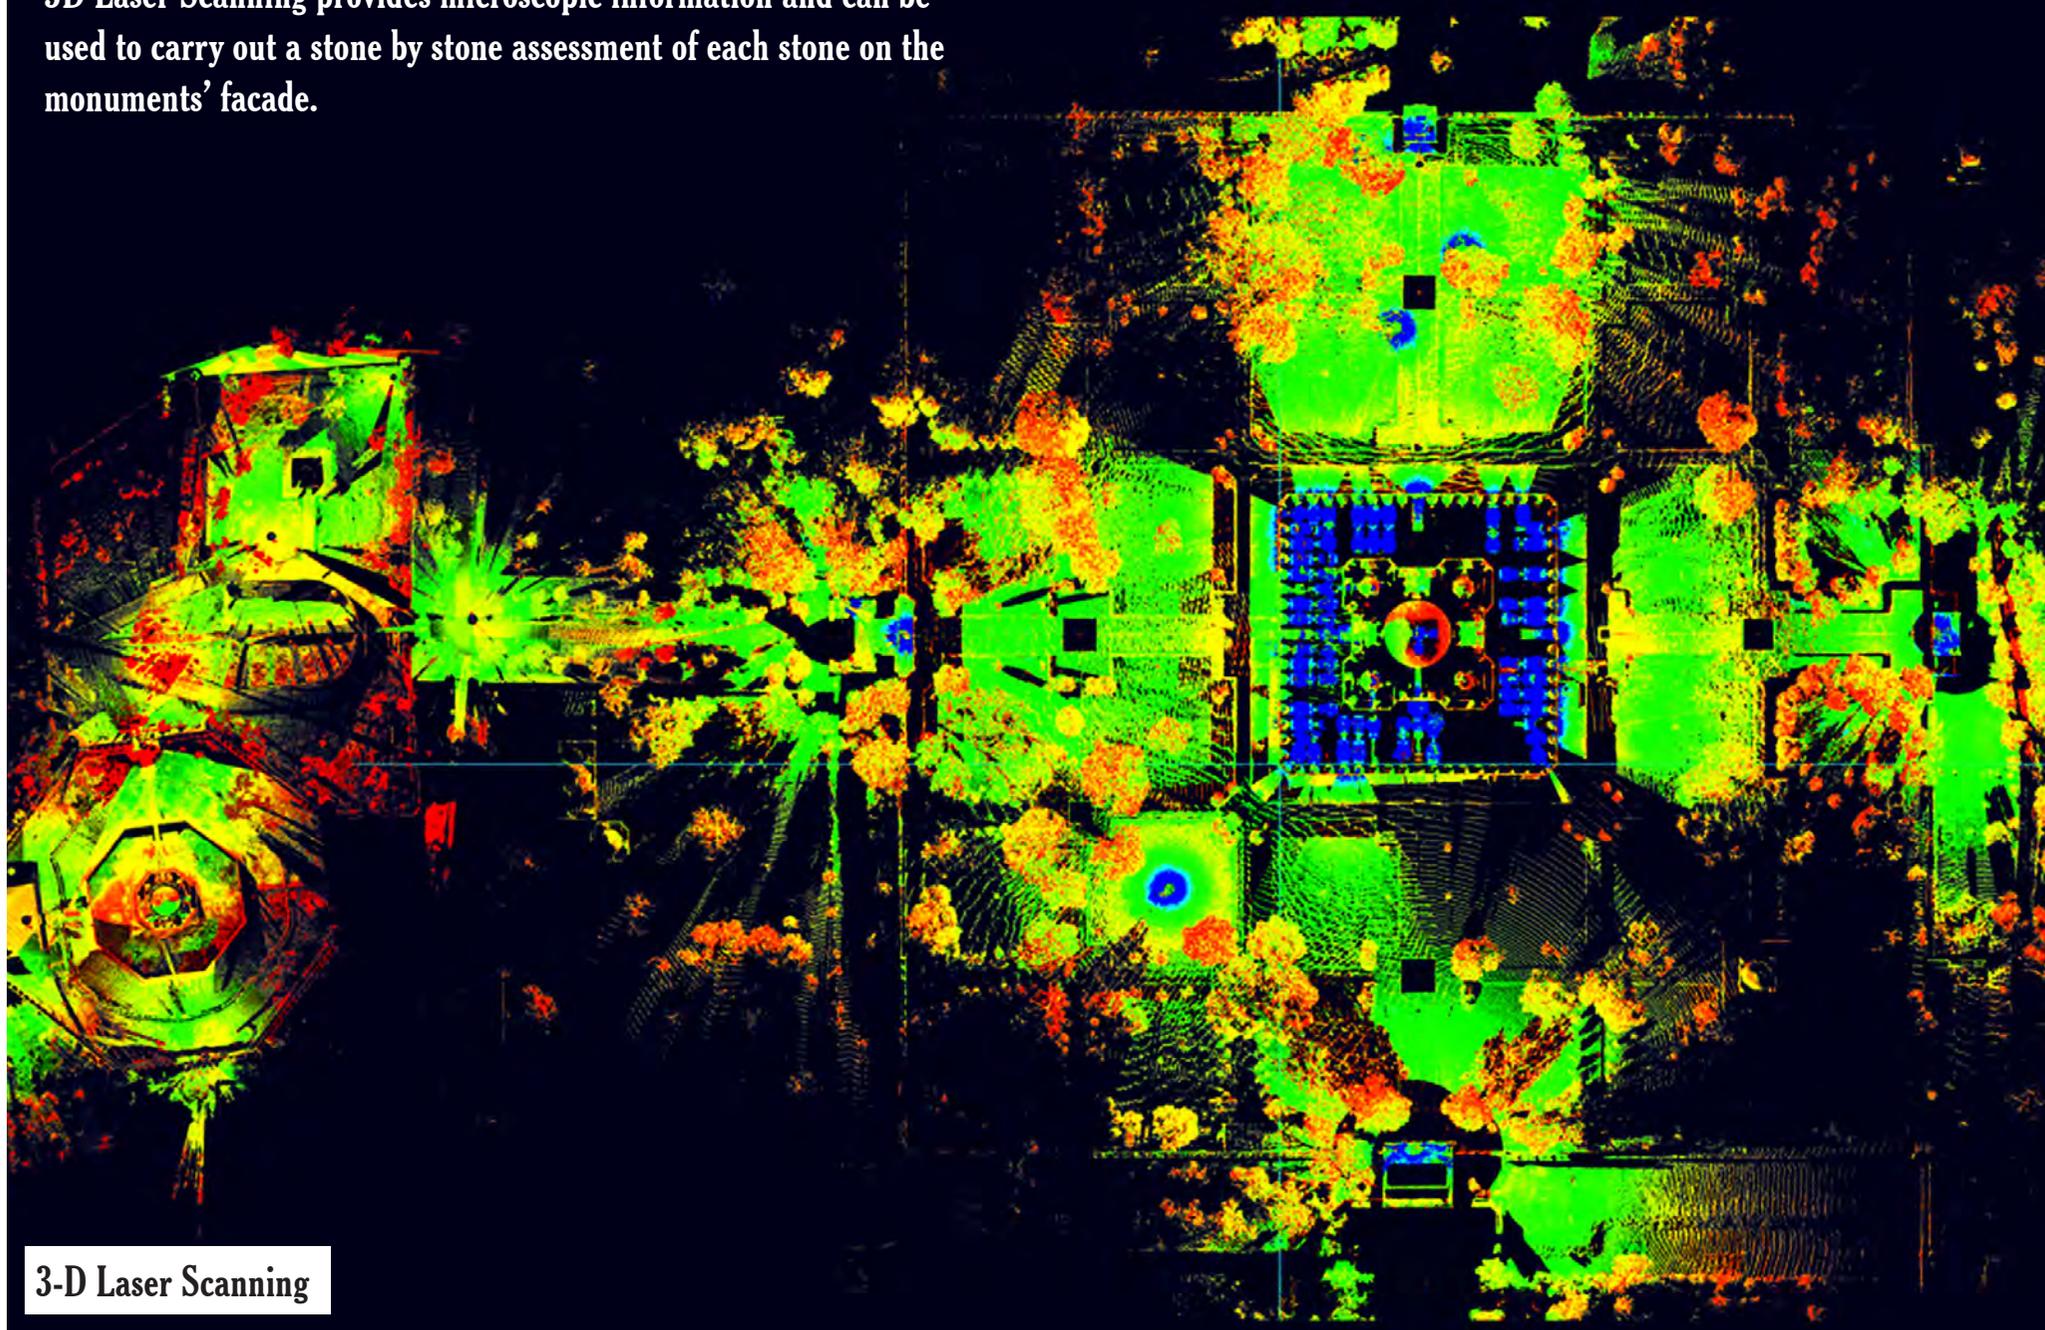
3-D Laser Scanning

3D Laser Scanning provides microscopic information and can be used to carry out a stone by stone assessment of each stone on the monuments' facade.

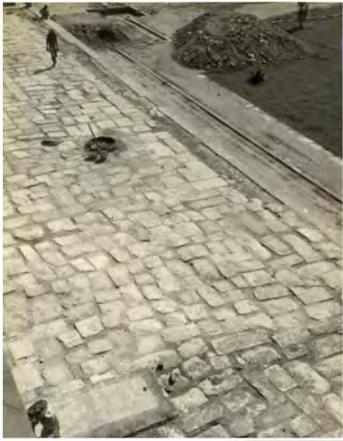
Humayun's Tomb- Lower Plinth-  
Original Delhi Quartzite

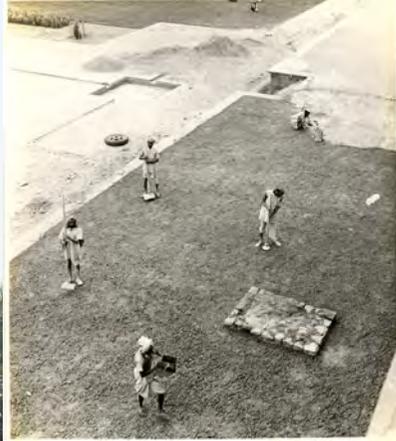
Humayun's Tomb- Lower Plinth-  
Concrete layer added later

- Removal of 3150 cum cement concrete layer from the original DQ paving
- Lifting up the settled stones up to 3000 kgs and relaying them
- 450 rmts red sandstone edging lifted and partially replaced

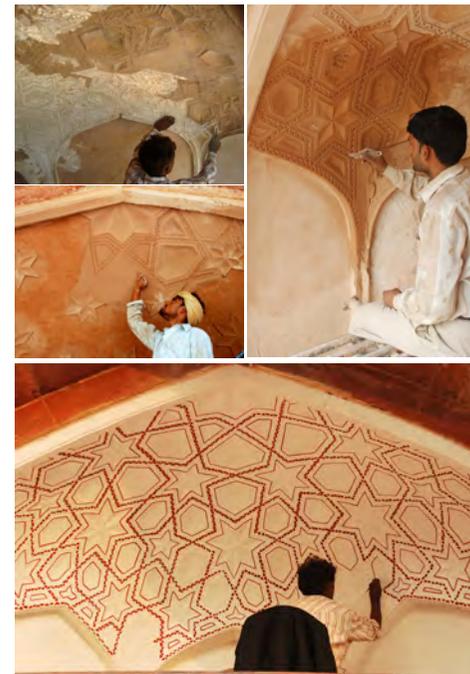
DURING CONSERVATION

The principal conservation challenge was to restore the ornamental plasterwork of the 'half-domed' surface which comprises less than 1% of the façade yet is a prominent architectural feature.

Lime plaster, applied in layers, then incised to bring out the desired patterns transformed the character of the mausoleum, from ruinous to splendour. The final 1 mm thick layer of lime-marble dust plaster not only served as a protective layer for the underlying plaster but the Mughals used it to mimic white marble. The ornamental patterns in incised plasterwork were once again emphasized with red lime plaster obtained by the traditional additive of geru powder.

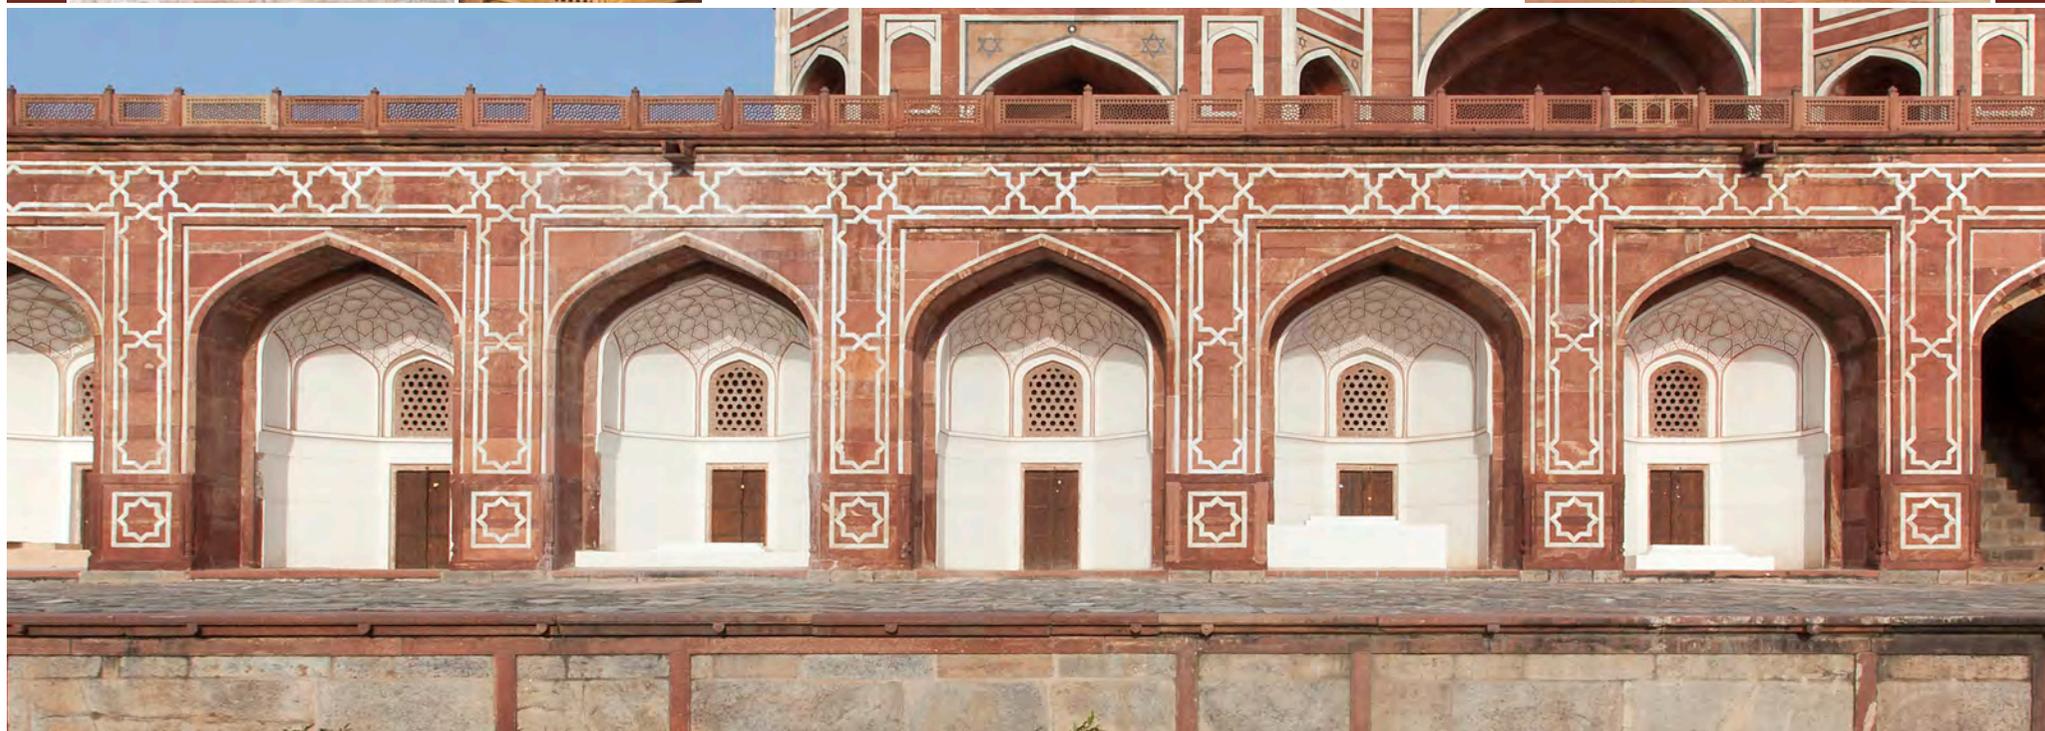
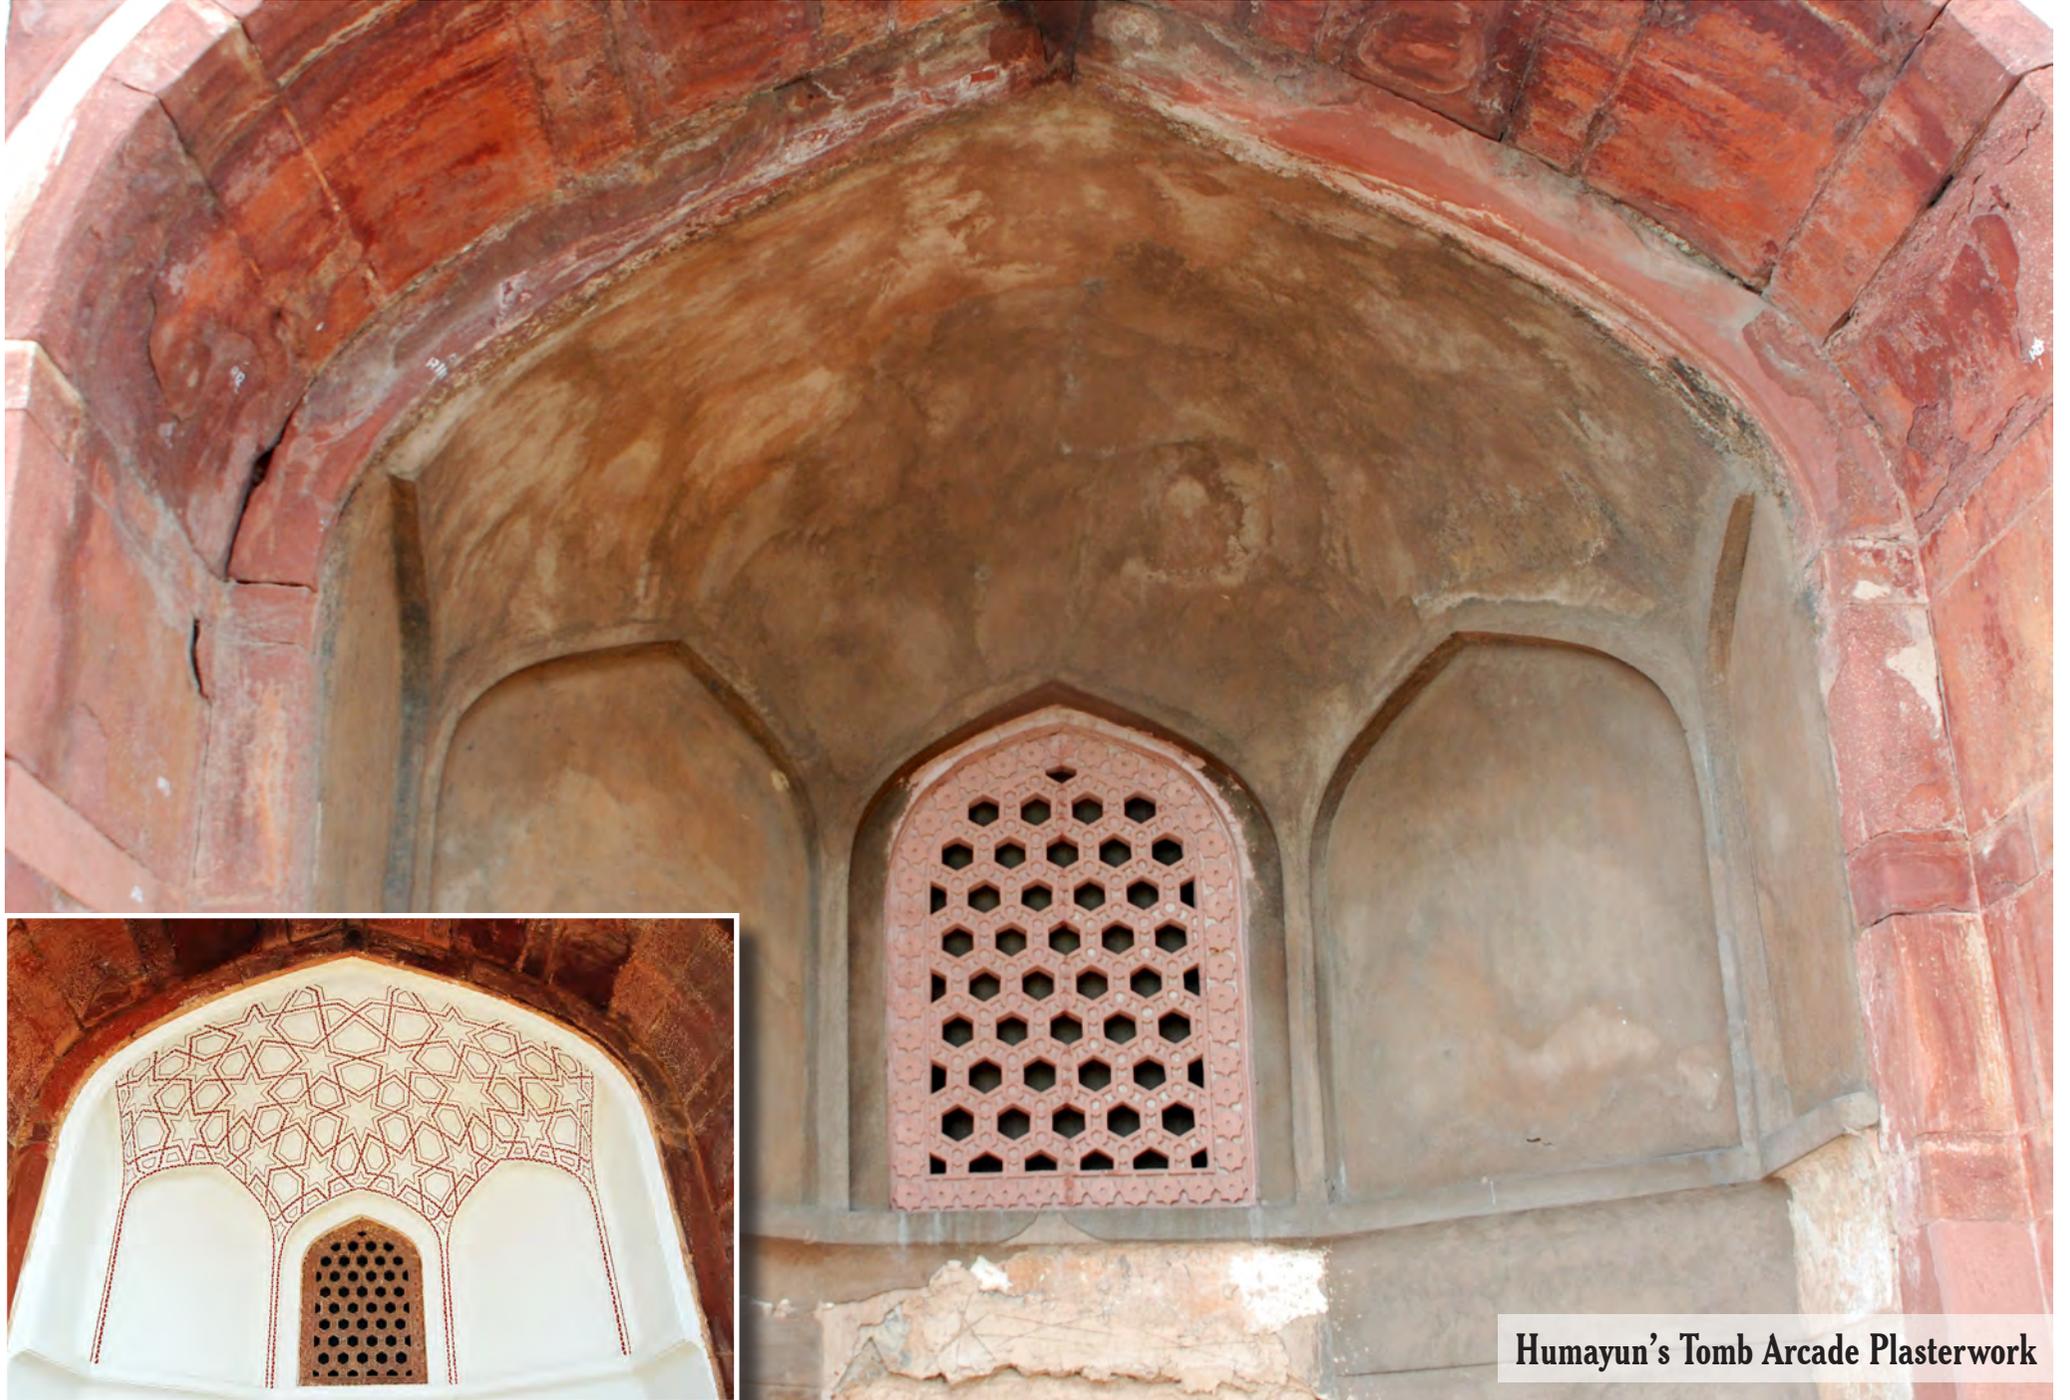
**Humayun's Tomb Arcade Plasterwork**

On each façade of the mausoleum are 17 arched openings, and one each of the four corners. Though the facing of this spectacular arcade is clad in sandstone with marble inlay, the 'half-domed' wall surfaces are plastered with ornamental star shaped patterns. Water percolation from the terrace led to most of the original lime mortar disintegrating and then replaced with cement plaster in the 1990's, obliterating decorative plasterwork where traces of this had remained.

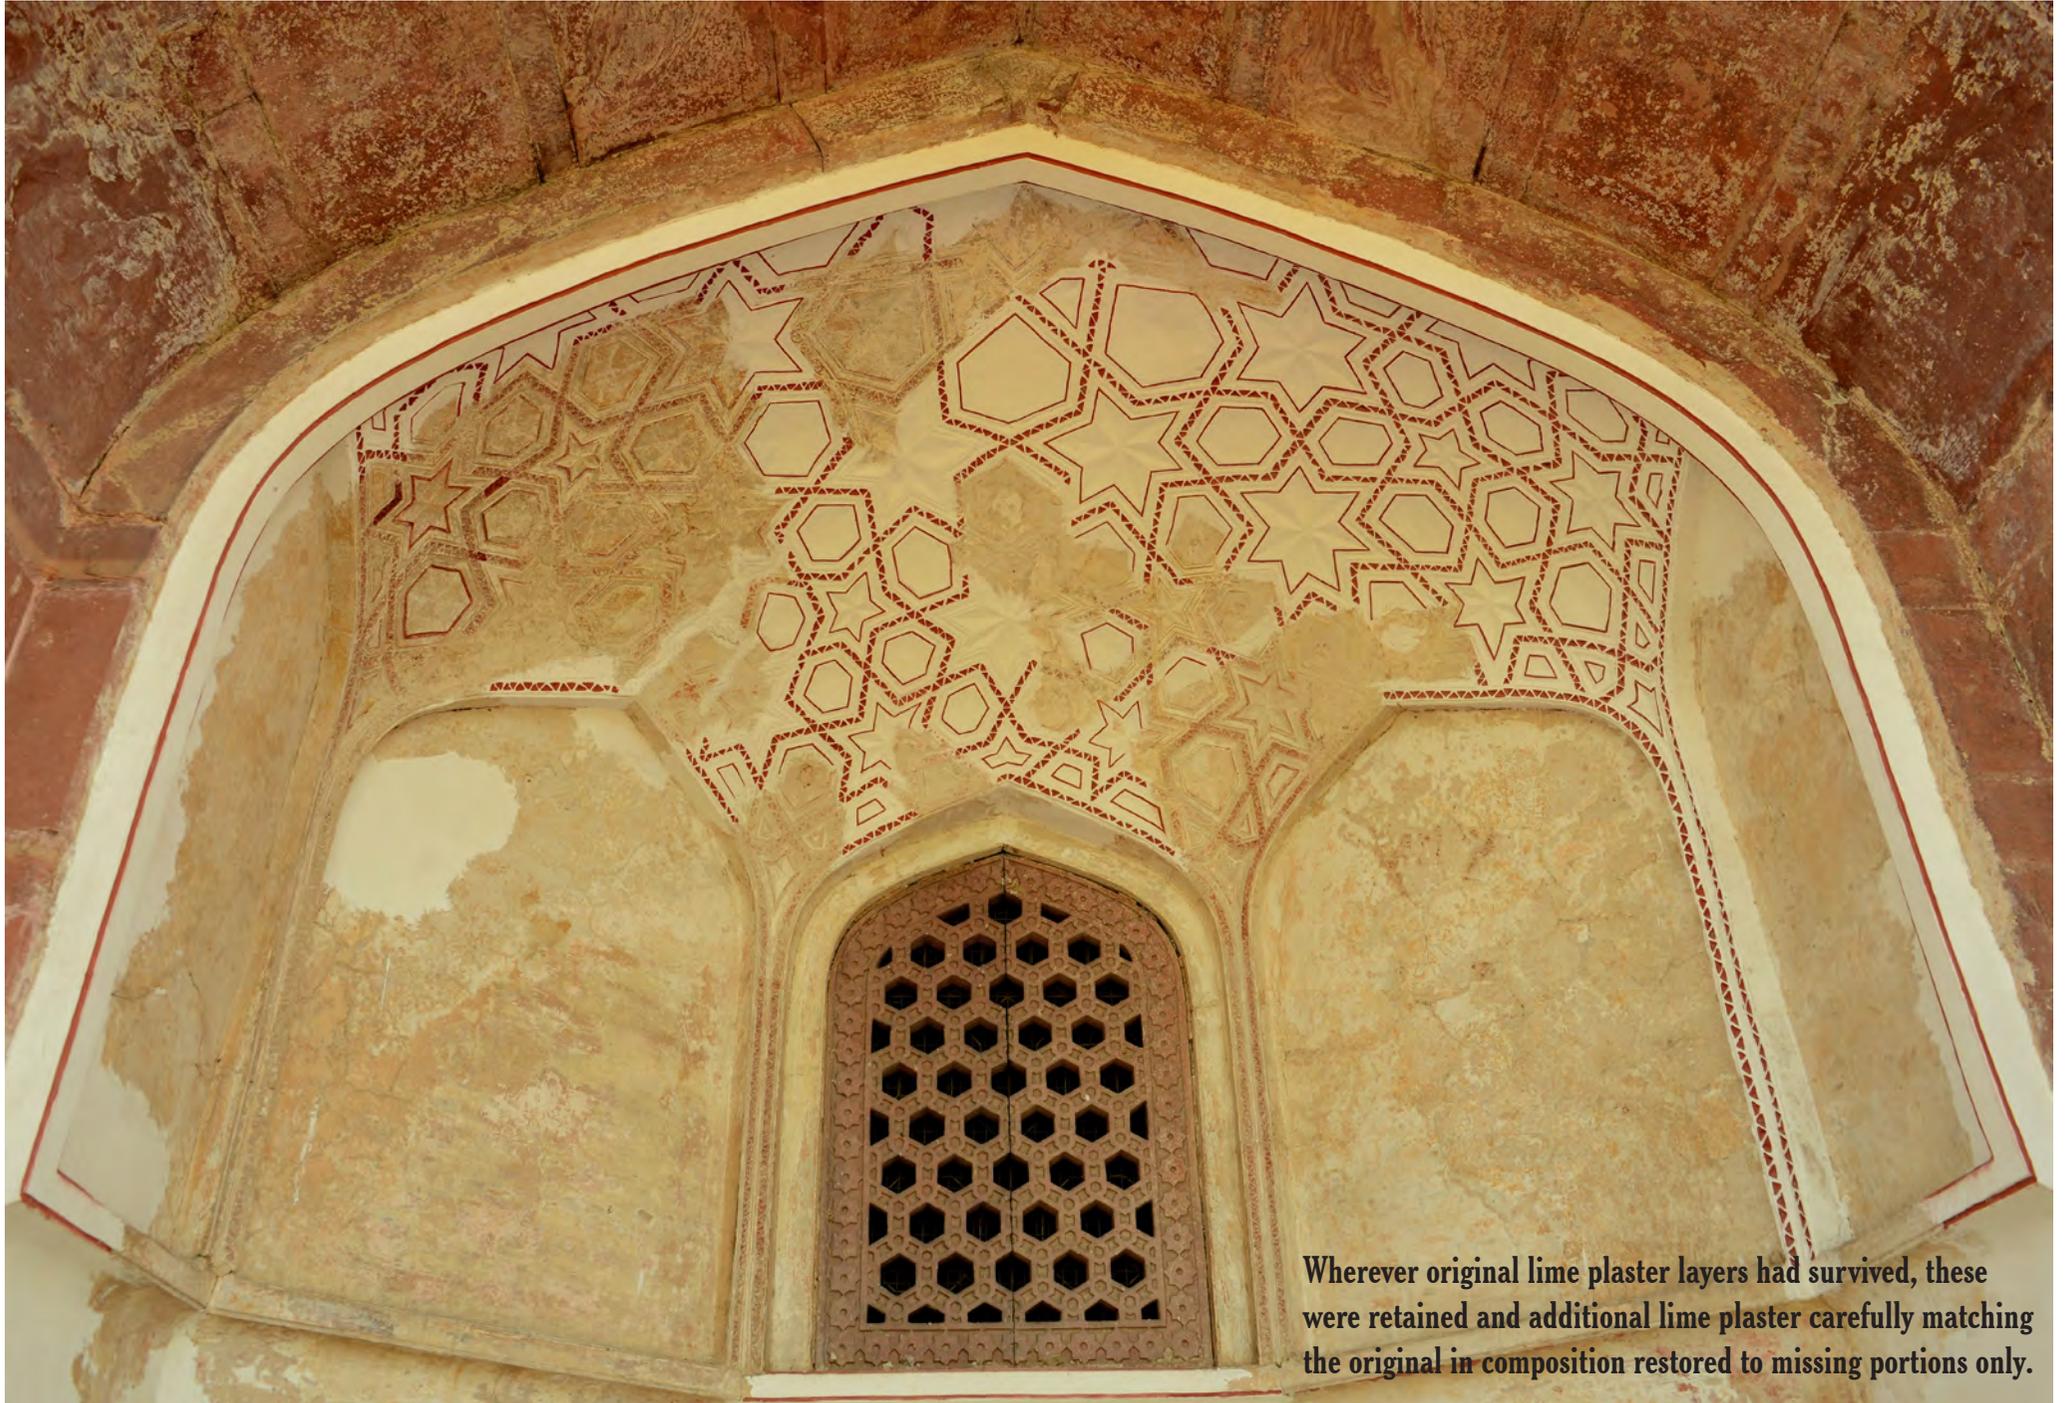
Wherever original lime plaster layers had survived, these were retained and additional lime plaster carefully matching the original in composition restored to missing portions only.

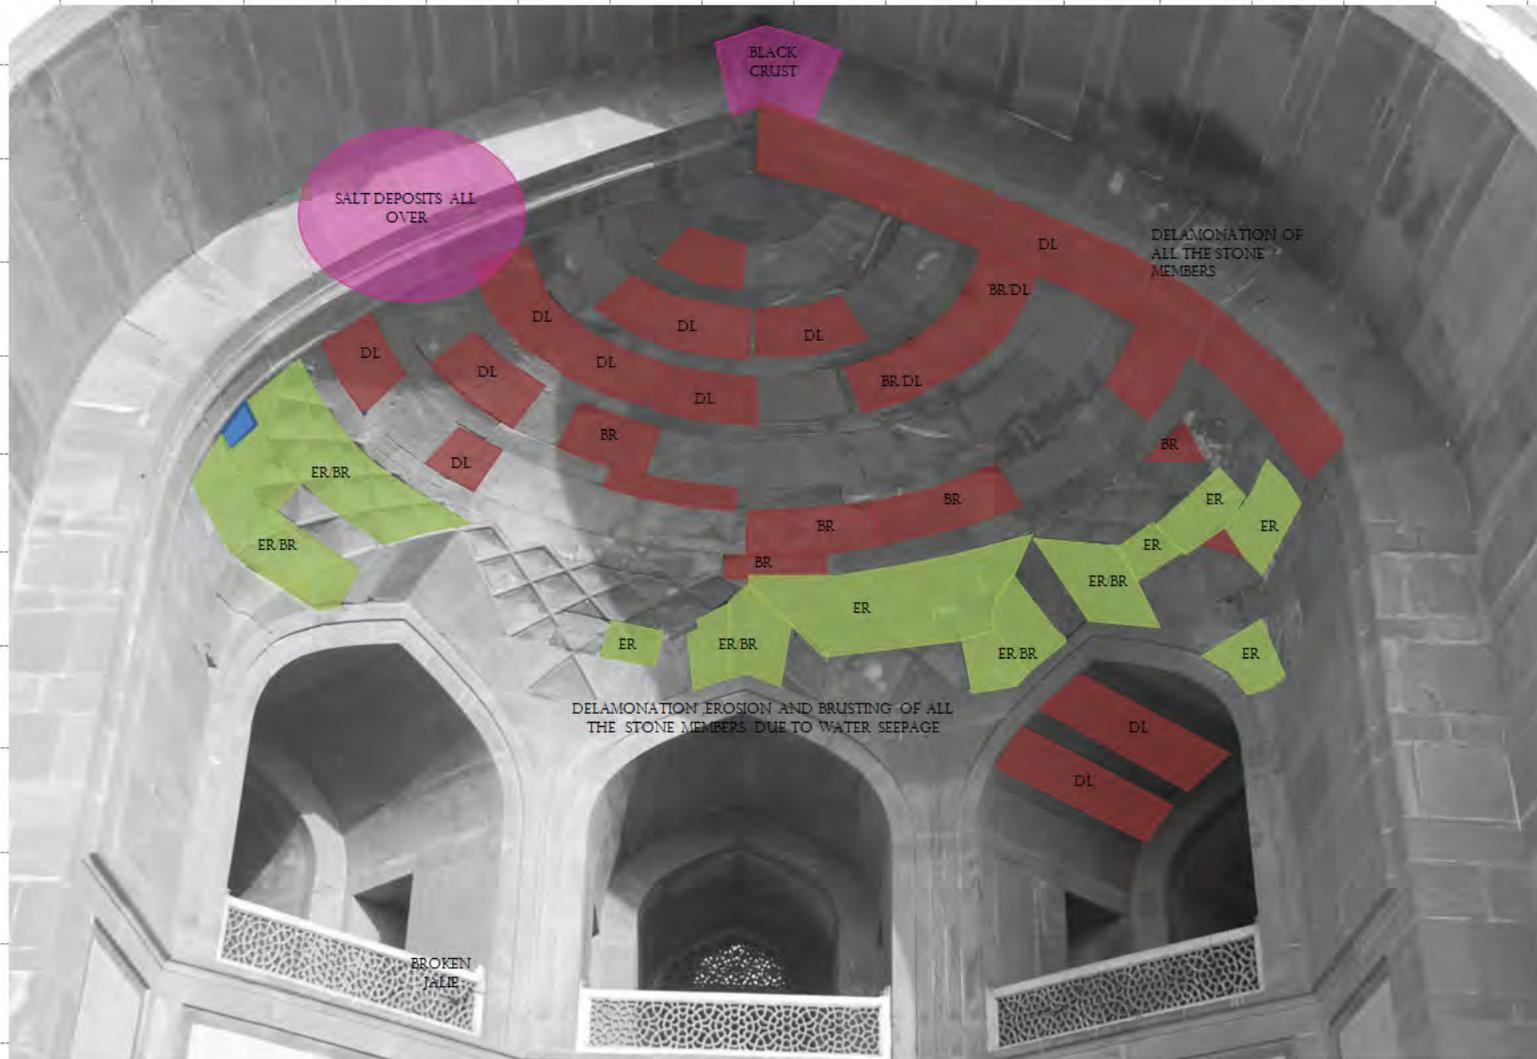
W4- CONDITION MAPPING ,  
 INTRADOS

**Humayun's Tomb: Condition Assesment**

Conservation works aimed at restoring original slope to ensure no water percolation to chambers below takes place, restoring the pattern as documented in the 1880's as well as replacing inappropriate stone (on account of thickness, finish, texture and colour) with stone matching the original

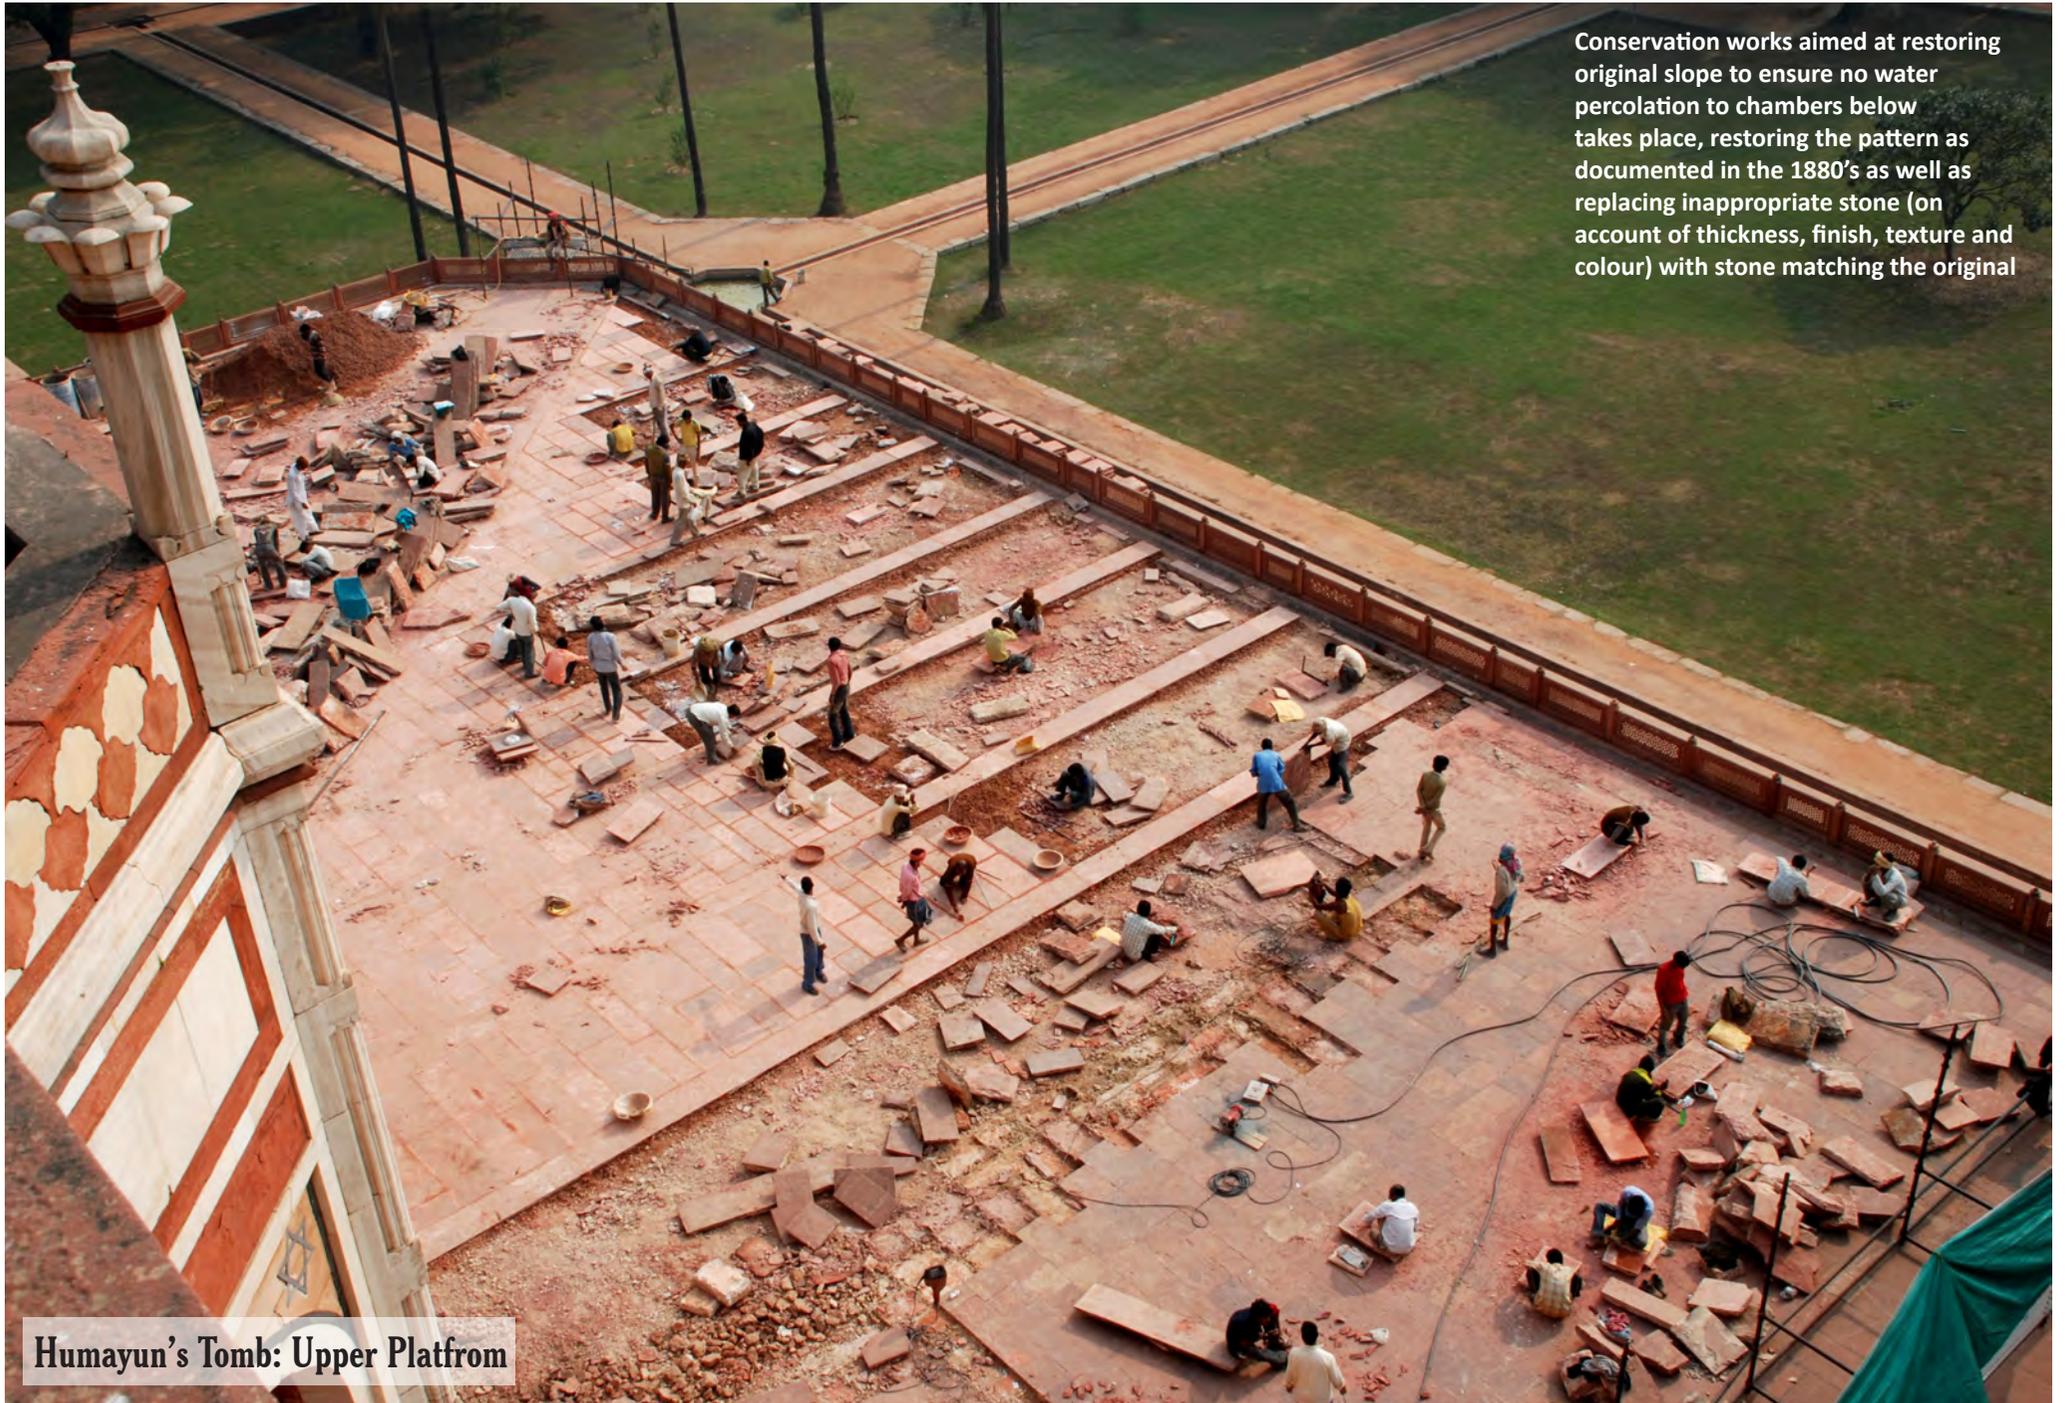
Humayun's Tomb: Upper Platform

A 3D laser scan survey of the sandstone terrace revealed that past repairs – of which the most intrusive were those carried out in 2003-5 had also reversed the slopes and created a shallow drain along the edge of the mausoleum. Furthermore once works commenced it was discovered that many stones had been reused during past repairs by reversing the stone and chisseling it down – thus resulting in a stone which was of a thin section and thus inappropriate to use.
