# Humayun's Tomb Complex

Conservation Works undertaken during 2008-14

**Nizamuddin Urban Renewal Initiative**

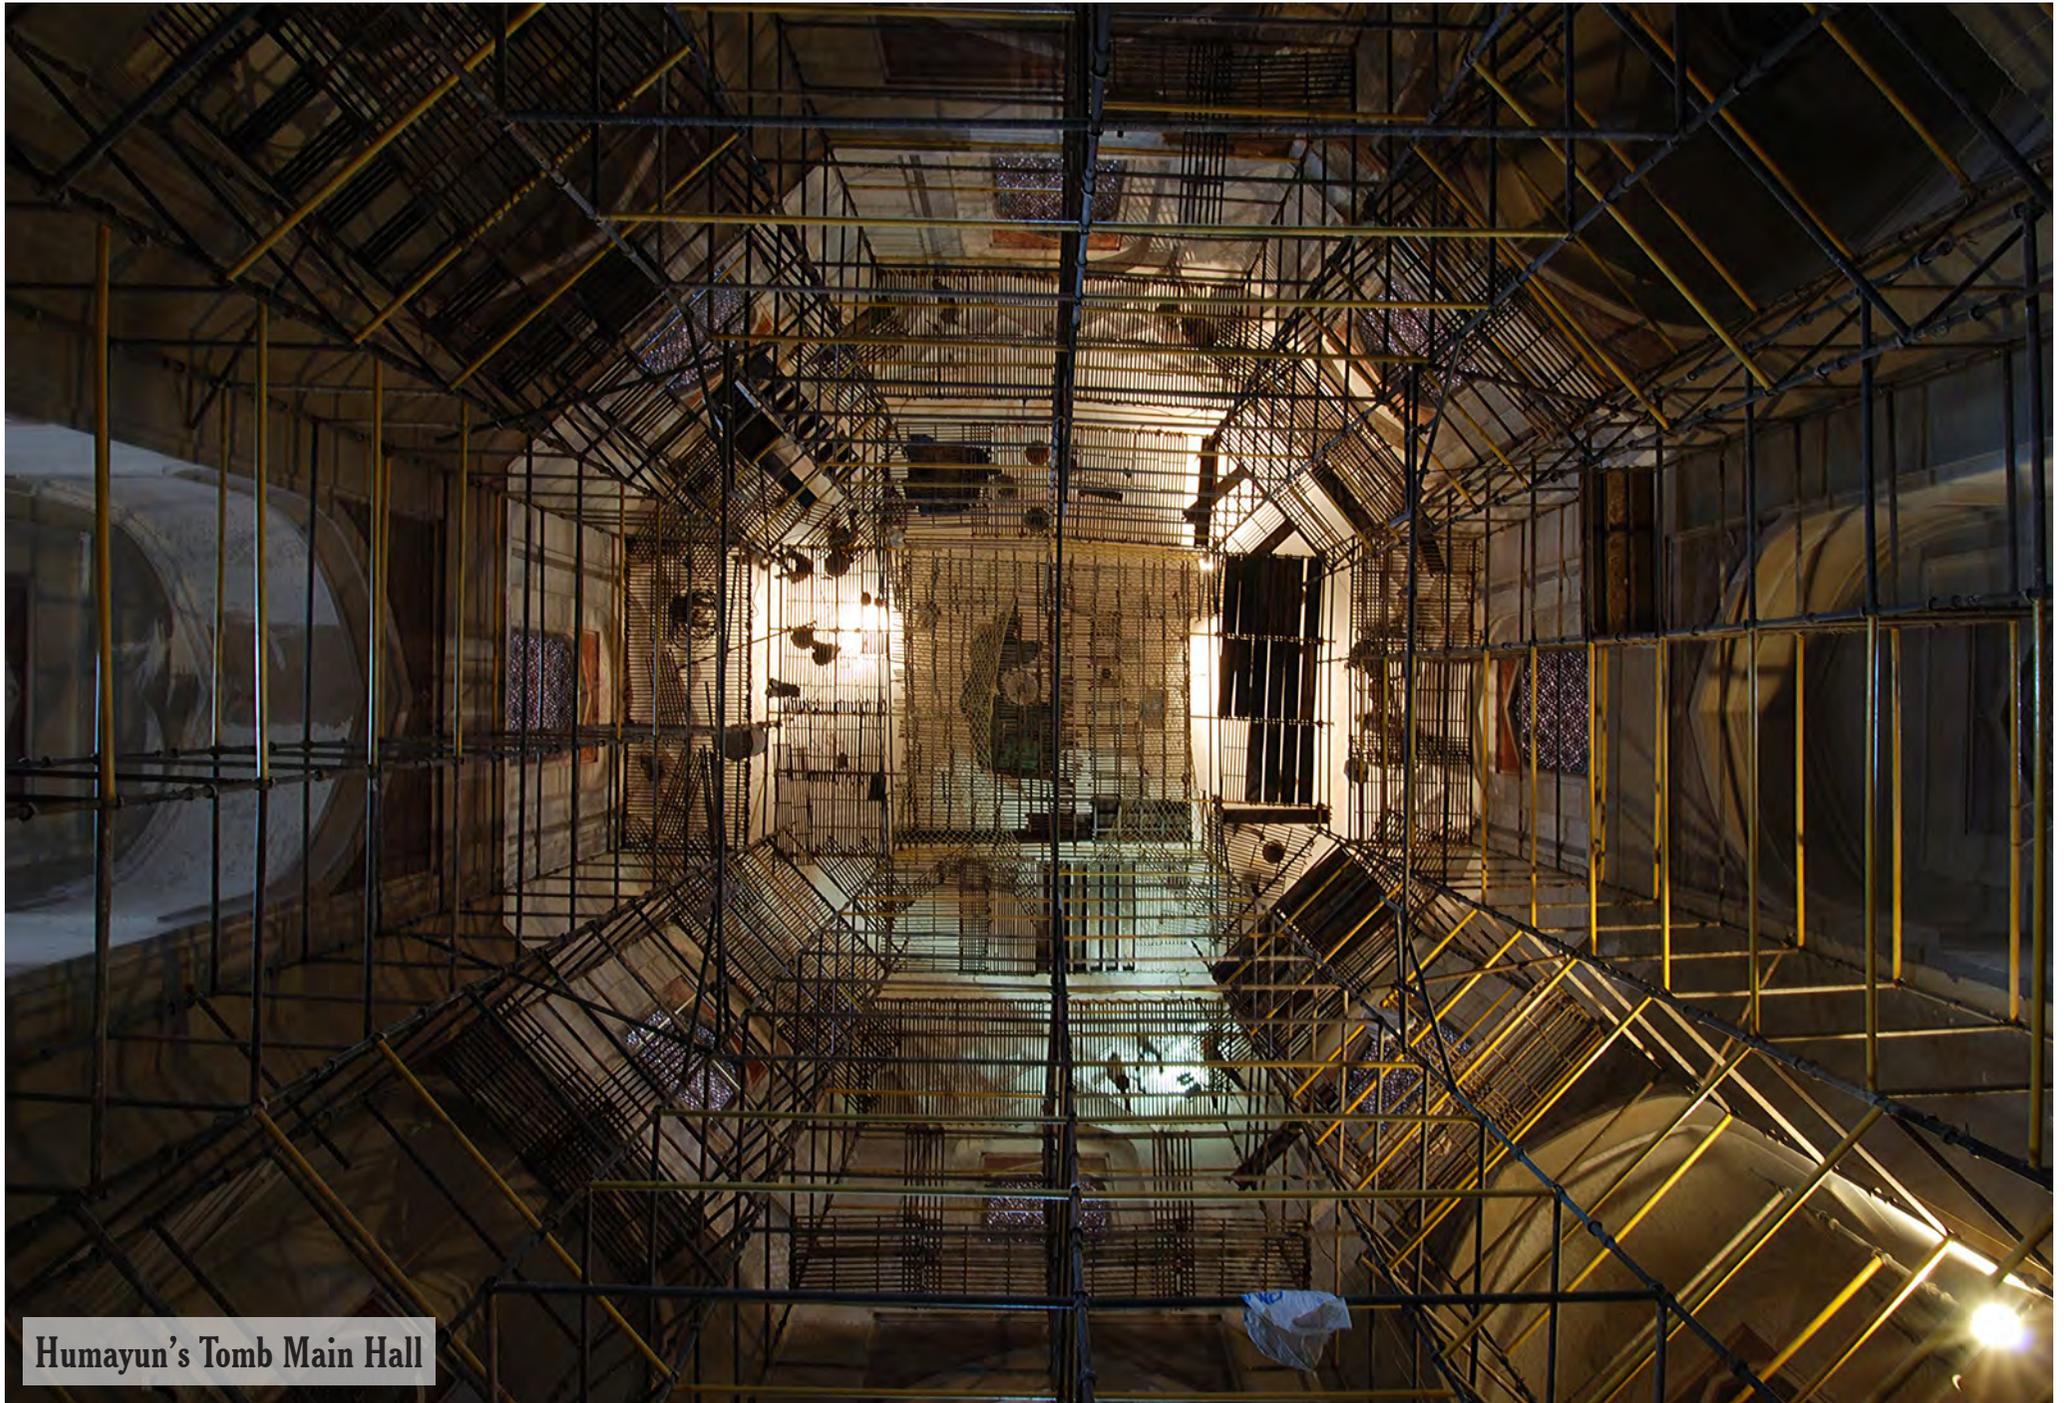
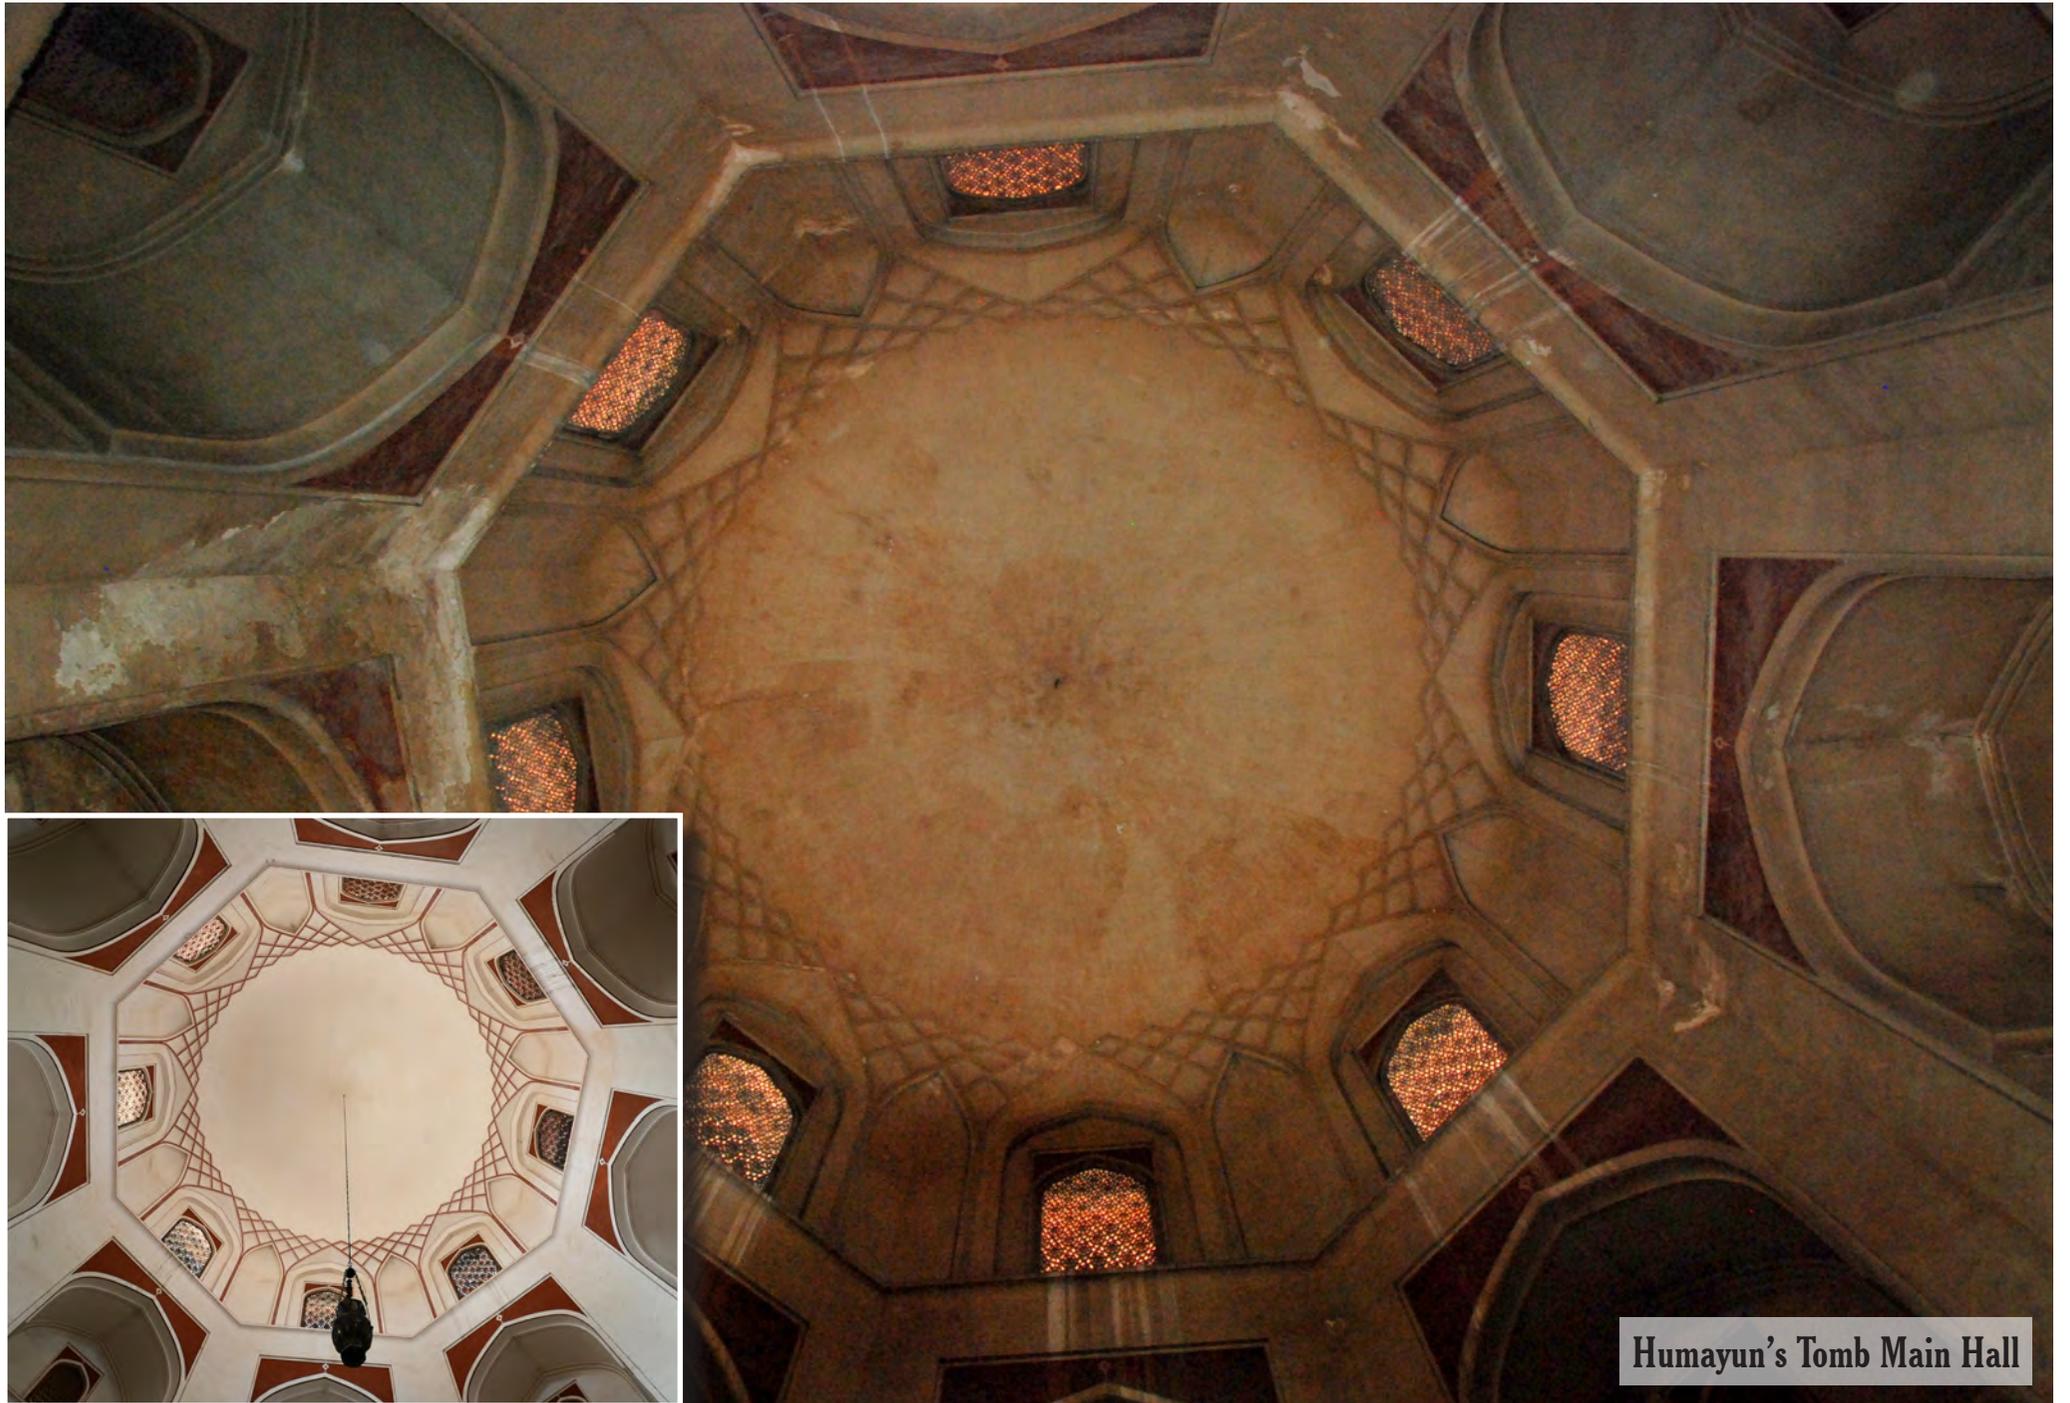
Humayun's Tomb Main Hall

Several layers of paint and lime-wash were applied to the internal wall surfaces of Humayun's Tomb chamber in the late 20<sup>th</sup> – early 21<sup>st</sup> century. The resulting dirty appearance did not resemble original condition at all and severely compromised the authenticity. Please also note stains caused by water seepage from lattice screens due to increase in roof levels.

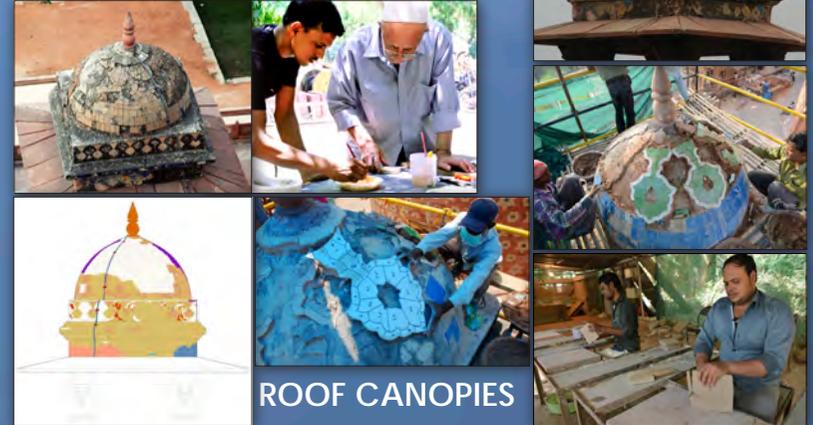
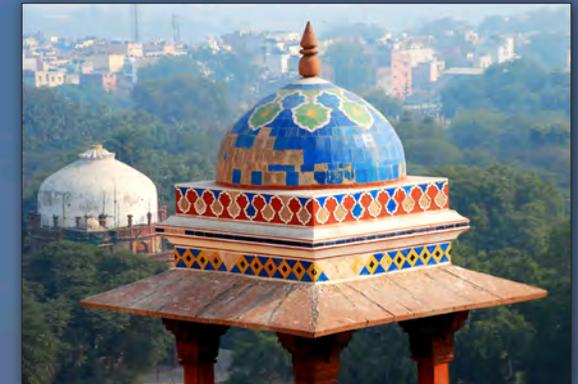
ROOF CANOPIES

Restoring Tilework on Canopies

Five colours of tiles were found to have been used at the Humayun's Tomb canopies and for each of them thousands of samples were prepared – totaling over 20000 samples. all original tiles found on the canopies – even with their glaze lost – have been retained and new tiles exactly matching the original applied only where cement layers had been applied in past repairs.

Though many of the tiles found on the canopies had lost their glaze, it was agreed from the onset that all existing tiles would be retained. With craft techniques lost in India, the conservation process required three years of experimentation that commenced under the guidance of master craftsmen from Uzbekistan. 20,000 individual pieces in the five colours used were prepared in the experimentation phase until tiles matching the mughal tiles could be prepared.

Each tile piece for use was made to specific size as per impressions recorded in the plaster where possible. Tiles were prepared by youth from the adjoining Nizamuddin Basti in electric kilns set up within the Humayun's Tomb complex.

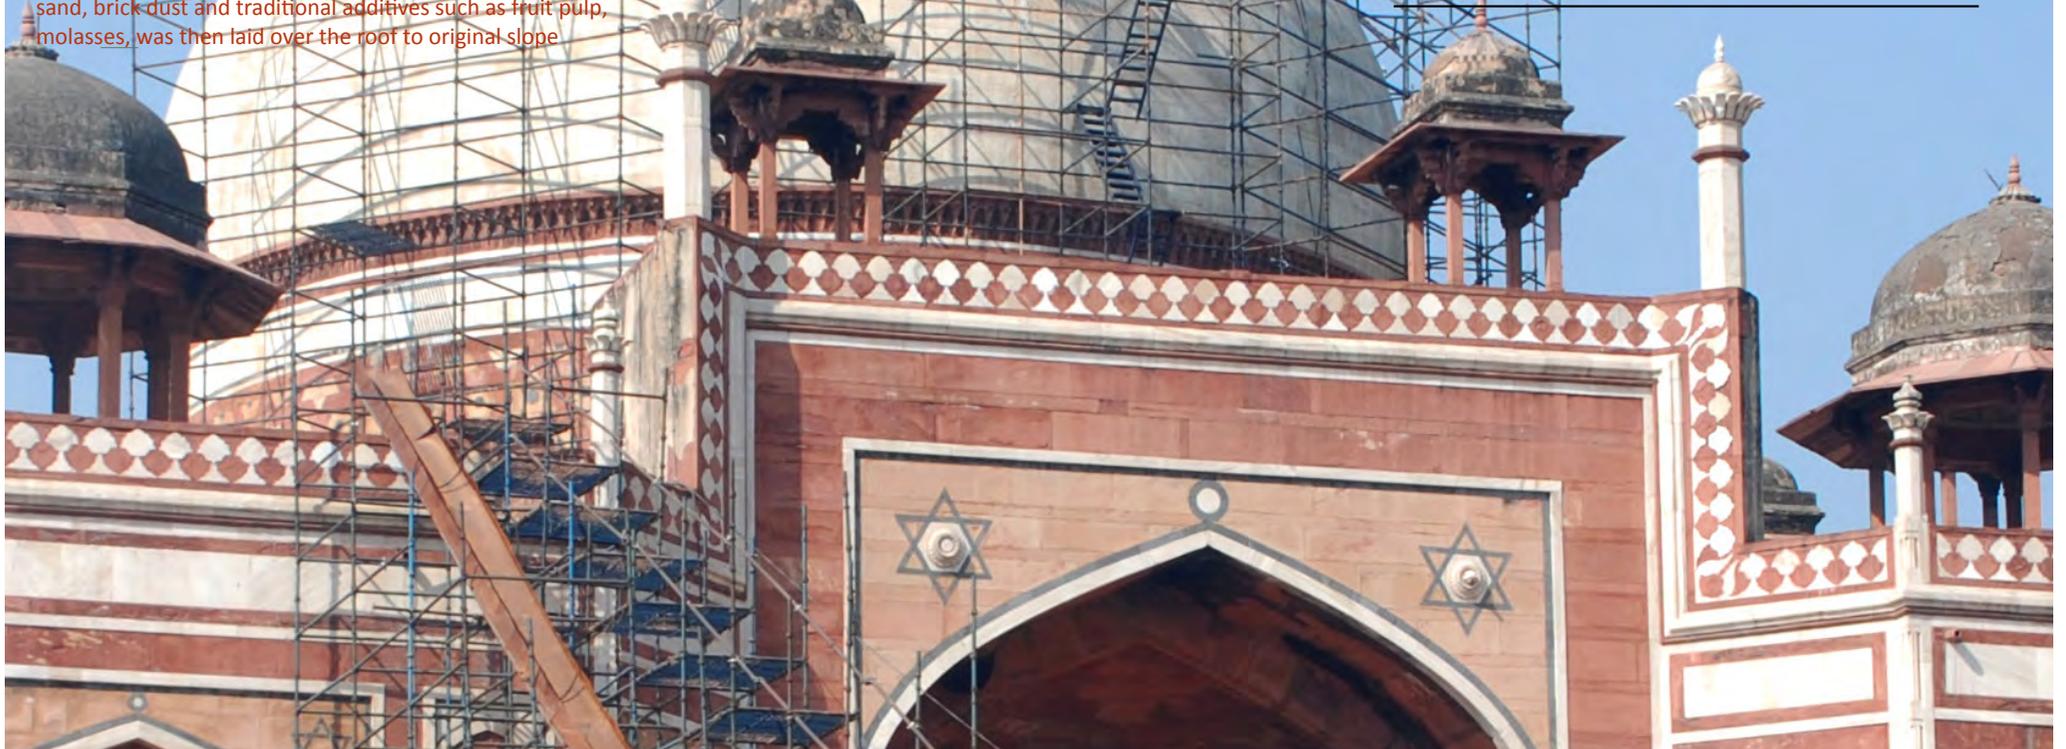
## DOME & TERRACE

Preliminary studies revealed 40 cm of concrete was laid on the roof in the 20<sup>th</sup> century. Removing over 1 million kilograms of concrete without any vibrations that could cause damage to the masonry posed a significant challenge. The removal commenced with a thin and deep cut using a diamond edged blade on a grid pattern. Specially imported low vibration tools then widened the cut to allow stone-carvers to remove the concrete using traditional hand tools, in a yearlong exercise. A layer of lime concrete matching the original in composition of brick aggregate, sand, brick dust and traditional additives such as fruit pulp, molasses, was then laid over the roof to original slope

**Manual removal of 1 Million kilos of concrete from the roof**

The Humayun's Tomb boasts of a grand double dome of a scale never before seen in India. The condition assessment revealed that the outer dome was leaking and the plaster on its inner surface had been completely lost. Conservation works required careful removal of cement from the joints of the marble dome and then filling the joints with lime mortar.

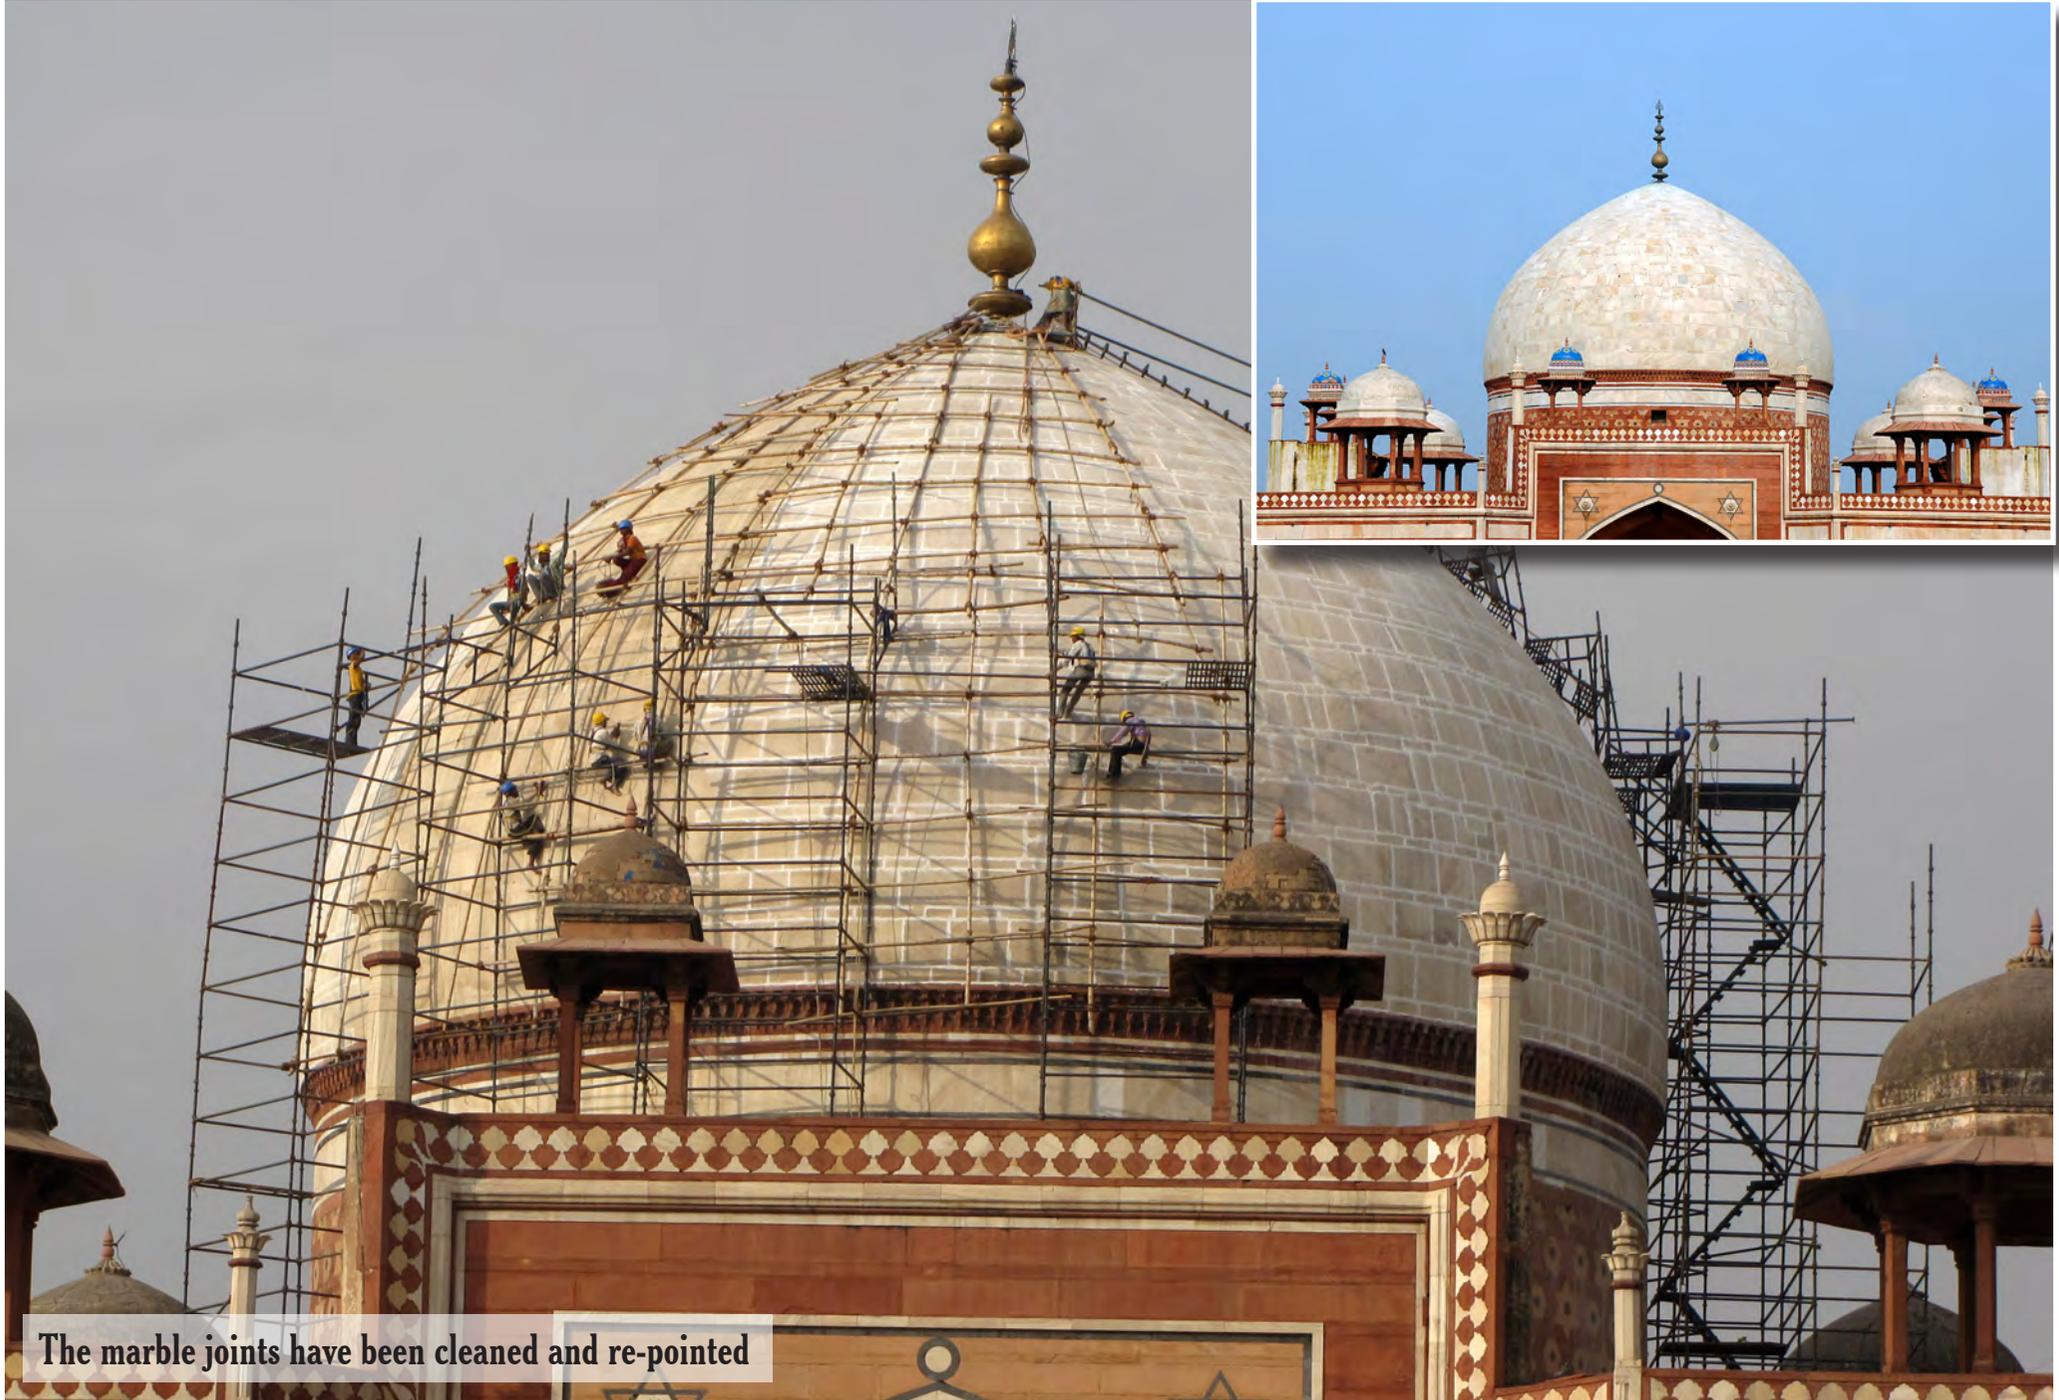
The marble joints have been cleaned and re-pointed

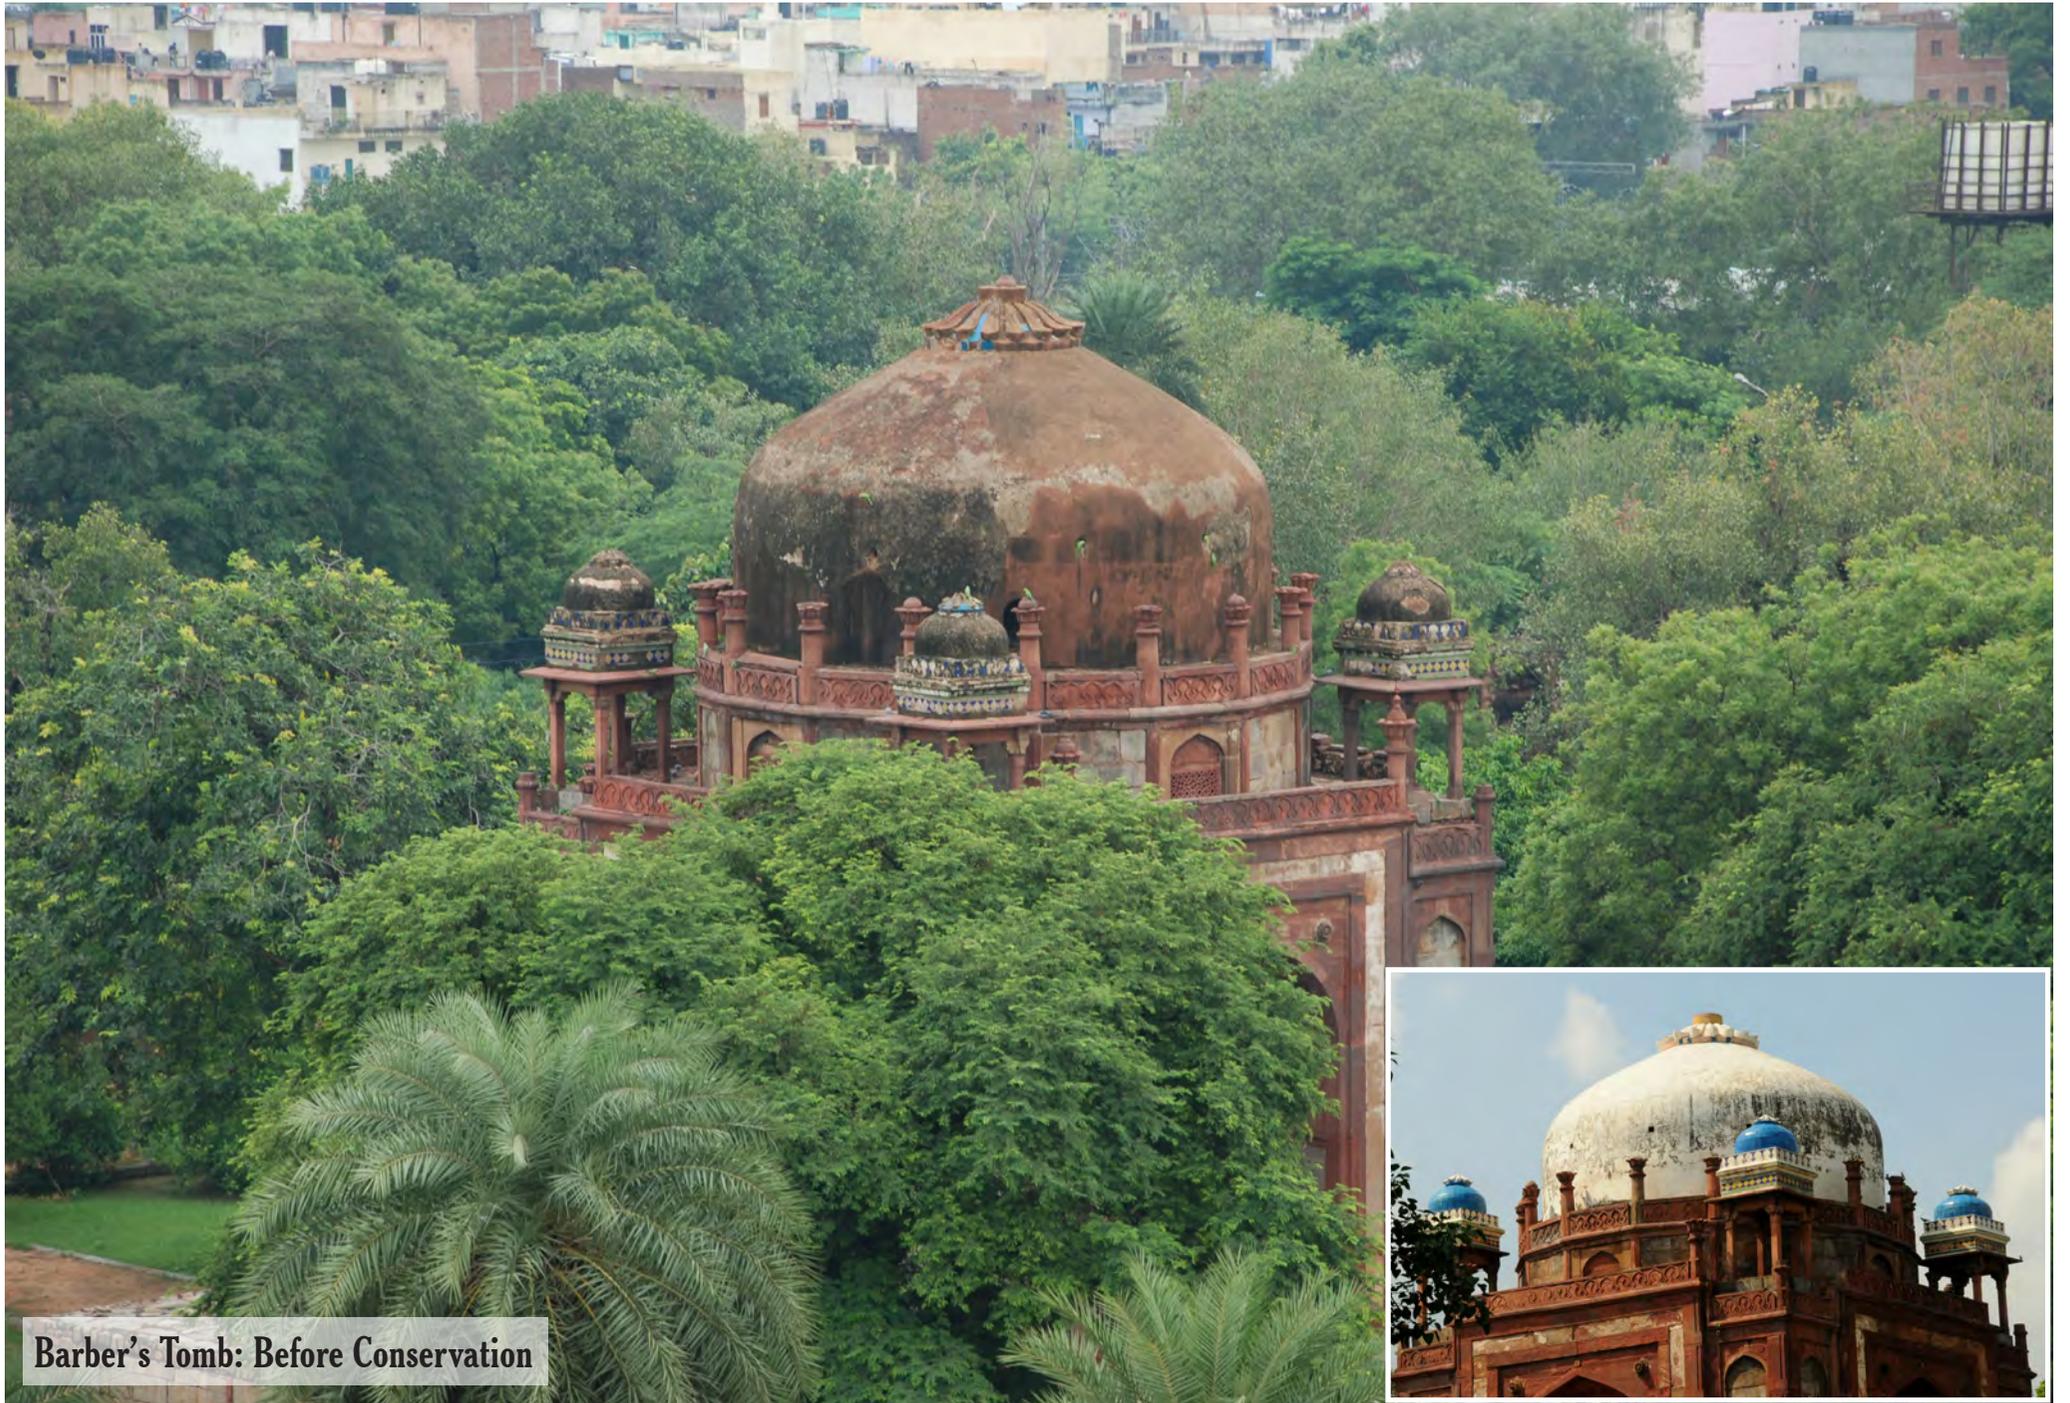
**Barber's Tomb: Before Conservation**

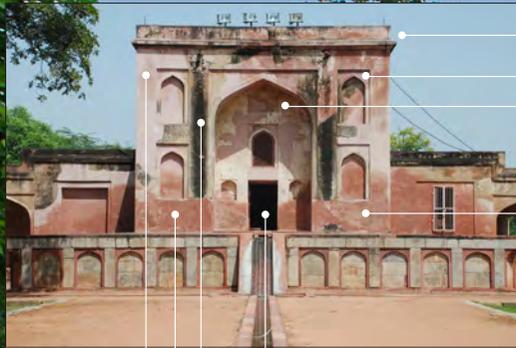
- Kangura Missing
- Polychromy Missing
- Ornamentation Obliterated

Damp Related Damage

- Broken Door Frame
- Water Drainage
- Cement Plaster
- Cement - Surkhi Plaster

Unlike the gateways, the northern and eastern pavilions were built in rubble masonry and finished in plaster – red and white – matching the contrasting colour scheme of the mausoleum. Besides required structural repairs, restoring the missing sandstone door frames, the wooden doors and the lattice screens, the most prominent conservation measures on these pavilions required the removal of all cement plasters – of which at least four different hues were found on the structure. As with the roof of the mausoleum, concrete required to be removed from the roof and replaced with lime concrete laid to adequate slope. Also, on the eastern pavilion, many of the sandstone slabs supporting the roof of the eastern arcade required to be replaced.

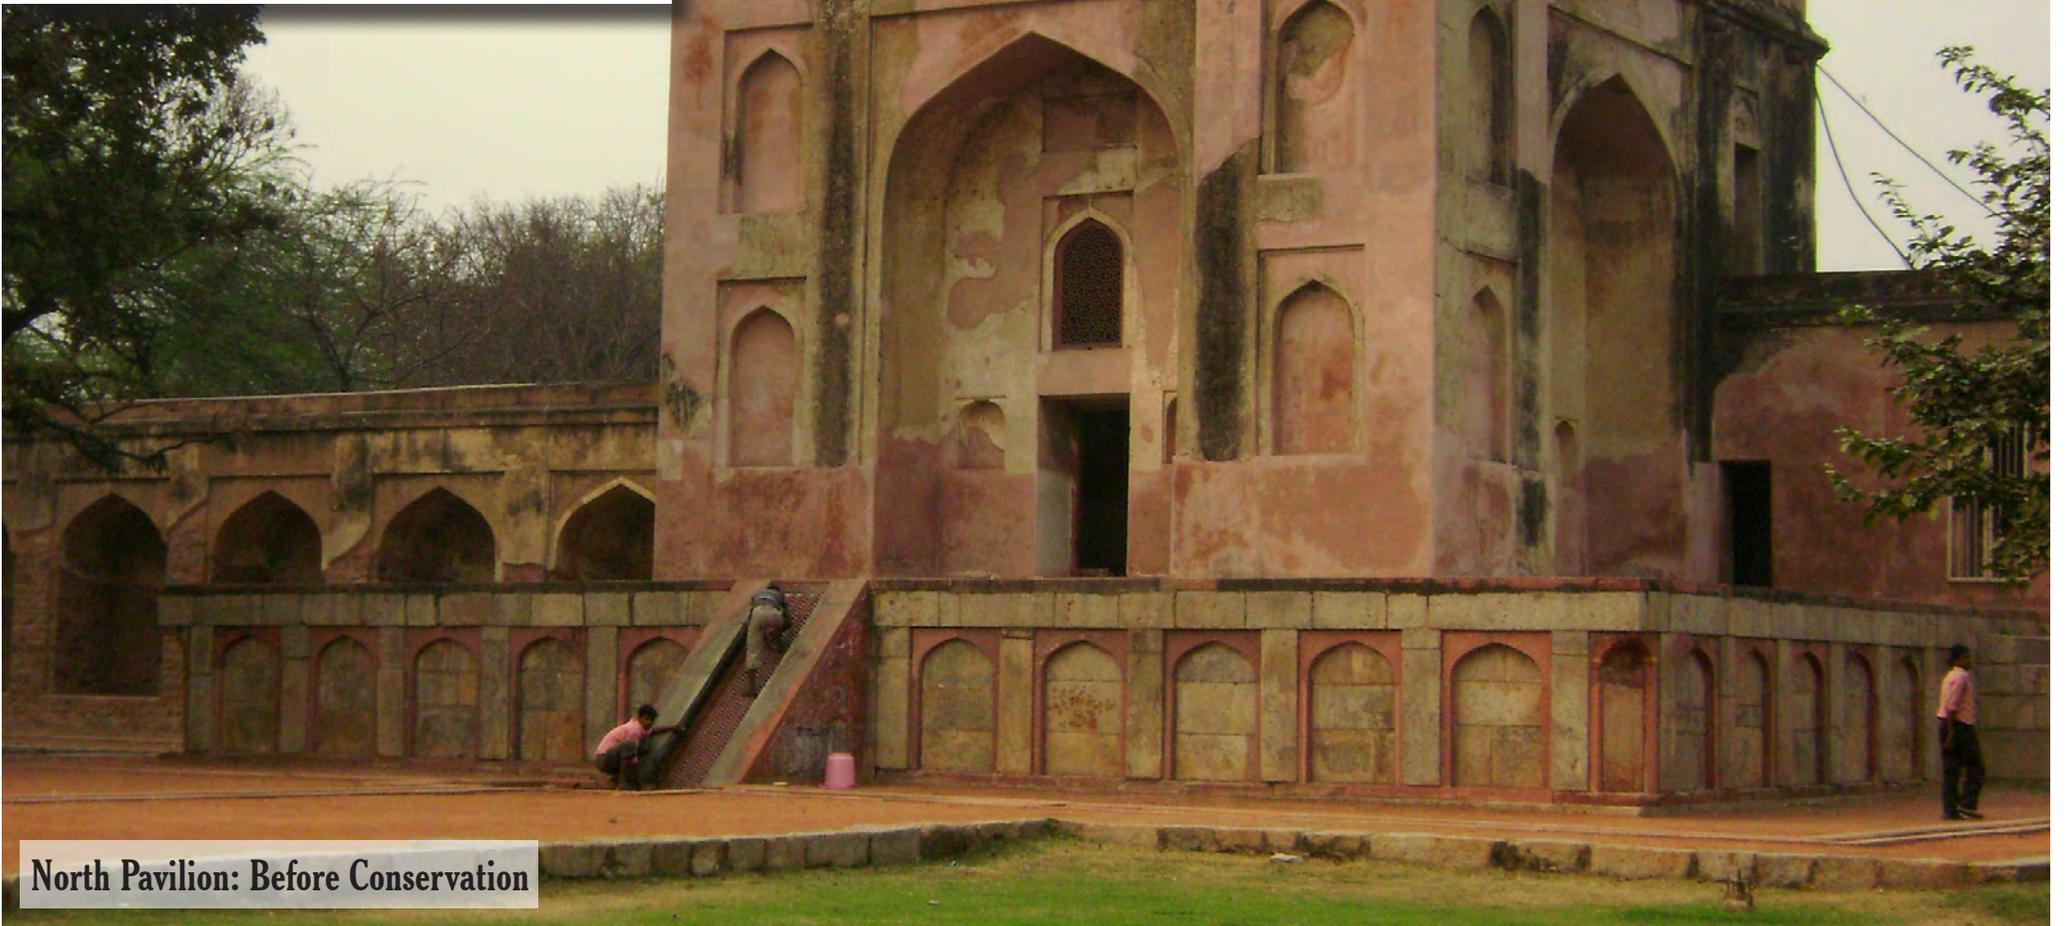
**North Pavilion: Before Conservation**

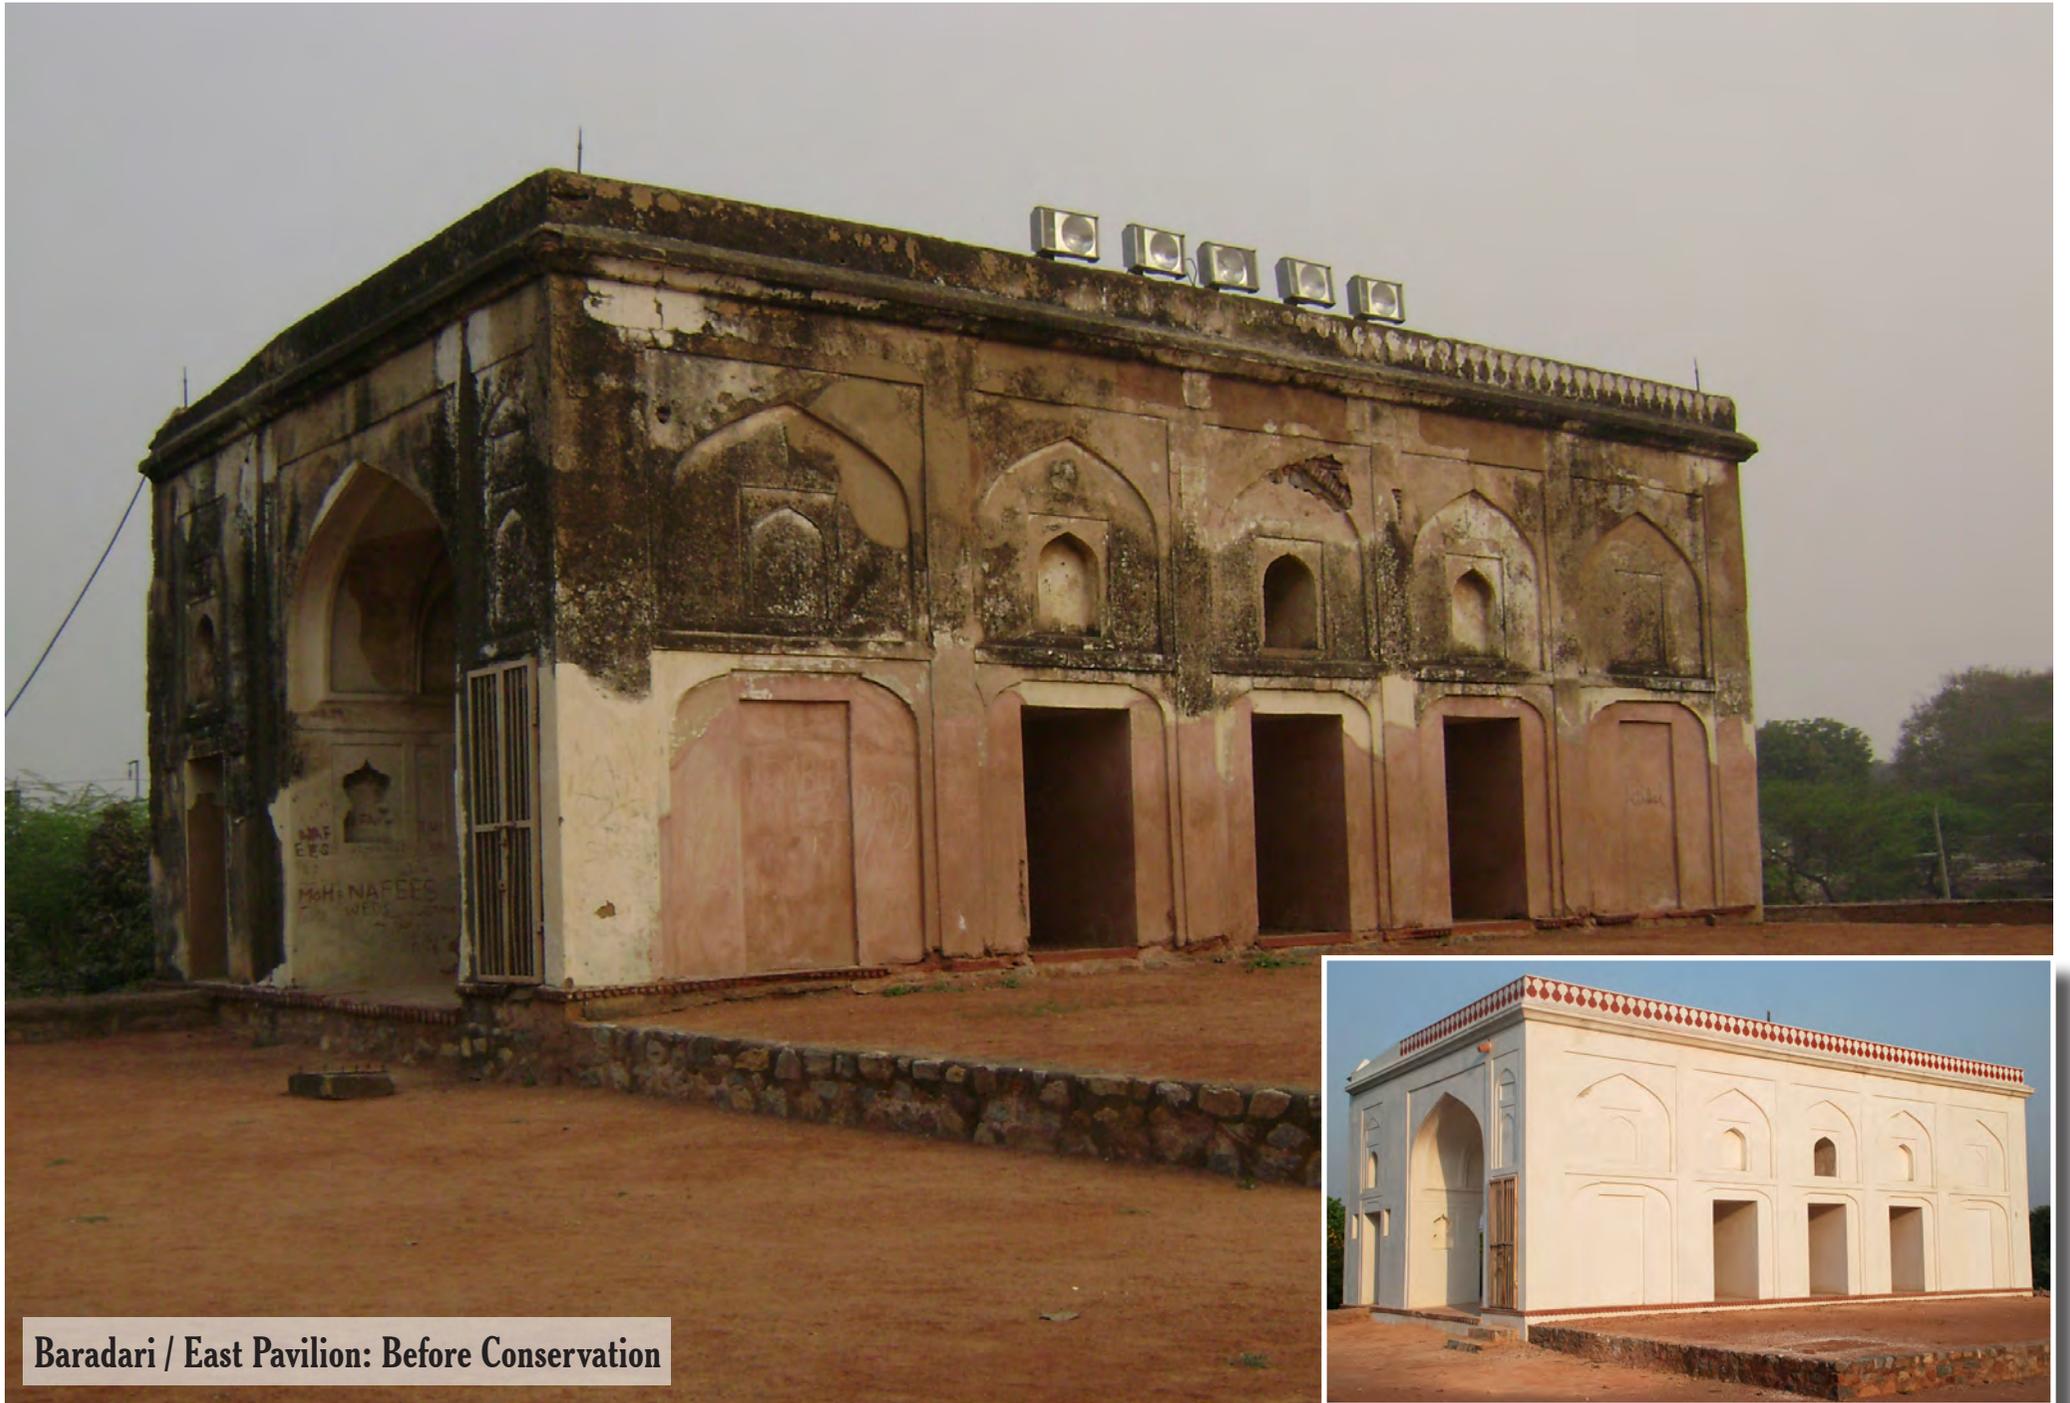
Baradari / East Pavilion: Before Conservation

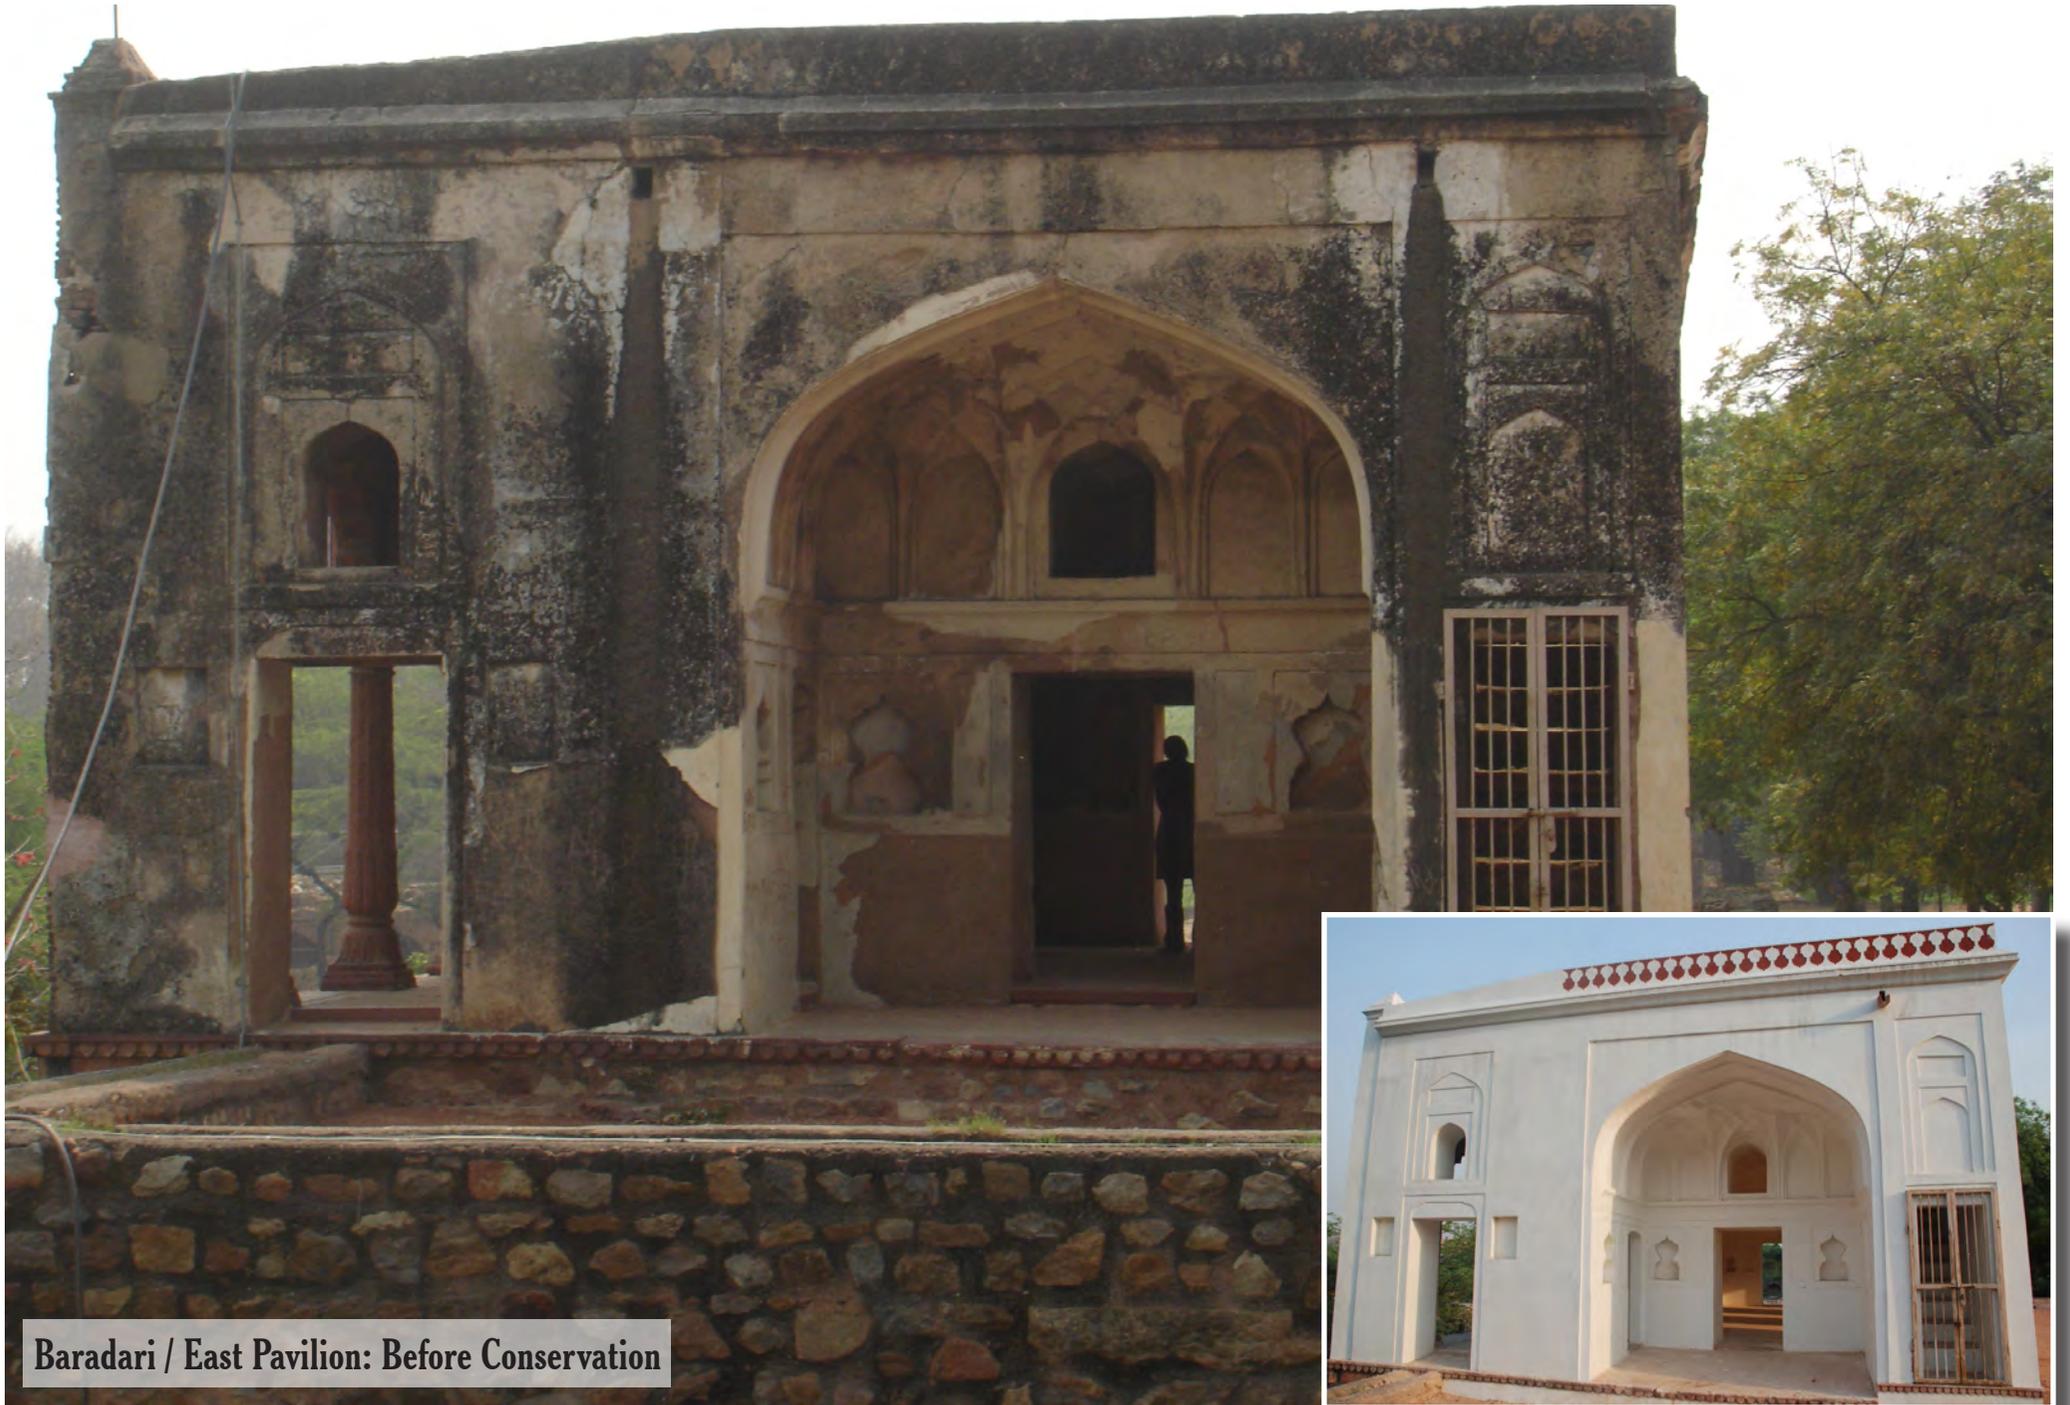
**Baradari / East Pavilion: Before Conservation**

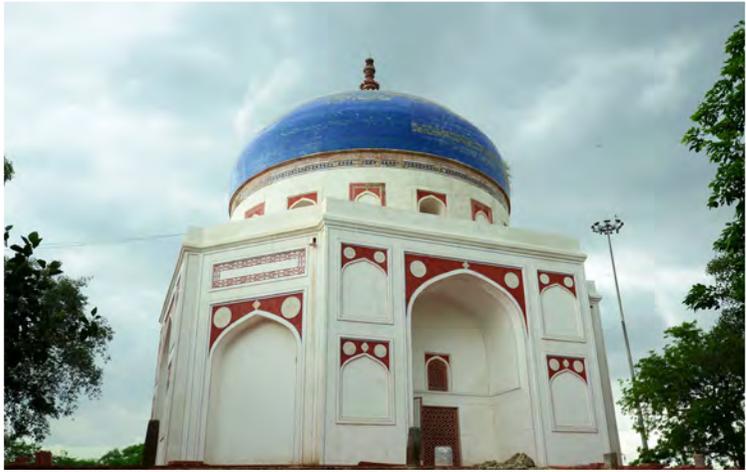
**Nila Gumbad: Before Conservation**
