ISA KHAN'S ENCLOSURE CONSERVATION

Major conservation and landscape works aimed at restoring the architectural and historical character of the Isa Khan's and Bu-Halima's Complex are proposed in 2011 with World Monuments Fund's co-funding.

ISA KHAN ENCLOSURE- BU HALIMA COMPLEX

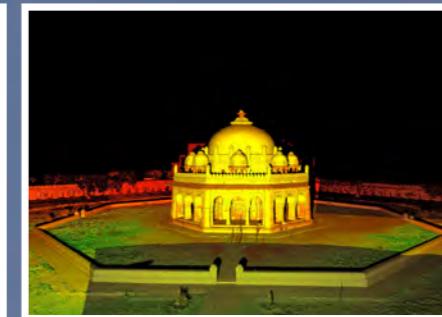
3-D Laser Scanning

Documentation, 3D Laser Scanning

- Documentation works commenced in late 2009 using 3D High Definition Survey for the entire complex.
- Following the laser scanning, over 500 drawings including condition assessment have been prepared, documenting each detail, including ornamental plasterwork and ceramic tilework in detail.
- All external and Internal surfaces of all buildings have been scanned and data is registered.
- Architectural measured drawings, Condition Assessment drawings and Drawing indicating Conservation proposals now prepared for all buildings including enclosure walls of the complex.
- All the structural problems are marked on the drawings for the structural analysis of the monuments. Detailed structural Analysis is done by Stuart Tappin, Stand Consulting Engineers, UK

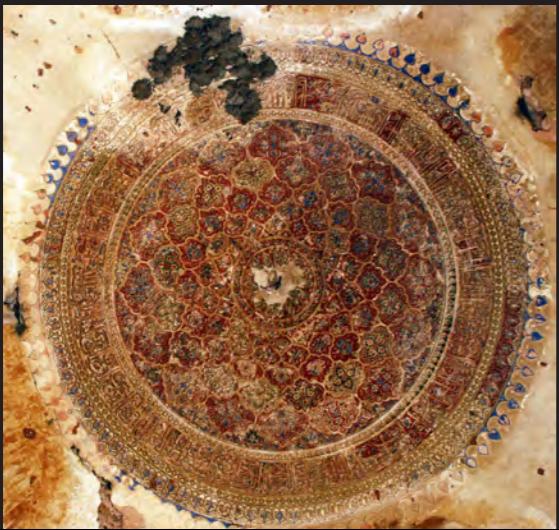
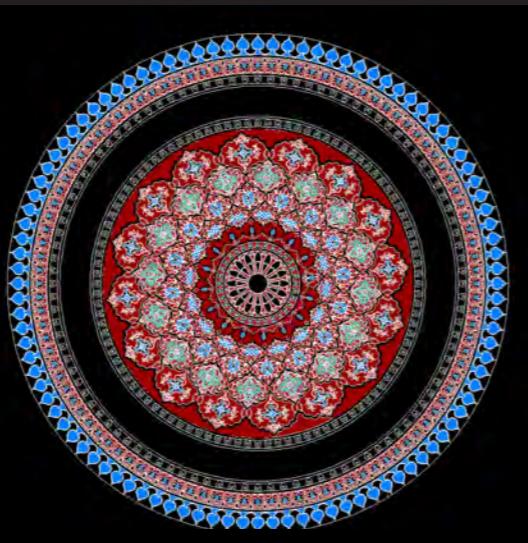
Architectural drawing of the Isa Khan's tomb's ceiling prepared using the 3-D Laser Scanning data

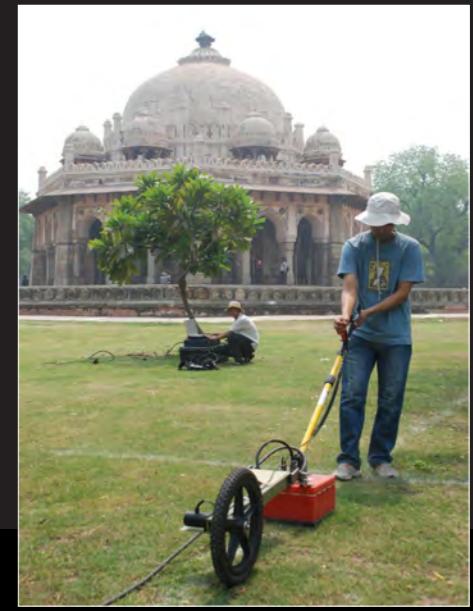
Ground Penetrating Radar Survey (GPRS) of the Isa Khan's Enclosure and the Bu-Halima's Enclosure

- Ground Penetrating Radar (GPR) survey has been carried out within and around the enclosure walls of Isa Khan's complex, Bu Halima Complex and open area with the entrance zone.
- This has enabled identification of underground archaeological remains which can be further investigated during the designing and execution of the works, especially the proposed interpretation centre.
- The portion of Bu Halima's Tomb enclosure wall demolished by the British to make a road in 1920's were discovered. It is proposed to complete the missing portion of the walls.

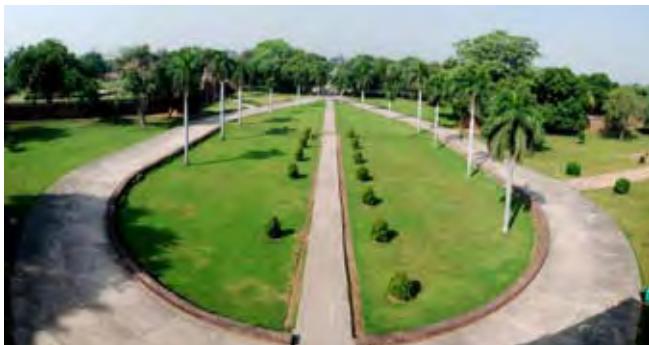
Landscape Plan

- Based on the study of archival material, results of GPRS, the flow of visitors and the conservation proposals including rebuilding missing portions of the Bu Halima enclosure wall, a landscape plan for the two complexes has been developed.

- The landscape plan aims to restore the Mughal layout and levels of the two complexes.
- It is also proposed to remove the vast quantities of Cement concrete paving that is found in the entrance zone and rationalise the pathway layout to enhance the historic character and visitor experience.
- Following trial trenches in the Isa Khan complex, it was discovered that roughly 3 feet of earth was to be removed from the outer half of the enclosure to restore original levels.

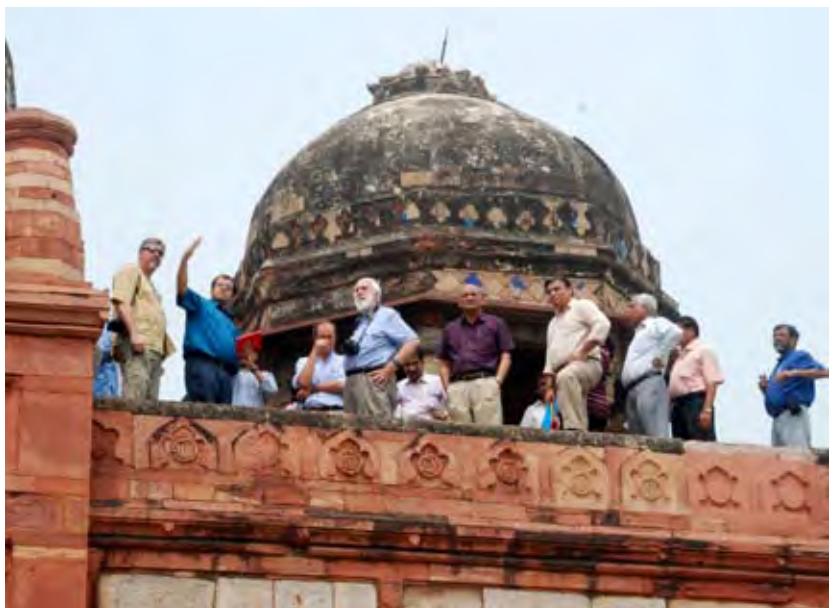
Isa Khan's Tomb's Ceiling - Before Conservation

The highly ornamental ceiling of Isa Khan's Tomb had suffered severe decay due to neglect and water ingress. Also with the dome white-washed and cement plastered, it was too dark for the ceiling to be visible. Careful restoration of the ornamentation has been carried out by master craftsmen and the cement plaster replaced with lime plaster thereby significantly enhancing the historic character of the tomb chamber.

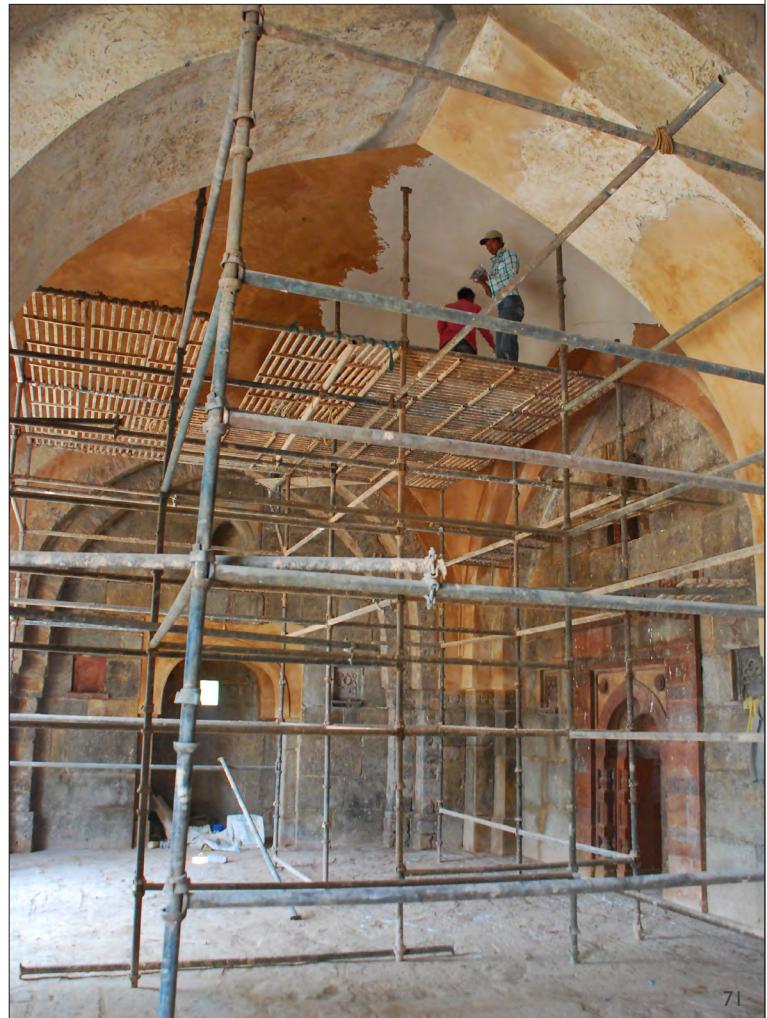
As with the Isa Khan's Tomb, the interiors of the mosque also required cleaning of the stone surfaces and re-plastering with lime mortar following the removal of cement plaster ►

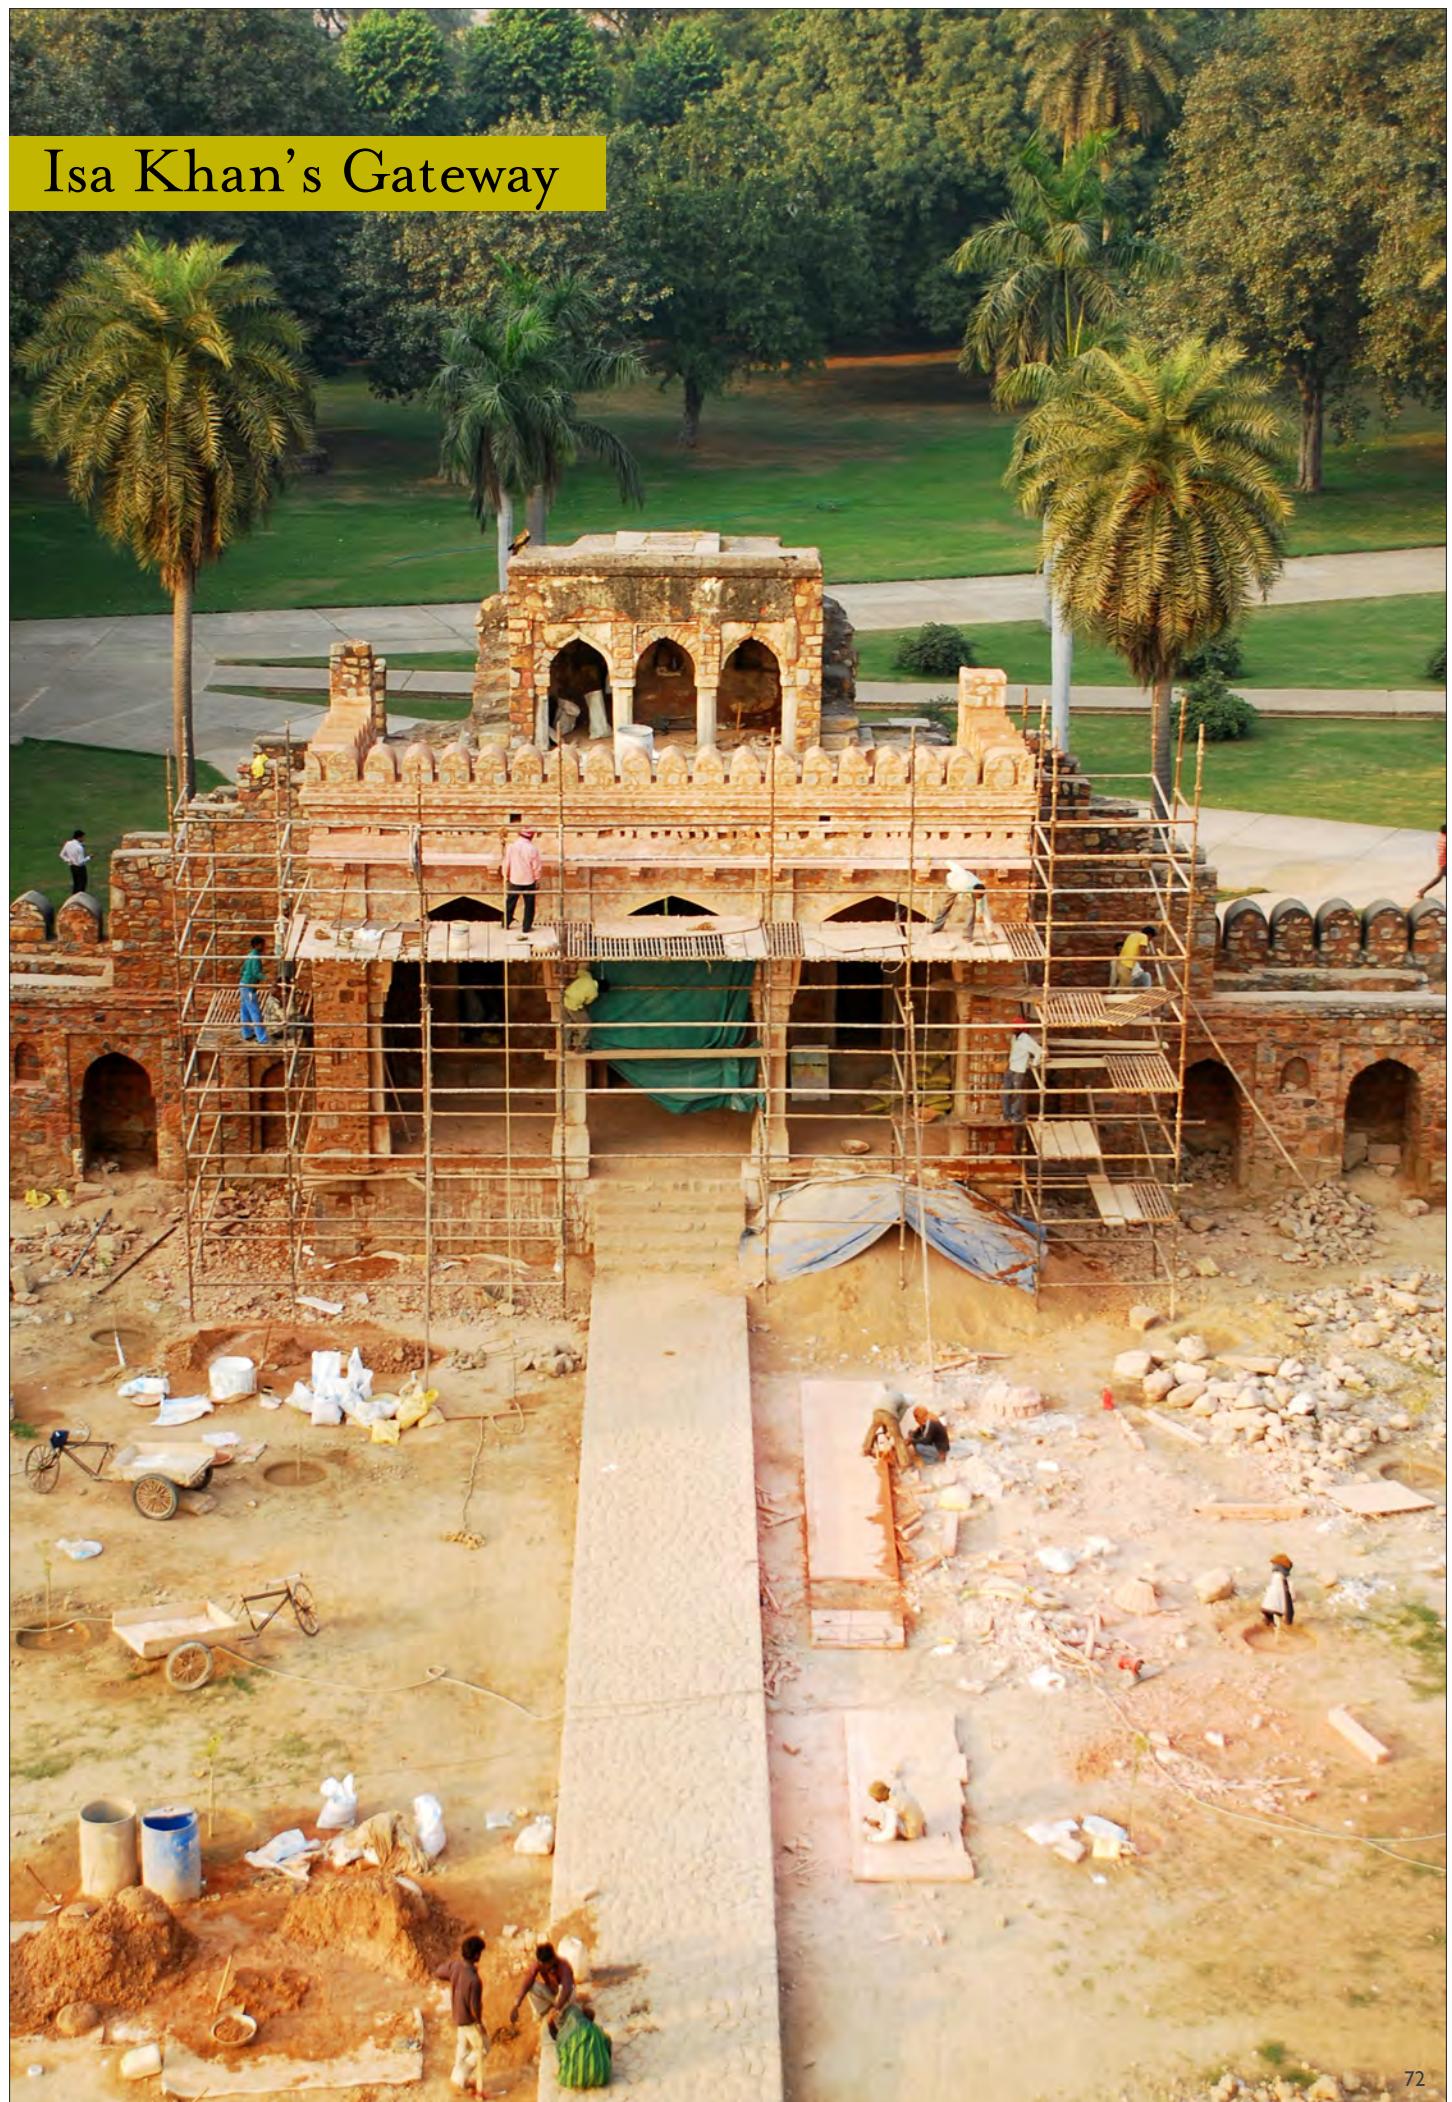
Following structural repairs to the domed ceiling, the battlemented parapet wall was re-built using traditional materials, tools and building techniques ▼

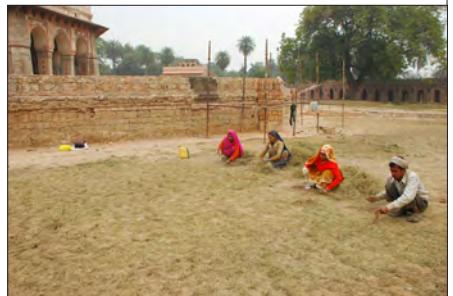
- The Isa Khan's tomb garden was discovered to have an inner garden in the immediate setting of the tomb and a lower outer garden, both separated by a masonry retaining wall.
- On original garden levels being restored and cement plaster being removed from the retaining wall, the wall exhibited severe stress and portions began to collapse.

- Structural analysis revealed that large portions of the wall were built in mud mortar and were built of rubble. An archival research that followed revealed that the wall was completely rebuilt in the mid 20th century.
- Large portions of the wall were completely dismantled to ground level and rebuilt on the original foundations. This reconstruction also included rebuilding the corner bastions that were revealed during the earth removal exercise.
- 530 cum of random rubble stone masonry thus required to be reconstructed in lime mortar. It was agreed not to plaster the wall and leave the masonry exposed.

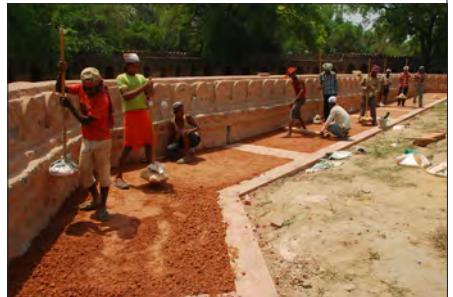
Plinth protection & Pathways

- For visitor access, pathways have been built in the cardinal directions in Delhi Quartzite. Though it was suggested that the pathways have a width of 3 m the narrower width of the staircase at the gateway was considered more appropriate by the ASI Core Committee.
- These pathways meet the plinth protection built for the arcaded outer enclosure wall and the plinth protection on both sides of the inner retaining wall.
- In total, 1120 meter of the plinth protection of up to 2m width has been constructed.

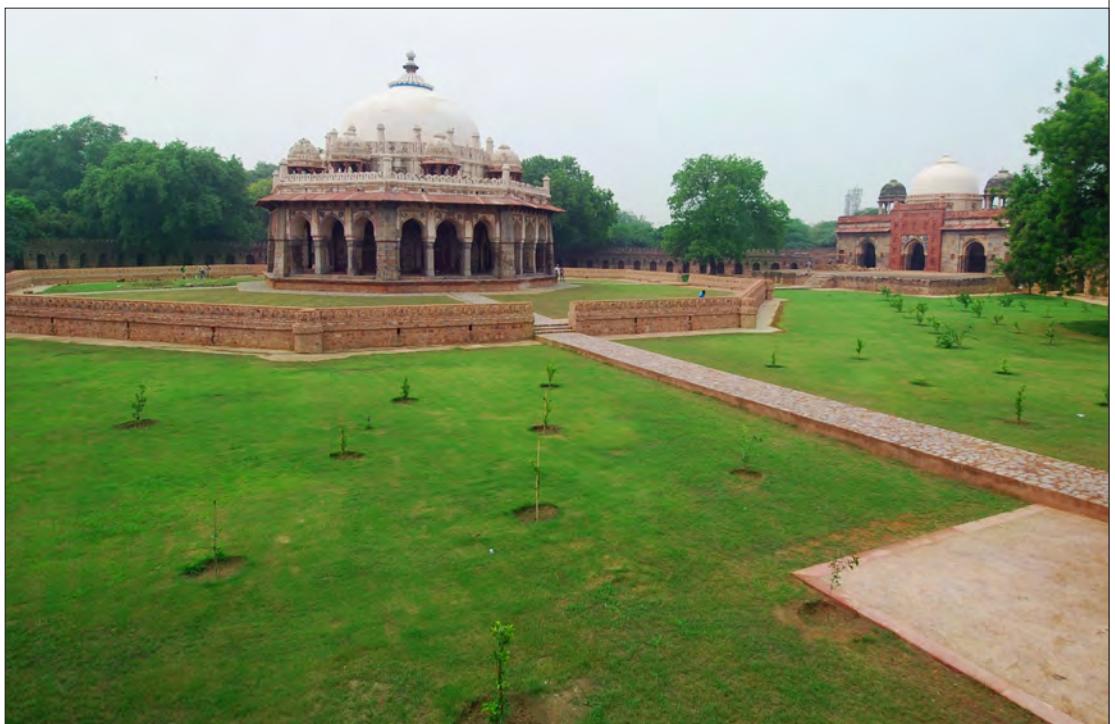
▲ 11,440 Sq.m of Garden restored
- 3,25,000 Cu.Ft. of earth removed -
5000 Man-days of work went into the
discovery of this earliest known sunken
garden of India

- In keeping with traditional design for sunken gardens, which were irrigated by flooding and planted with fruit trees, the outer garden has been planted with a citrus grove.
- This will eventually allow visitors standing on the upper levels to be at eye level with tree-tops.
- The inner garden is merely grassed to provide a clear line of visibility.

Isa Khan's Tomb - Garden: Now
Restoration of the earliest known/
surviving sunken garden and in turn
the original/ historic setting of the
mausoleum ▼

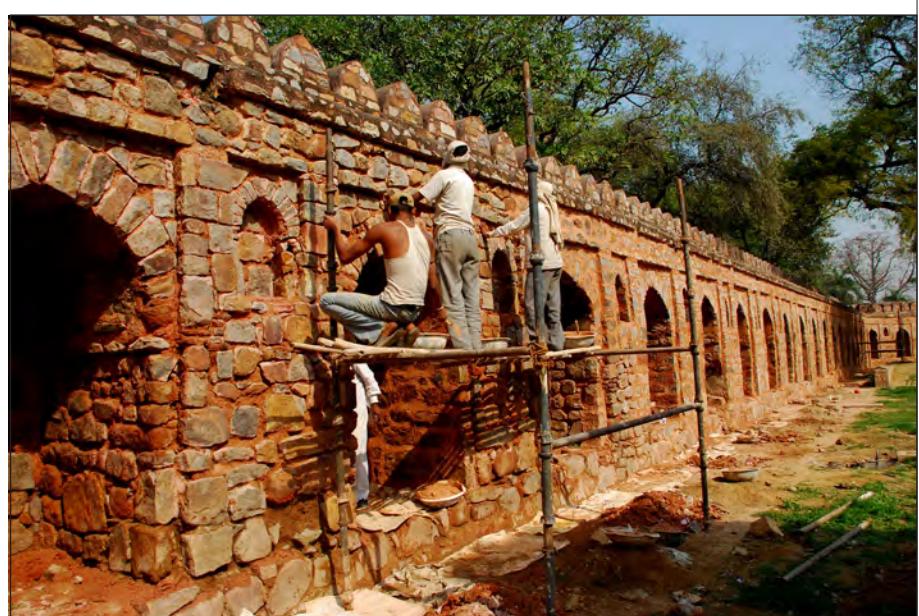
▲The octagonal internal retaining wall allowed the outer garden to serve as a typical Persian sunken garden, irrigated with flooding. The purpose of the wall and its extent was revealed after the removal of earth. Since it was in a poor state, almost 70% of it required to be reconstructed to once again serve as a structural retaining wall.

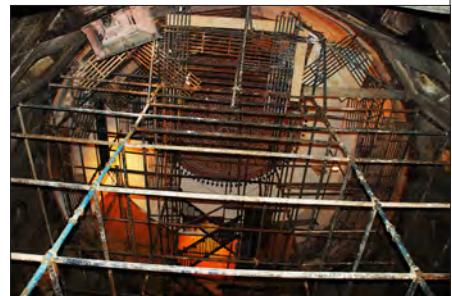
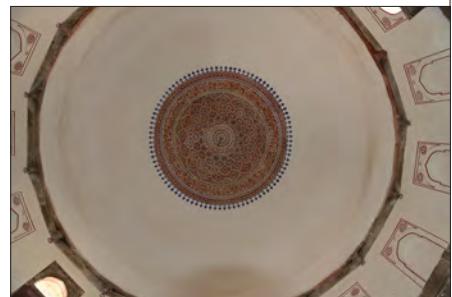
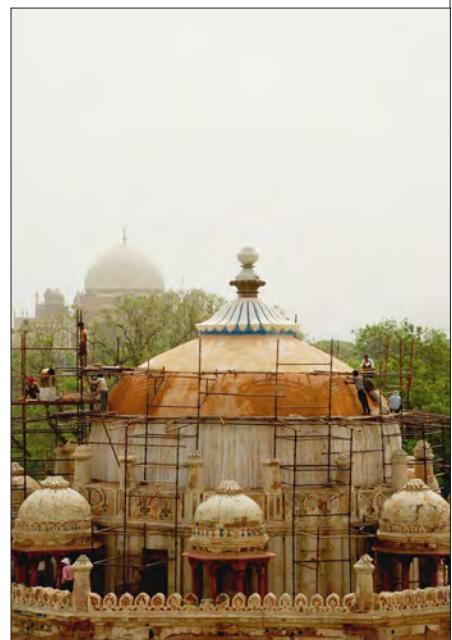
▲ Conservation works on the tomb have included major structural repairs on the dome, restoration of the ceiling and the finial. Restoration of the tilework will carry on through 2013

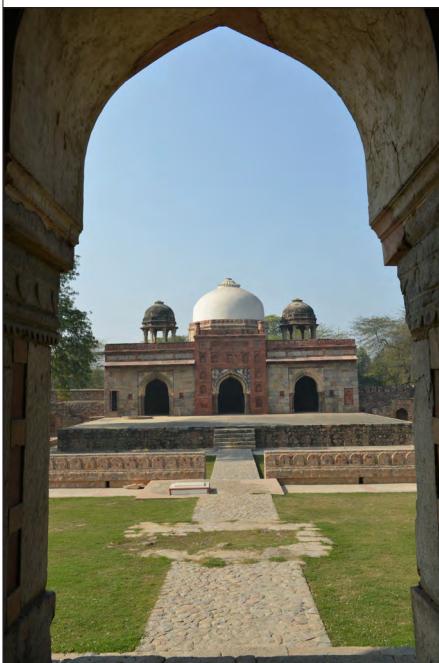
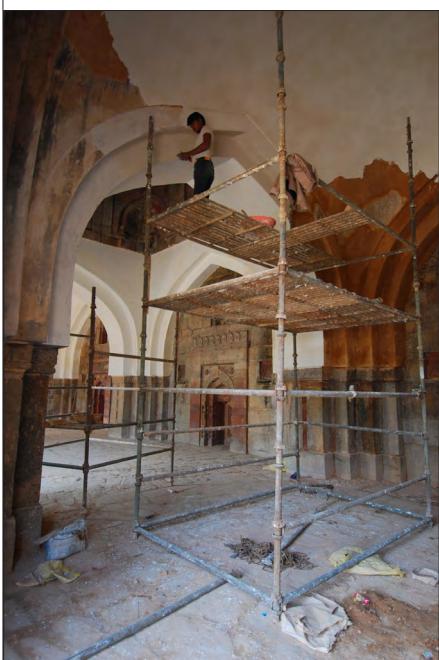
▲ Major roof repairs and stitching of cracks in the dome were required to halt water penetration from the roof. The internal wall surface had to be re-plastered in lime mortar after the removal of cement plaster.

- Following extensive documentation in 2010, conservation works carried out in 2012 included re-plastering the central dome after removing cement plaster and deteriorated lime plaster.
- With the dome re-plastered thus removing vegetation growth filling in of cracks on the plaster surfaces and removal of decayed materials the water ingress could be halted and the internal surfaces replastered and the stone surfaces cleaned.
- All the internal and external wall surfaces of the mosque had cement mortar in the joints which needed to be carefully removed. Cement pointing of the internal wall surfaces has now been replaced with lime mortar pointing.

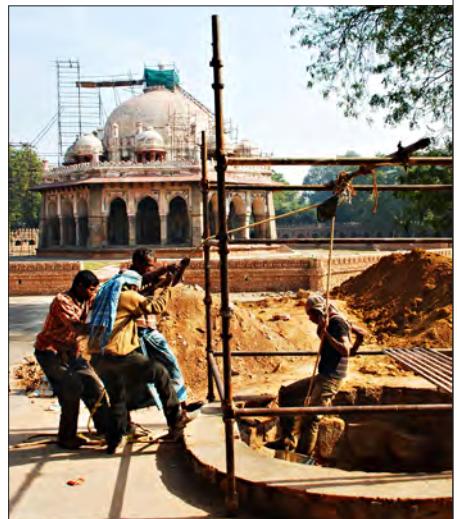
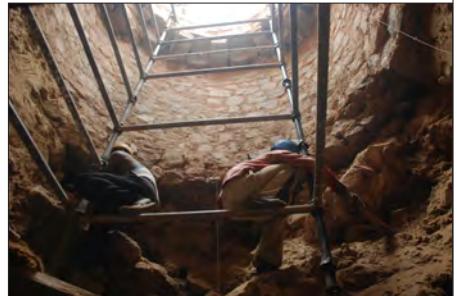
- During the conservation works of the mosque, a well was discovered on the platform of the mosque which was filled in past century.
- The well has now been excavated. This required a very complicated process wherein two men were taken to the bottom on ropes and excavated material listed up in buckets pulled up to the surface.
- During the excavation works it was realised that major wall portions of the well had caved in and which is what probably led to the well being filled in the first instance.
- Caved in portions were carefully conserved with underpinning with random rubble masonry.

▲ De-silting of historic wells in the project area, and removing decades of rubble and deposits from them

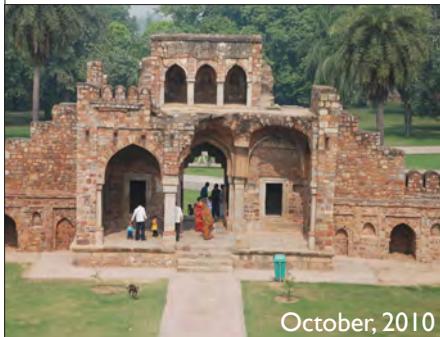
October, 2010

On the northern end of the complex is a gateway which allows entry to visitors. The outer façade of the gateway has suffered from inappropriate past repairs to an extent that the original details have been obliterated. The internal portion had mostly collapsed with the western bay still standing. Conservation works aimed at structural repairs and restoring the architectural integrity to the extent possible.

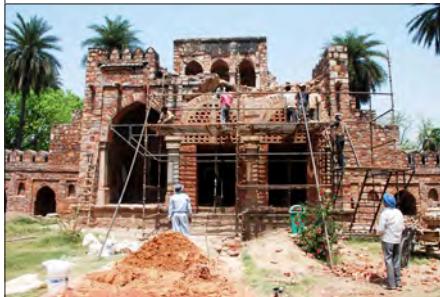
August, 2012

The Gateway: Now

The two collapsed internal bays have now been reconstructed on the basis of the surviving western bay. The reconstruction was possible as the missing column was found embedded in the earth. ►

Following reconstructing the collapsed central and eastern bay in 2011, the conservation works on the gateway in 2012 included restoring the eaves as well as the battlemented parapet.

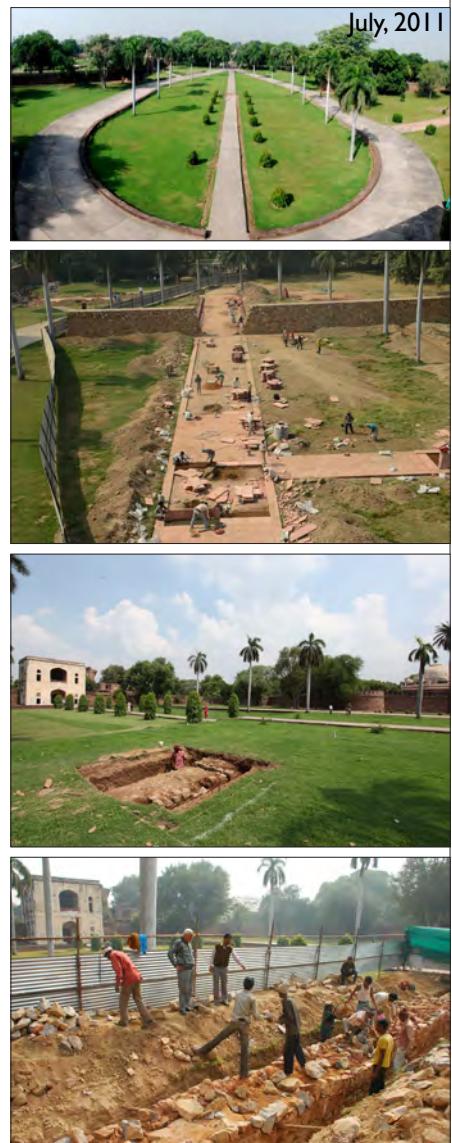
Bu-Halima Tomb - Garden ▲

Early 20th century British-era carriageway disfigured the historic character of Bu Halima's Tomb - Garden and the entrance zone of the World Heritage Site. Works underway on the landscape and restoration of the enclosure wall

- As part of the landscaping works, the levels of the area on the west of the gateway were lowered to ensure the historically appropriate relationship between the gateway and its settings restored. Retaining walls in brick masonry were erected on the either side to minimise earth removal in view of large trees.
- Planting layout was carried out in the Bu-Halima's Garden Tomb, after the complete reconstruction of the missing wall in 2012. Orchards of peach trees are now grown in the complex.
- Sandstone pathways have been laid in the garden and as plinth protection along the entire internal length of the enclosure wall.

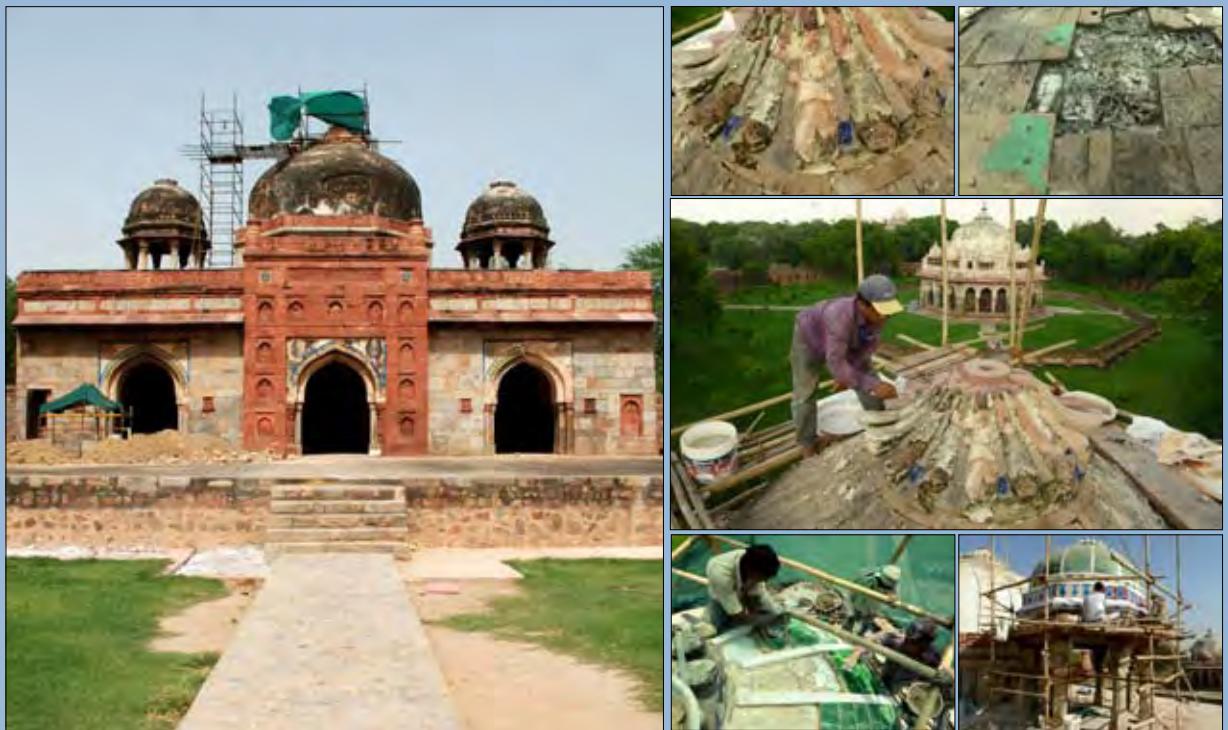
(Left) Isa Khan's Mosque in 2011, before conservation;
 (Right) Various stages of tilework restoration on canopies and finial

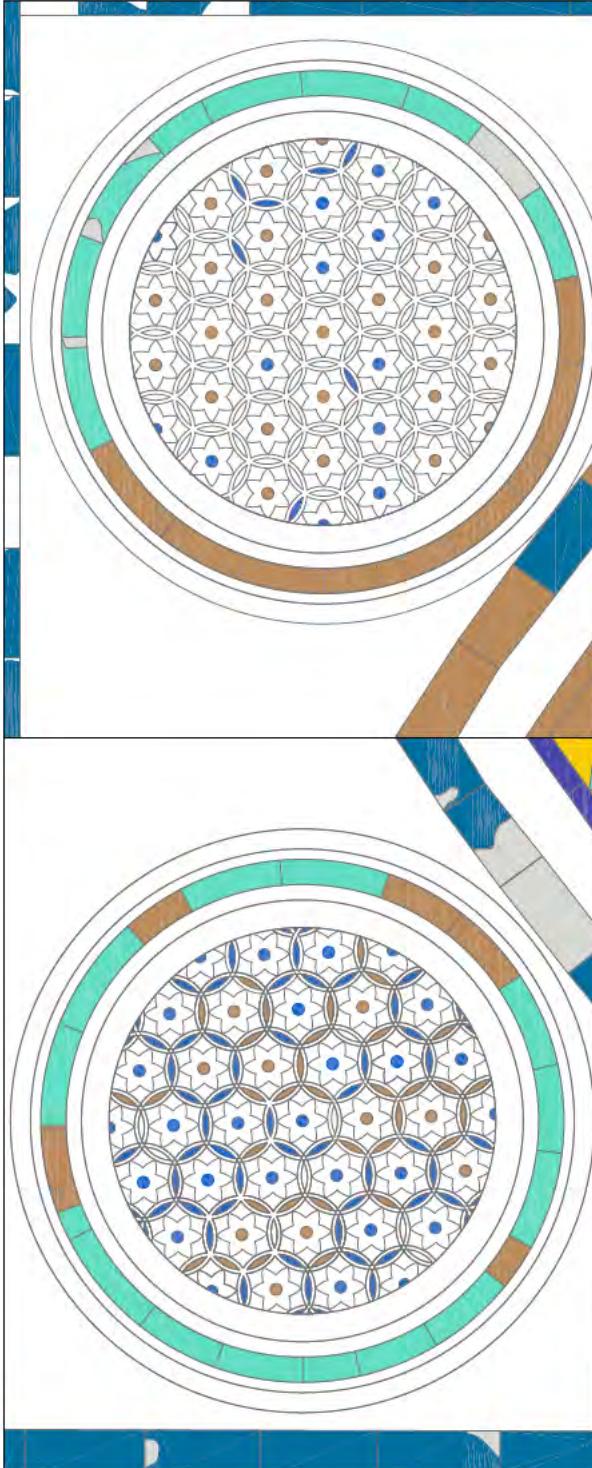
Right Arch Medallions

**Condition Assessment
Right side Arch**
