## Khilji Mosque/ Jamaat Khana Masjid

# KHILJI MOSQUE

## Jamaat Khana Mosque

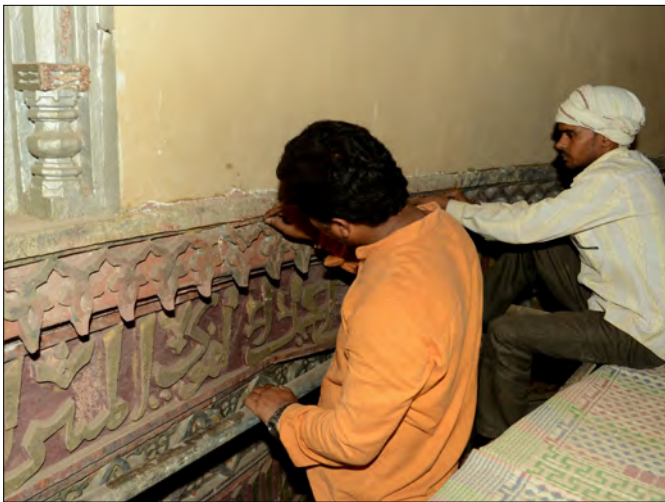
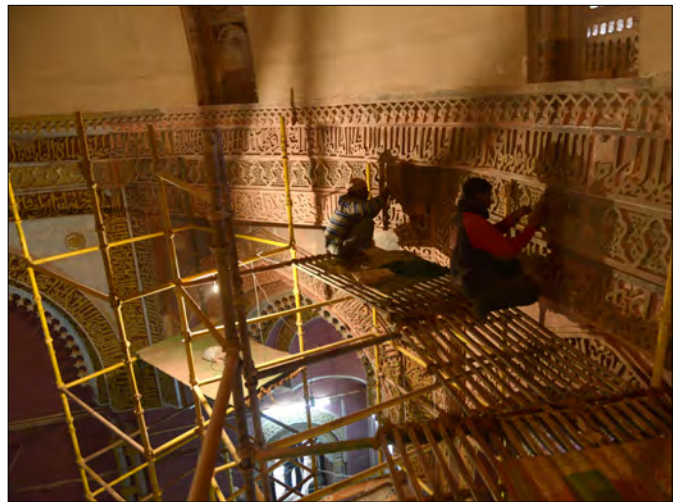
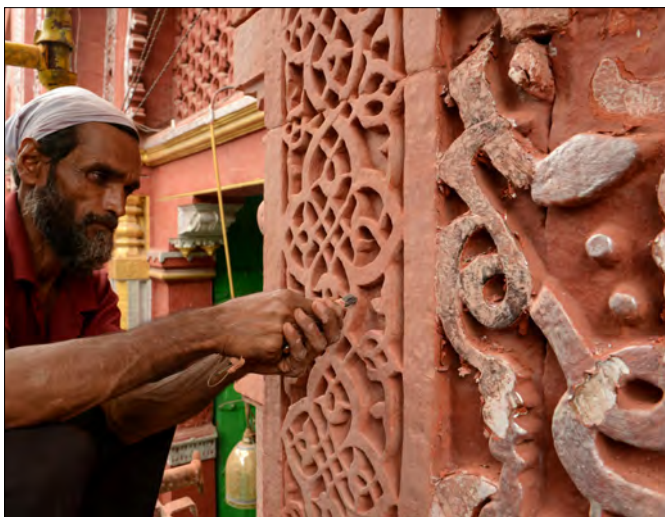
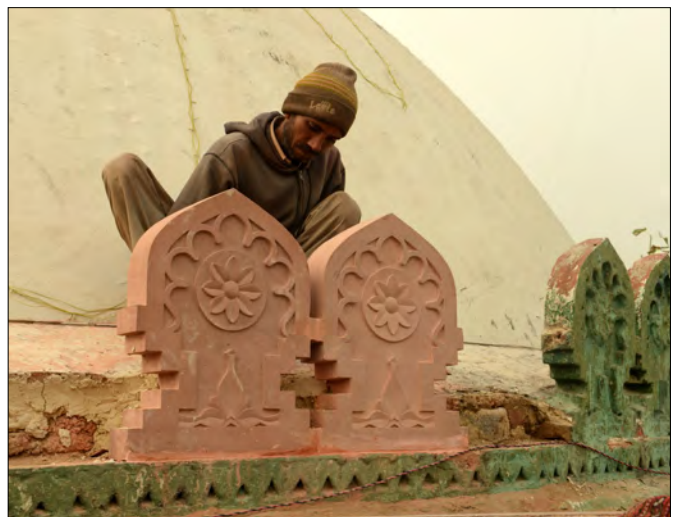
Conservation works at the 14<sup>th</sup> century Khilji mosque required scrapping of several dozen paint and cement layers prior to repair or replacement of the damaged sandstone elements.

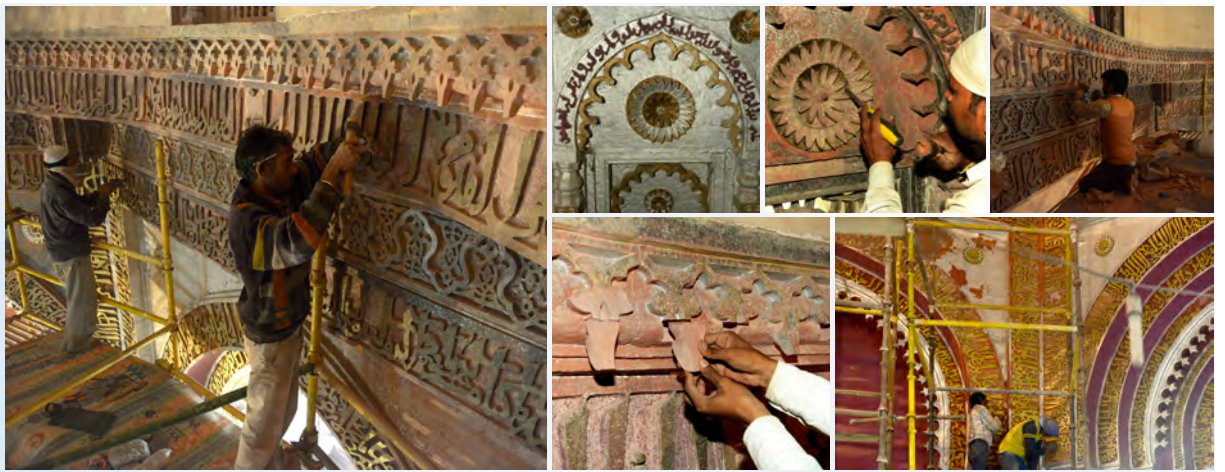
**INTERIORS: During Conservation**

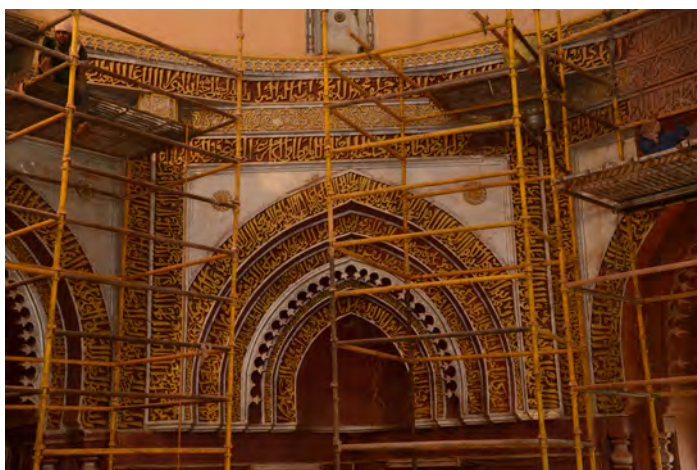
*(Below) Jamaat Khana Mosque interiors - before and after conservation*

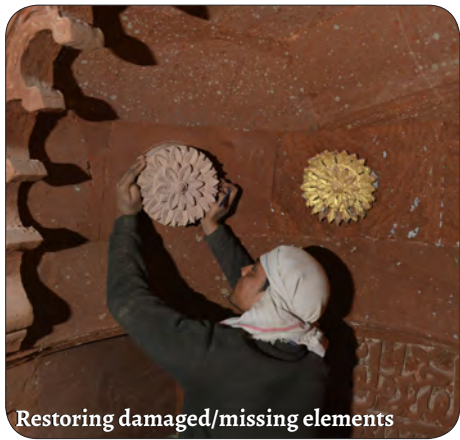
Restoring damaged/missing elements

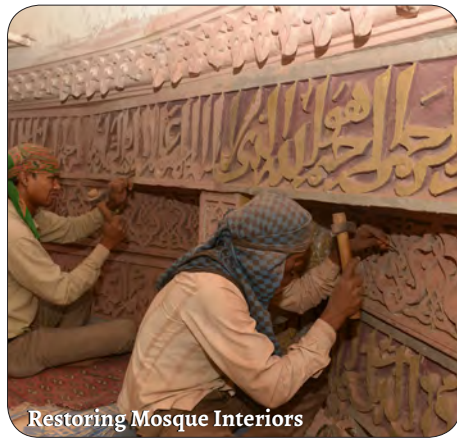
Restoring Mosque Interiors

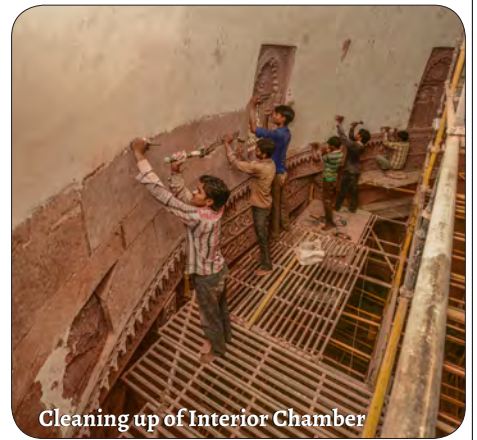
Cleaning up of Interior Chamber

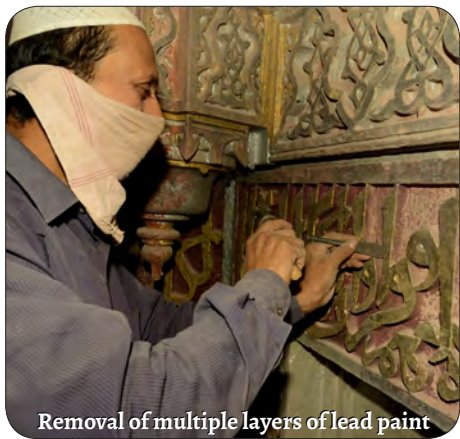
Removal of multiple layers of lead paint

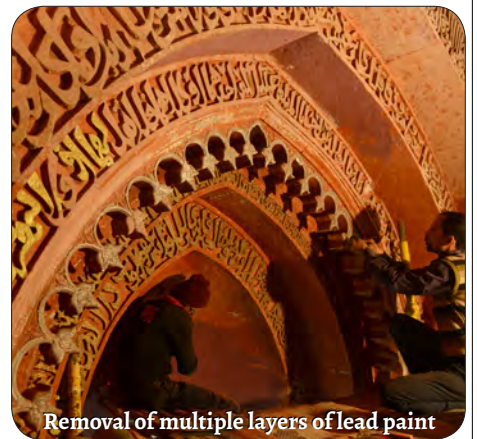
Removal of multiple layers of lead paint

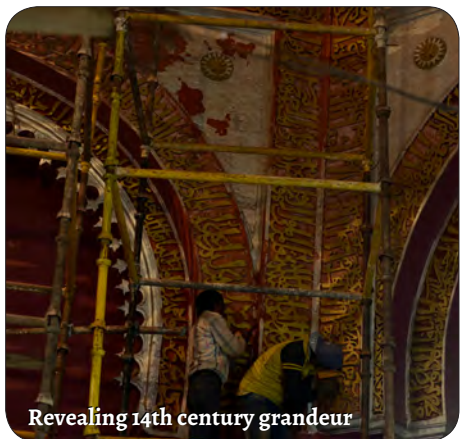
Revealing 14th century grandeur

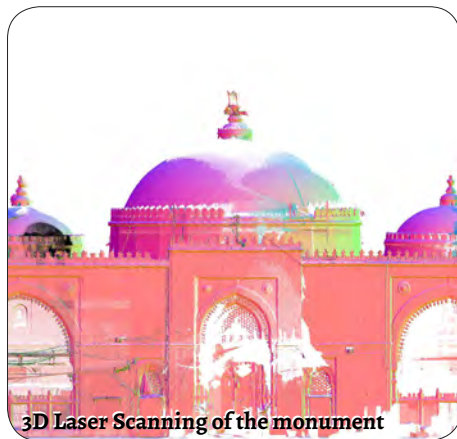
3D Laser Scanning of the monument

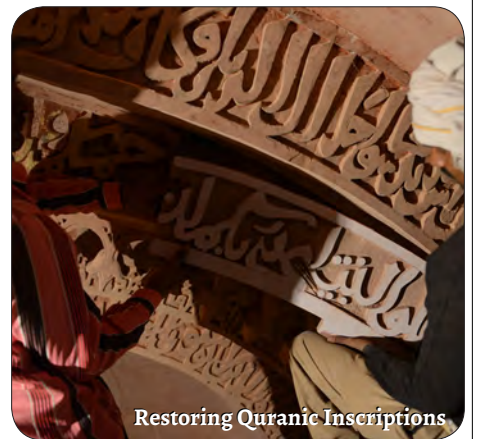
Restoring Quranic Inscriptions

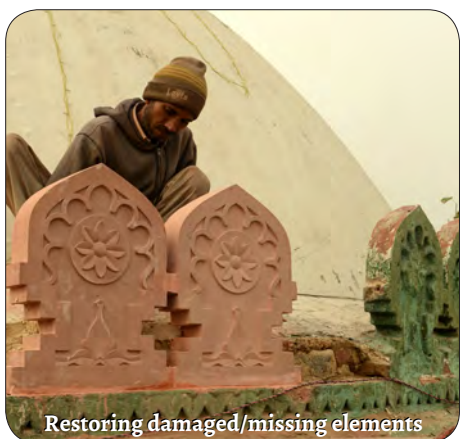
Restoring damaged/missing elements

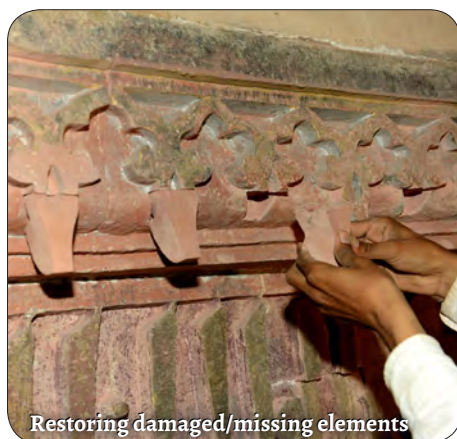
Restoring damaged/missing elements
