# Batashewala Complex

## CONSERVATION & LANDSCAPE RESTORATION

# BATASHEWALA ENCLOSURE

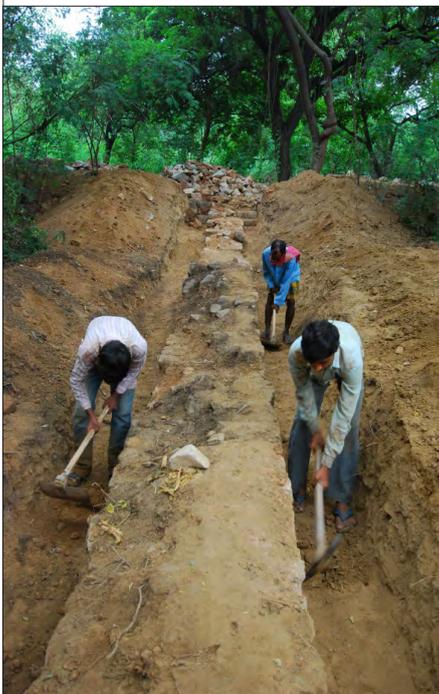
▲ On the north-east corner of the enclosure walls a historic well was discovered and this has been desilted to its original depth, conserved and enclosed within the enclosure

- On the north-east corner of the enclosure wall of Batashewala Complex, a historic well was discovered.
- After proper de-silting to its original depth, the well is now conserved and enclosed within the enclosure.

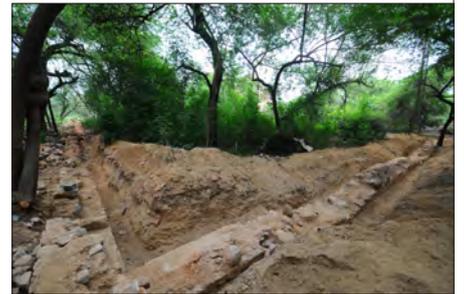
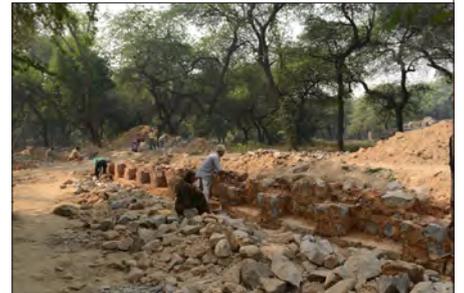
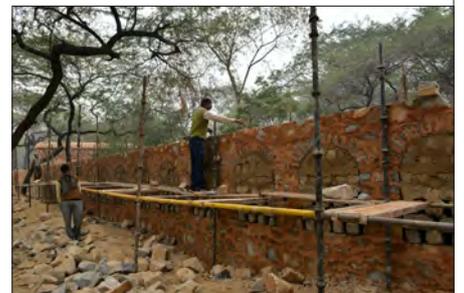
▲ The enclosure wall of the Unknown tomb complex has been reconstructed thus restoring the setting of this 16<sup>th</sup> century structure.

- The reconstruction of the enclosure wall is now ongoing with the western stretch largely complete. This is carried out on the original foundations which have been strengthened by lime grouting.

- The stretch on the northern side required a retaining wall to be built outside the enclosure as the ground in the area has paved considerably.
- The profile of the arches and coping of the southern section discovered to be standing under the modern buildings was used for the entire wall stretch.

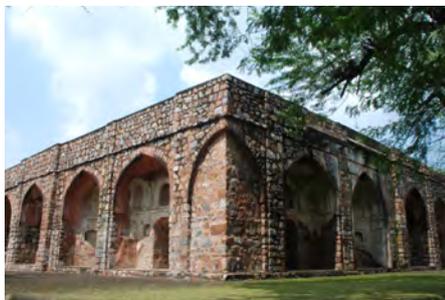
**Mirza Muzaffar Hussain's Tomb**  
*Before conservation in 2010*

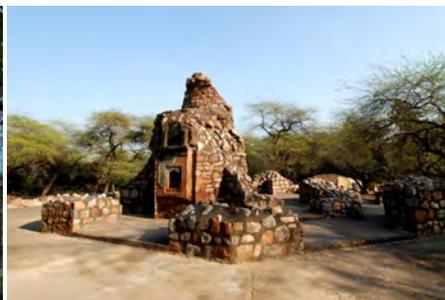
**Chota Batashewala**  
*Before conservation in 2010*

The ASI protected monument known as Chota Batashewala, seems to have largely collapsed following the leveling of land, by Bharat Scouts and Guides, in its immediate setting in 1989 to build the structures for the Bharatiyam event. This as the structure seems to have had no foundations and with the leveling of the mound on which it stood all its foundations were exposed.

- The remains on the site were found to be either raised or consolidated in cement concrete as past repair. It was also found that the entire surface area of the plinth was covered by 20 cm of cement concrete. The first conservation task was to remove all the cement concrete from the entire plinth and the remains of the walls of the tomb.

- During earthworks near the Chota Batasha, it was found that platform stood directly over the earth. The stabilization of the structure required a support from all the sides.

- To counter this problem, an earth mound is designed all around the structure which provides stability to the structure.
- The mound rises till 1M and has a 900 mm wide DQ masonry wall to a depth of 900 mm wrapping all around it.

- The remains found on the site were carefully studied and the details of the structure were discerned. On the basis of these remains, archival texts and images, the reconstruction proposal was made.

- Detailed drawings and model was made to understand the structure.
- As per the evidences and archival images found, it was decided that only the portions that were visible in the archival records will be reconstructed and the roofing system in the internal chamber will not be conjectured.

- Thus three bays have been partially reconstructed on the basis of archival photographs from the 1980's to allow visitors an understanding of this After receiving the approvals from the Archaeological survey of India to reconstruct collapsed portions, the conservations works started where the three bays out of eight are reconstructed.

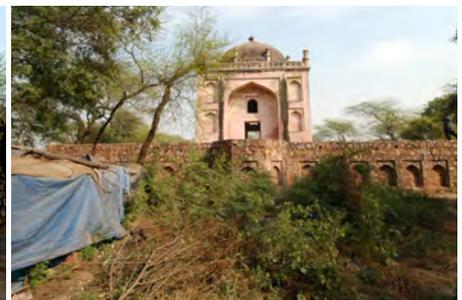
**Mughal Tomb**  
*Before conservation in 2010*

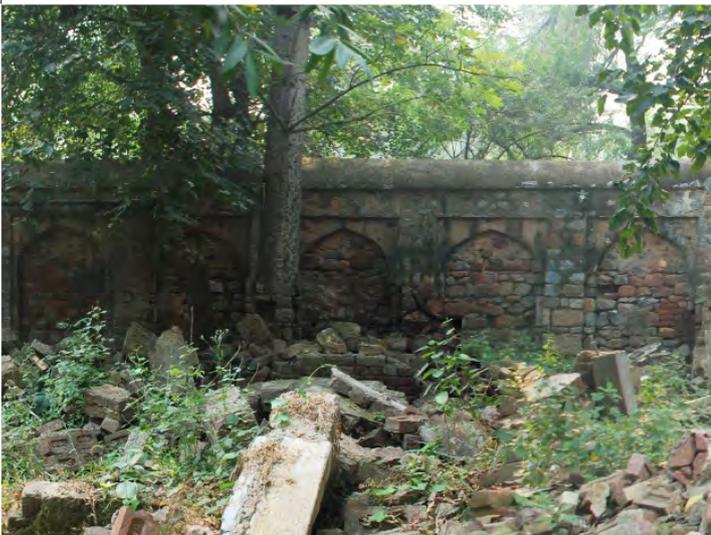
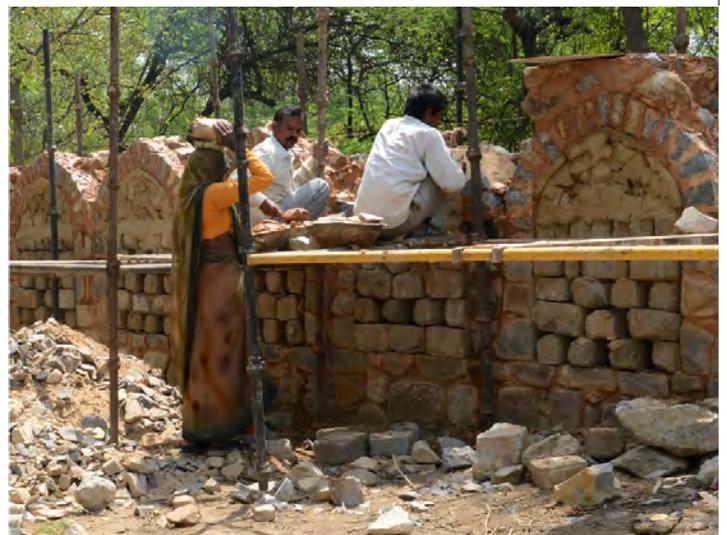
*(Bottom Left) Stretches of the garden enclosure walls, were demolished in 1989 by Bharat Scouts and Guides. The foundations of missing portions were excavated in order to guide the reconstruction of these sections as per the design and structure of standing portions to restore the tomb - garden enclosure.*

- A large portion of the enclosure wall of Batashewala Complex, measuring 740 m has been repaired, rebuilt and reconstructed. The excavations were made to find the original foundations. At some places underpinning works were carried out and the masonry wall was required to be built from a depth of 2M.

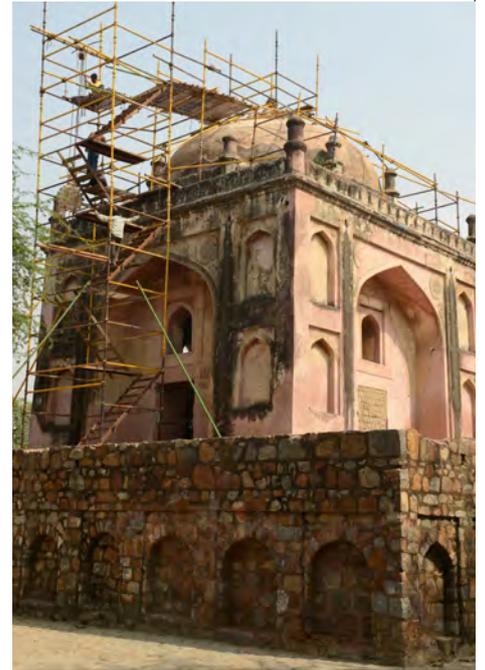
At the Mughal Tomb, a sandstone plinth replaced the earlier cement plinth (Below) which was found to have been laid over construction rubble. The sandstone is long lasting, especially in view of the large number of visitors expected to visit here in future years.

- The plinth of the tomb had multiple layers of cement concrete which added a lot of weight on the foundations of the tomb structure.
- This existing cement concrete is systematically dismantled which has also helped in revealing the original floor levels.

- After dismantling existing concrete, the base using lime concrete was applied and this helped in revealing the original floor levels.
- The red sandstone of required quantities for the platform had been procured and the red sandstone flooring was provided along the length of the platform and in the internal chambers.

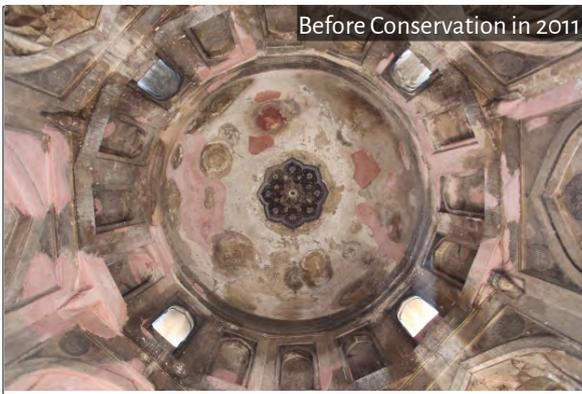
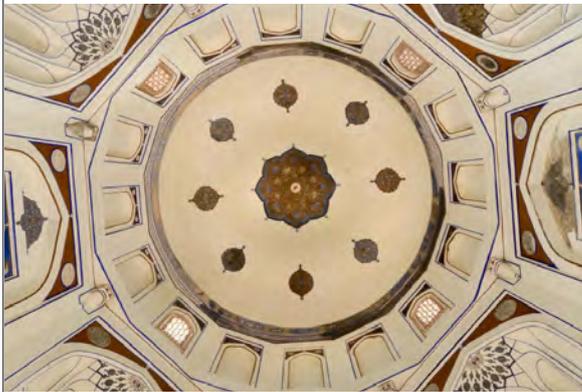
(Left) The domed ceiling of the Mughal tomb required removal of cement, restoration of sandstone lattice screens in the four openings and a final 1 mm layer of lime plaster prepared with marble dust.

- The Mughal tomb had an ornamented interior though much of the interior ornamentation had been lost due to neglect, water seepage and inappropriate past repairs wherein plain cement plaster was used on wall and ceiling surfaces that were originally decorated.

- After the careful documentation of the existing remains of the original incised plaster and paintwork, the restoration of the decayed decorative patterns were undertaken on the internal ceiling and the works are now complete.

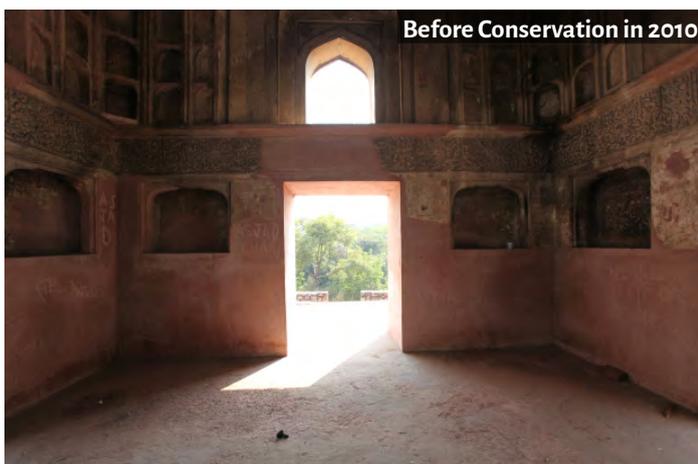
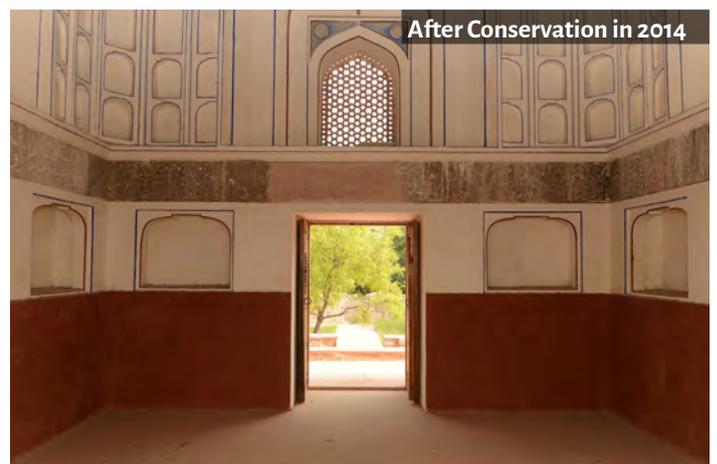
(Below) The north face of the tomb chamber. Conservation works required the complete removal of the 'pinkish' 21<sup>st</sup> century cement plaster, restoration of lime plaster layers as well as the sandstone lattice screen that seems to have been removed in the 20<sup>th</sup> century for the antique market.

Before Conservation in 2010

After Conservation in 2014

- All the 7 lattice screens (4 small, 3 rectangular) were prepared by the master craftsmen and are restored on the tomb after removing the cement plaster from the surface of the walls.

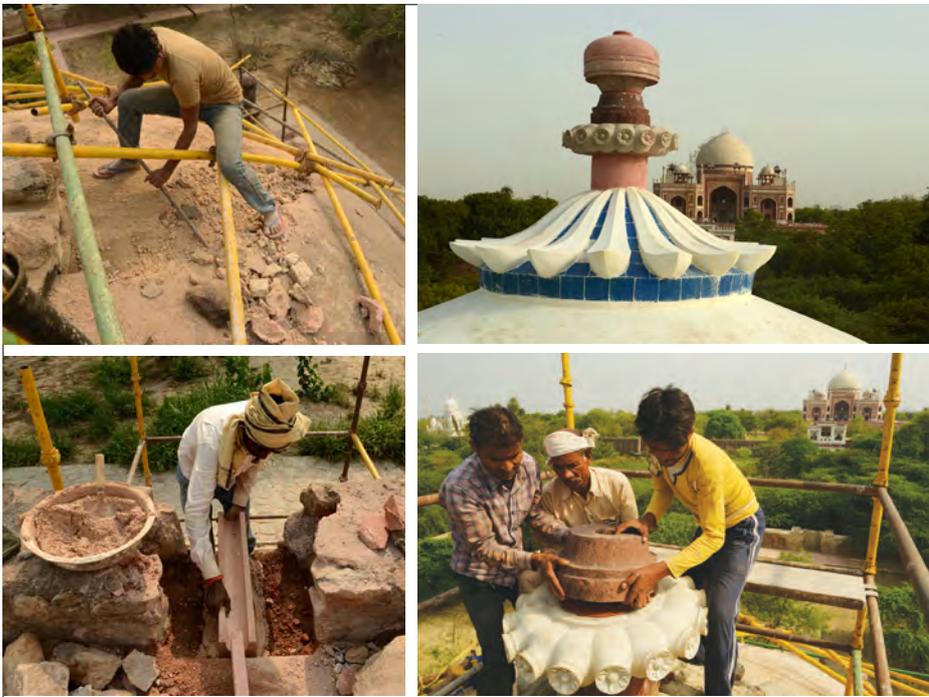
*Broken portions of the finial were found collapsed on the roof. Master craftsmen prepared matching finial pieces to restore on finial on the dome.*

- The finial was found collapsed on the roof and in broken fragments and has since been restored to the dome.

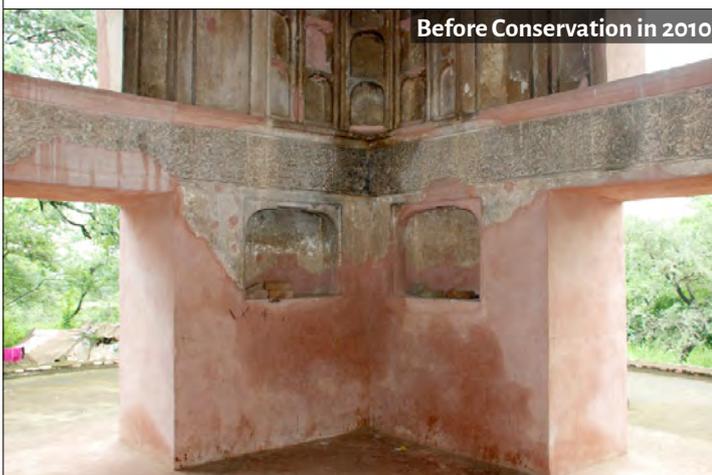
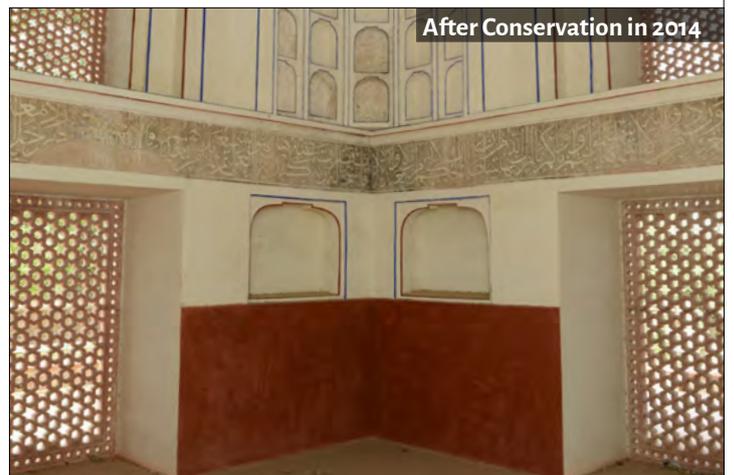
*Hand carved sandstone screens were restored to three of the ground level openings and to each of the four arches over the doorways, The pinkish 21<sup>st</sup> century cement layers were replaced with traditional lime plaster.*

**Before Conservation in 2010**

**After Conservation in 2014**

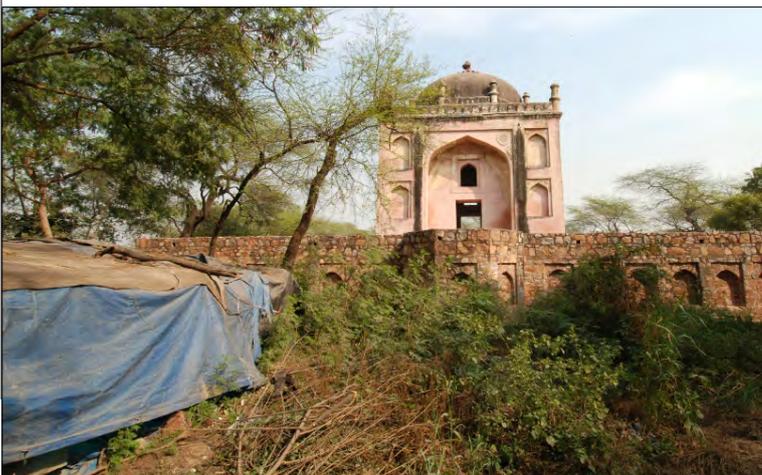
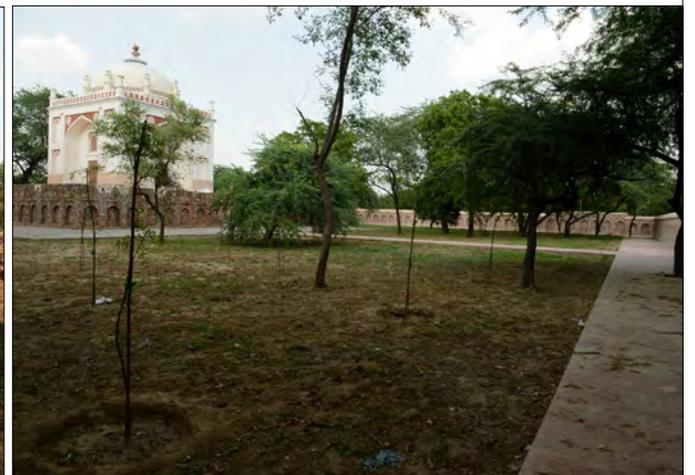
*(Left) The Mughal Tomb Complex, before landscape restoration in 2011; and (Right) during landscape restoration in 2014.*

- The red sandstone of 7.5 cm thickness has been provided as 3M plinth protection along the length of the enclosure wall of the monument.
- A water channel and tank discovered to the east of the tomb was exposed and repaired.
- The Delhi Quartzite stone was provided as 4.5 M plinth protection around the entire Plinth.
- Completion of all conservation works was then followed by garden restoration where sandstone pathways were laid and Neem trees were planted.

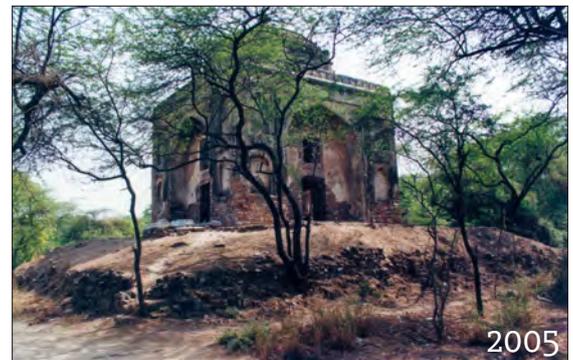
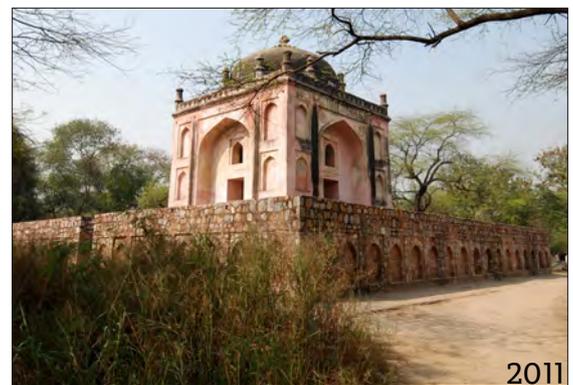
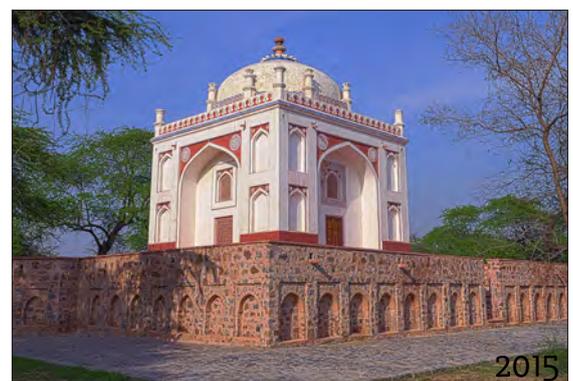
*(Right) In 2005-06, the ASI reconstructed the arcaded plinth wall of this tomb. Conservation works during 2011-15 have focussed on removing the cement plaster applied during 2005-06 on ornamental surfaces, and has employed master craftsmen using traditional materials such as lime mortar to carefully restore the Mughal-era details.*

- The principal works carried out in 2015 were on the facade and the plinth.
- On the construction rubble used as in-fill was removed and replaced by a stone in-fill. The concrete flooring of the plinth was similarly replaced with traditional sandstone flooring.

- On the facade all the cement-surkhi plaster applied here during 2002-5 was carefully removed and replaced with a traditional layer of lime plaster.
- All original lime plaster found on the structure was carefully consolidated and retained on the structure.

- Ornamental patters such as found on the neck of the dome, the parapet were carefully restored.
- A final coat of 1 mm lime: Marble dust plaster used by the Mughals to mimic marble was restored to the entire facade. Since the penultimate layers of lime plaster include organic additives such as jaggery, fruit pulp, egg white and lentil, the patina of organic growth is expected to return within a few years.
