NILA GUMBAD CONSERVATION

Conservation & Garden Restoration Nila Gumbad @ Humayun's Tomb

05 NILA GUMBAD

Conservation works on the earliest Mughal-era tomb in Delhi and restoring its historic linkages with the World Heritage Site of Humayun's Tomb

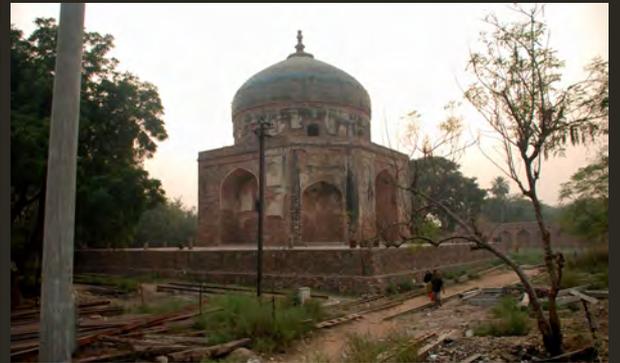
Existing road segregates Nila Gumbad from Humayun's Tomb

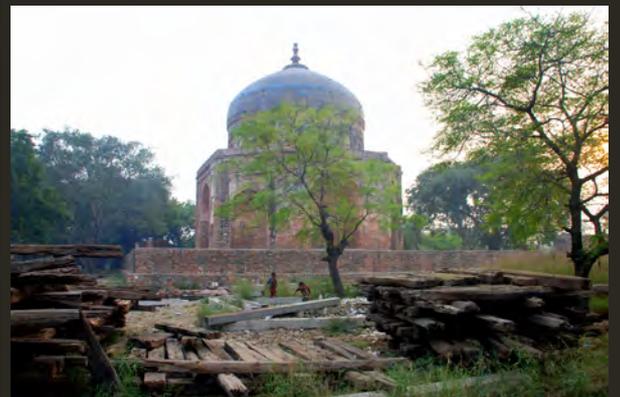
Monument area using as dump yard by Railways

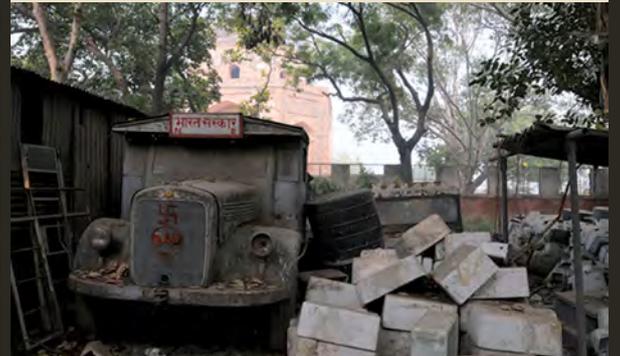
Nila Gumbad originally stood within a char-bagh, remnant of which have been recently discovered and stand beneath area used for storage by railways

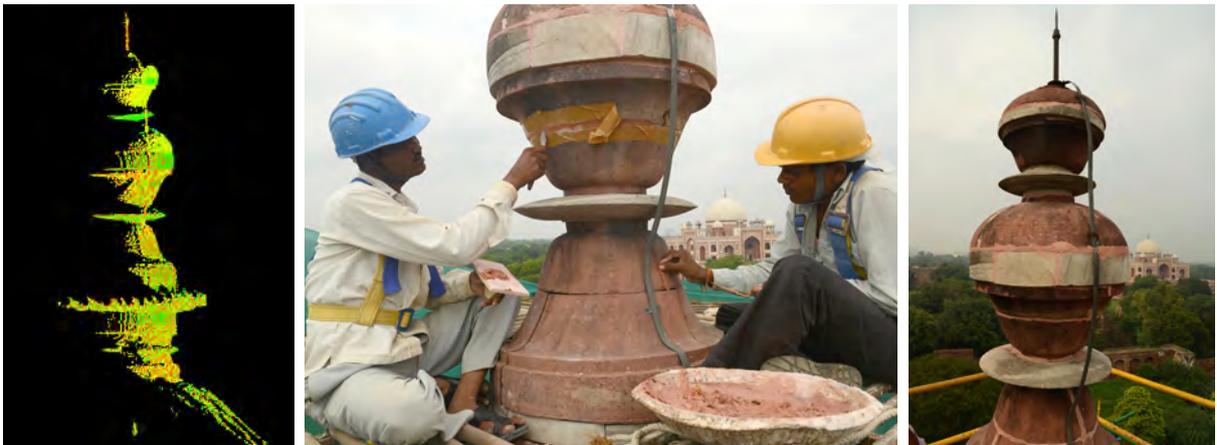
The ornamental stone finial on Nila Gumbad, which is a prominent architectural element on the tomb structure, was found in a poor state of preservation.

(Left) Finial of Nila Gumbad- Image generated using 3-D laser scanning Data (Centre) Craftsmen restoring the stone finial which is at the height (Right) Finial restored

- The finial comprises of alternate use of red sandstone and marble.
- On close inspection the stone pieces were found cracked possibly due to water ingress on the iron dowels. The finial was thus out of plumb.
- The restoration of the finial required extensive cleaning of the surface, removing the dust which had deposited in the joints and the severely damaged stones were required to be replaced with new stones carefully matching the original.
- The stone finial rests over an inverted lotus made of lime mortar and finished in lime plaster. The gaps between all the petals are filled by the turquoise tiles. Many of the tiles on the inverted lotus finial were found to have been replaced with rubber sourced from slippers and were removed and replaced with glazed ceramic tiles.
- The collapsed portions of the inverted flower petals were rebuilt and finished using lime plaster.

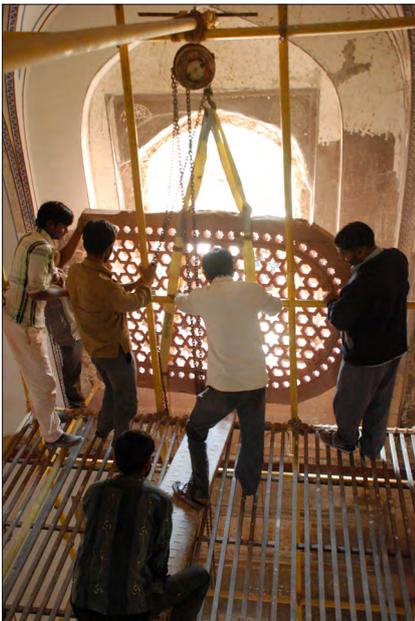
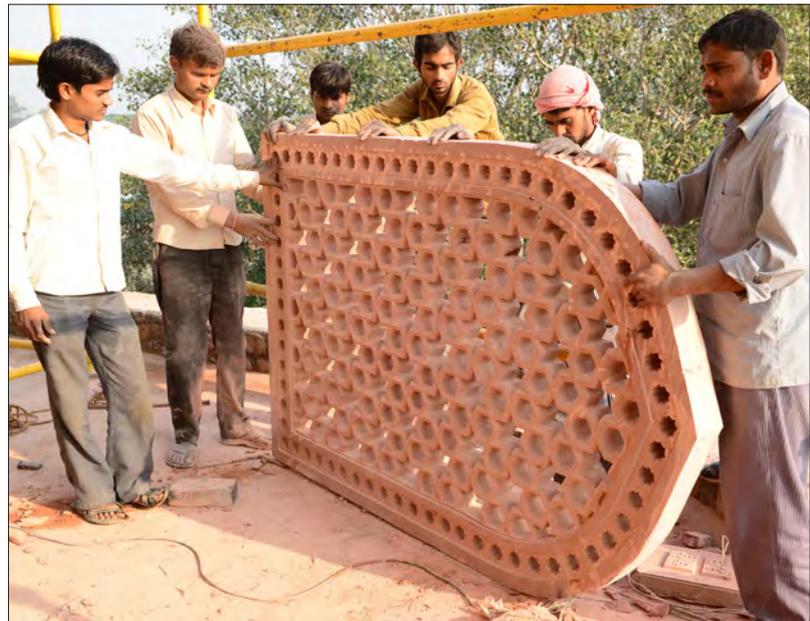
In the neck of the dome are eight vaulted openings where grooves holding sandstone lattice screens as is typical were still visible. As with Sundarwala Burj, Lakkarwala Burj, Sabz Burj, these screens seem to have been removed in the 20th century – possibly for the antique market – thus allowing free access to birds besides altering the original character of the structure. As with other monuments it was agreed to restore hand carved screens to the eight openings.

(Left) The craftsmen transporting the sandstone jaali weighing over 700kg to the height of over 40 feet (Right) It takes 2-3 months of hardwork by 8 craftsmen to prepare a jaali of this size and complexity. All the 8 sandstone lattice screens on the neck of the dome and 4 lattice screens on the lower level are restored.

- The drum has 8 arched openings each of size approximately 1250mm X 1890mm and the four recessed arched surfaces on the ground level have four arched openings each measuring approximately 855mm X 1225mm.
- The restoration of these screens revives the intended architectural character of the building and they also prevent entry of bird into the structure thus preventing decay resulting from bird droppings.
- The lattice screens were manually carved out by the master craftsmen over a period of six months using the original techniques.
- All eight sandstone lattice screens on the neck of the dome and the four lattice screens over the four doorways have been installed following the completion of the lime plastering of the Tomb chamber.

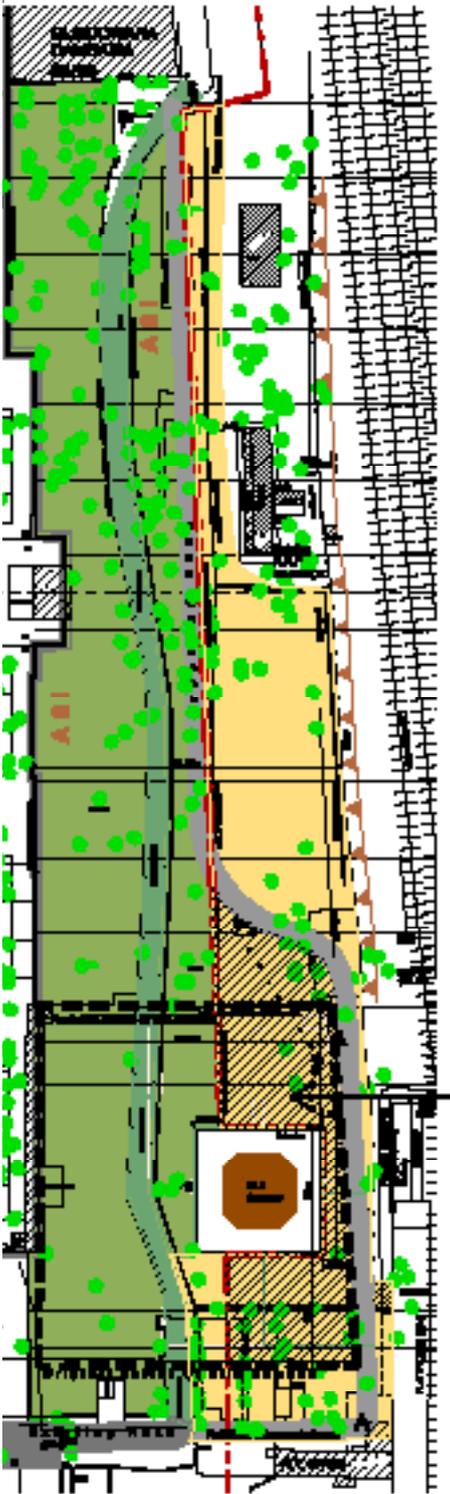
(Above) Landscape proposal of Nila Gumbad environs; (Right) Present-day view of the area around Nila Gumbad with railway sleepers dumped in the vicinity

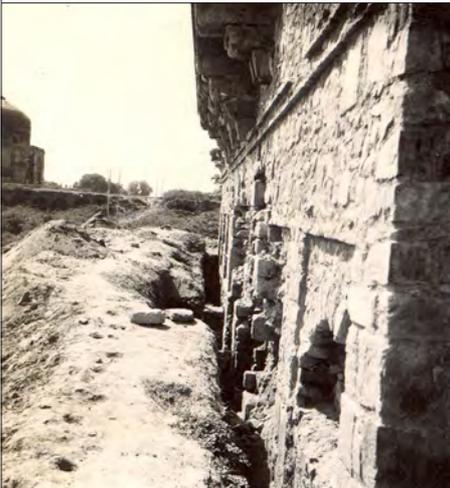
*(Top) Archival photograph showing the arcade between Humayun's Tomb and Nila Gumbad
(Left & Right) Restoration of the arcade based on historical evidence*

- The Tomb was originally surrounded by a walled enclosure and is recorded to have been originally entered through a large gateway on the south - both have now disappeared. A further entrance giving access from the Humayun's Garden Tomb exists in the adjacent wall which was blocked in the early 1900's.
- A large portion of the western arcade was in a state of collapse, and the southern wing has been partially rebuilt.

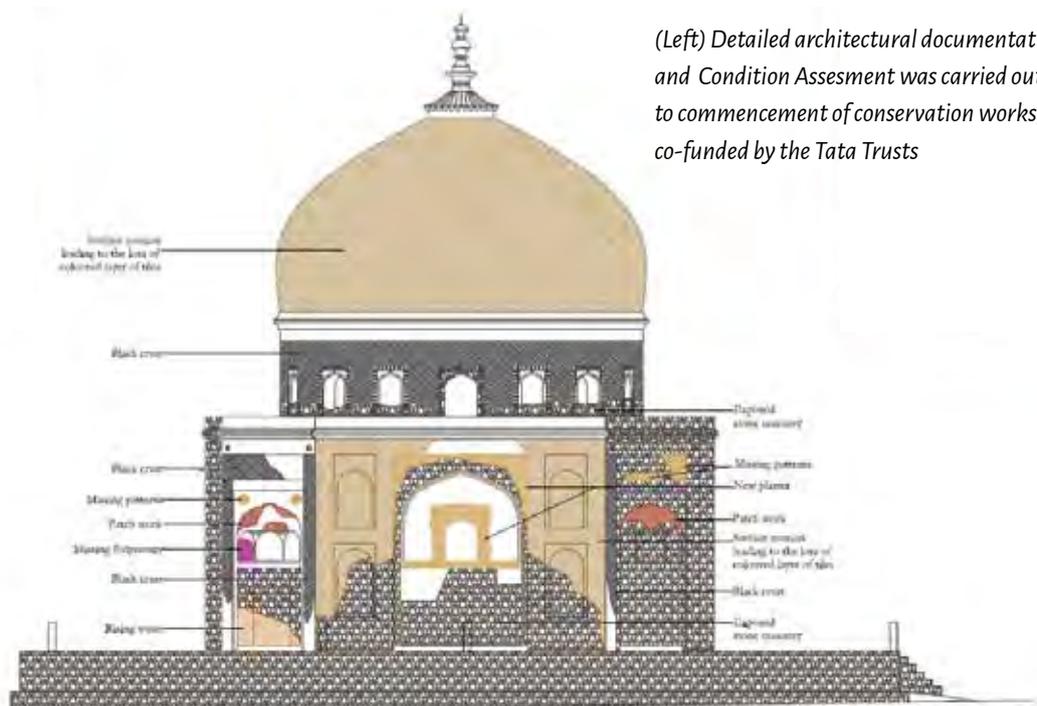
(Left) Detailed architectural documentation and Condition Assessment was carried out prior to commencement of conservation works, co-funded by the Tata Trusts

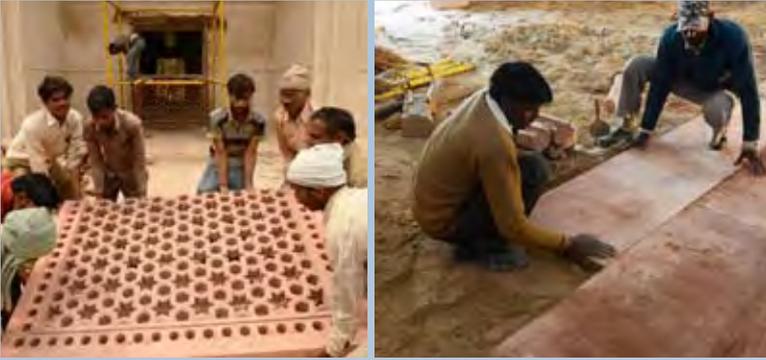
Reinstalling Sandstone jaalis and paving

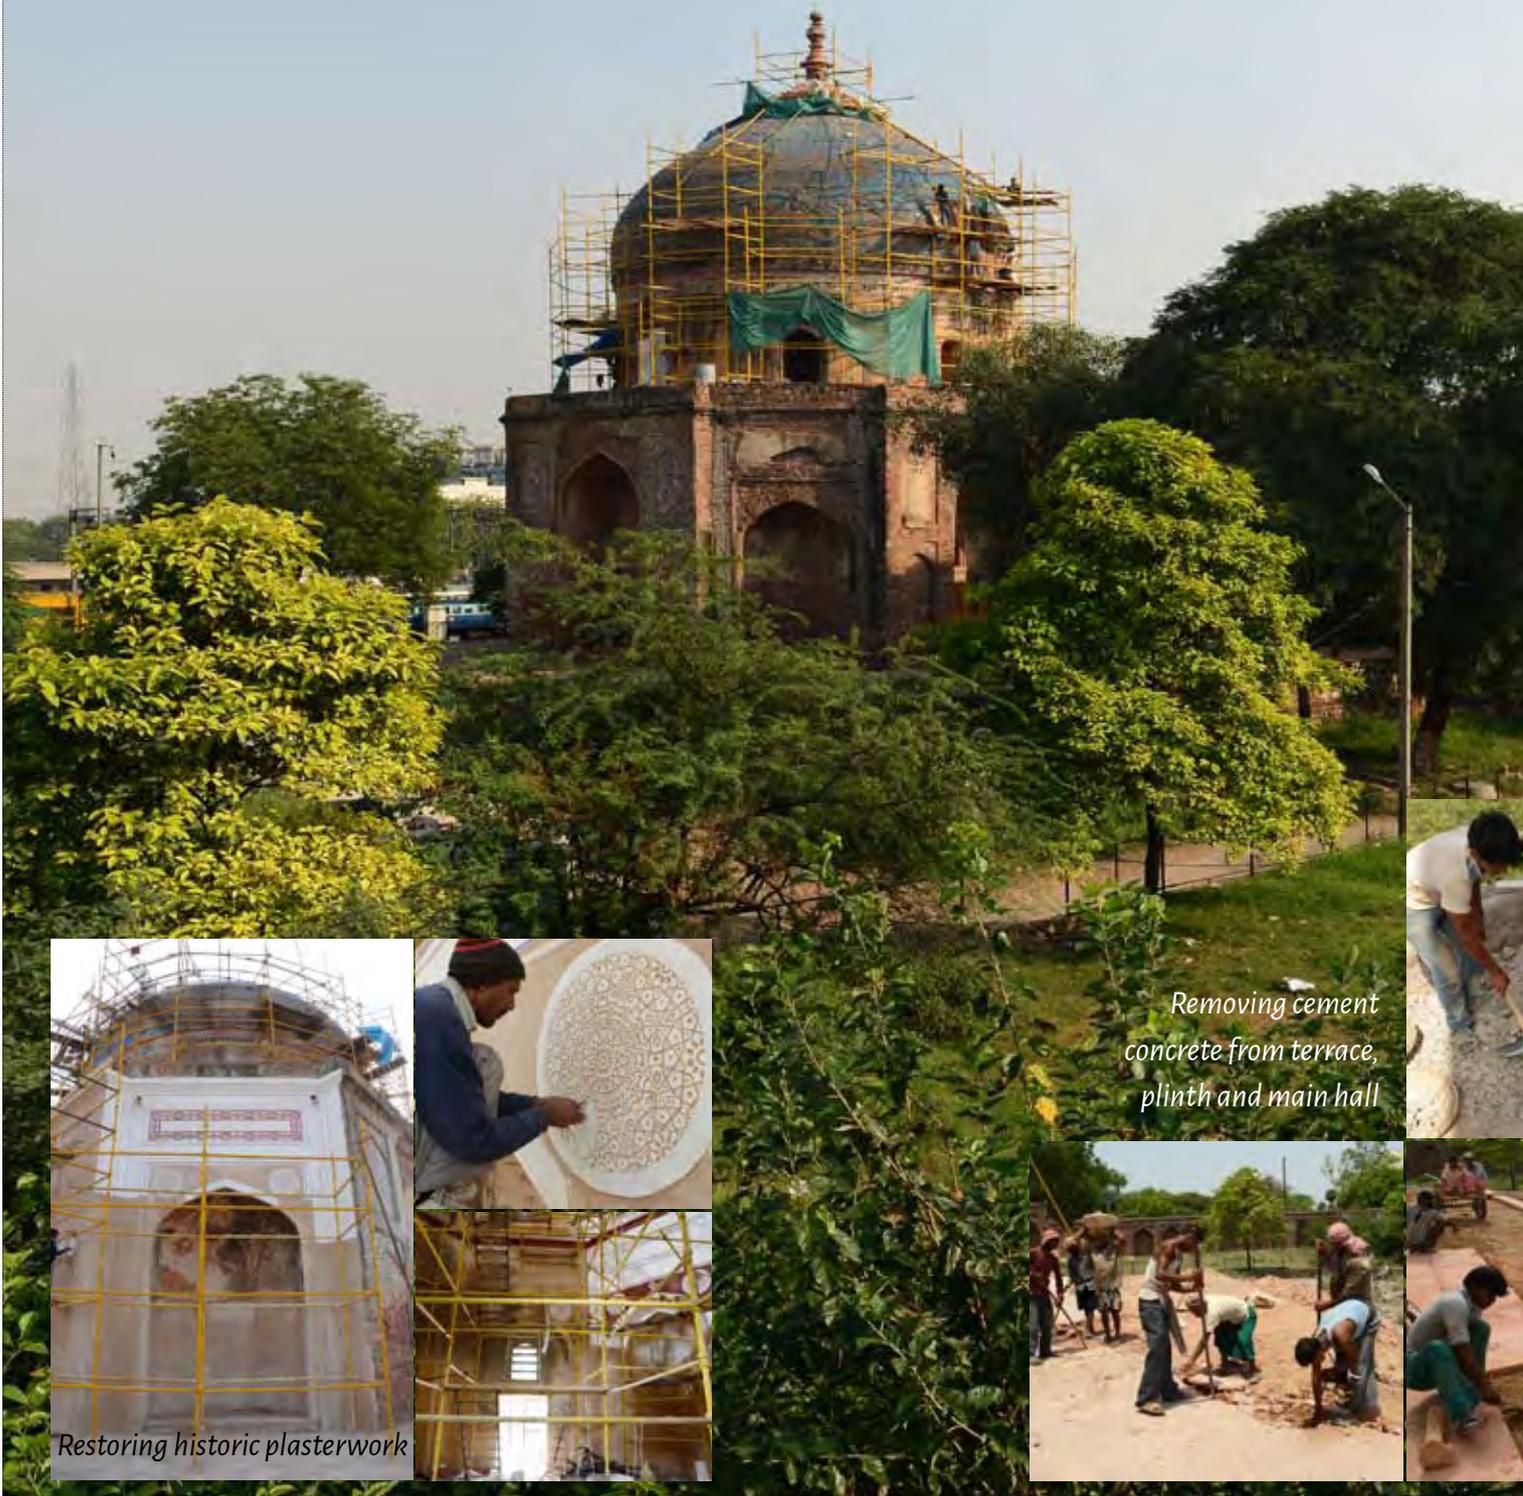
Removing cement concrete from terrace, plinth and main hall

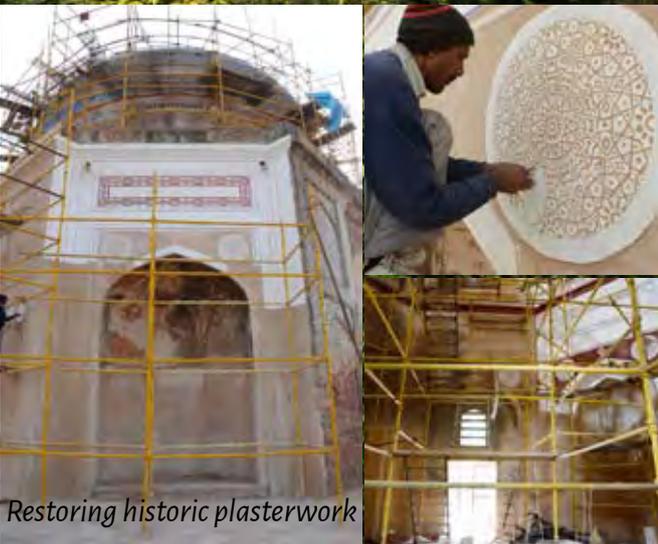
Restoring historic plasterwork

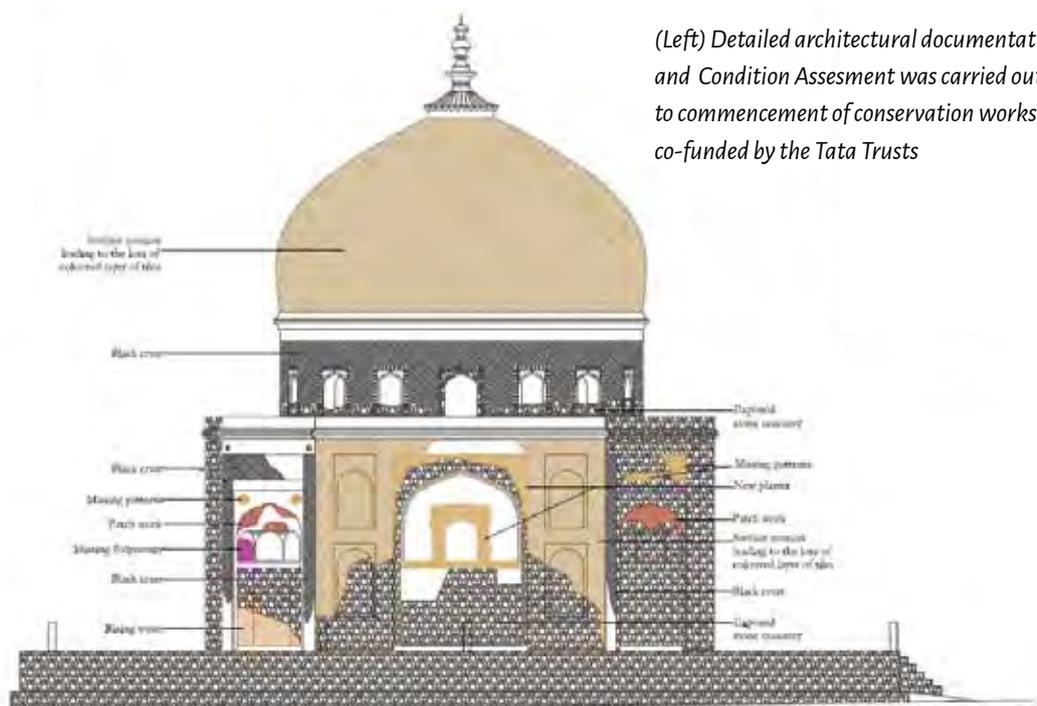
(Left) Detailed architectural documentation and Condition Assessment was carried out prior to commencement of conservation works, co-funded by the Tata Trusts

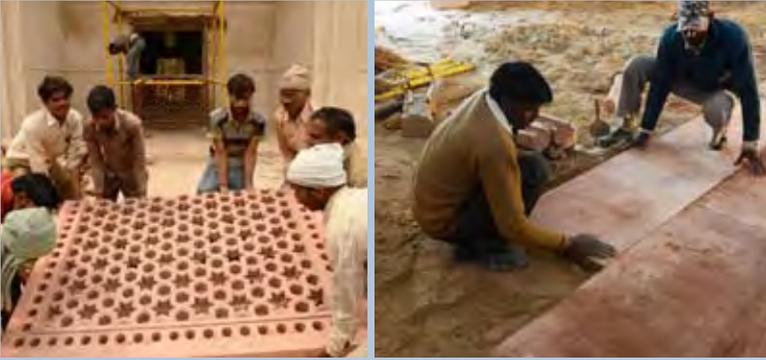
Reinstalling Sandstone jaalis and paving

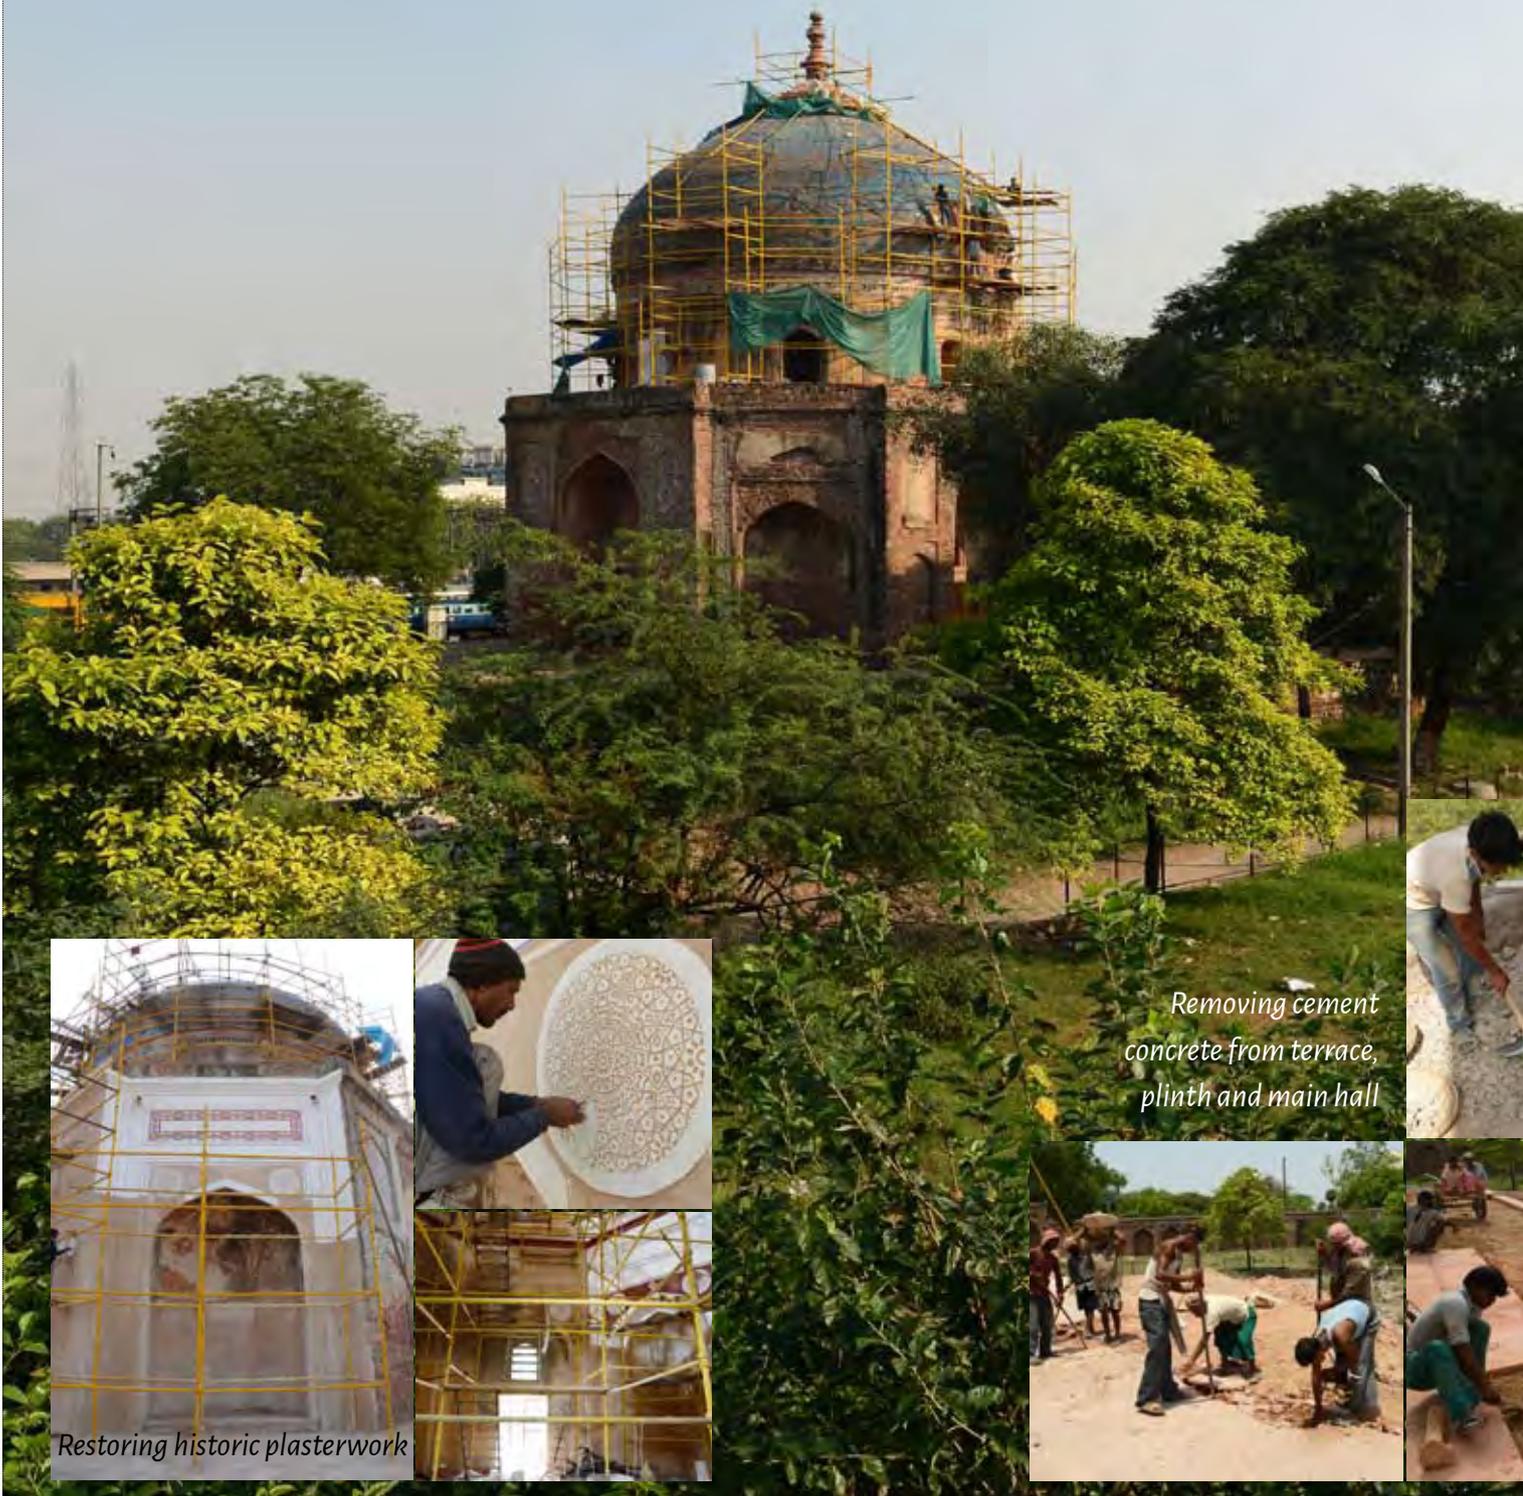
Removing cement concrete from terrace, plinth and main hall

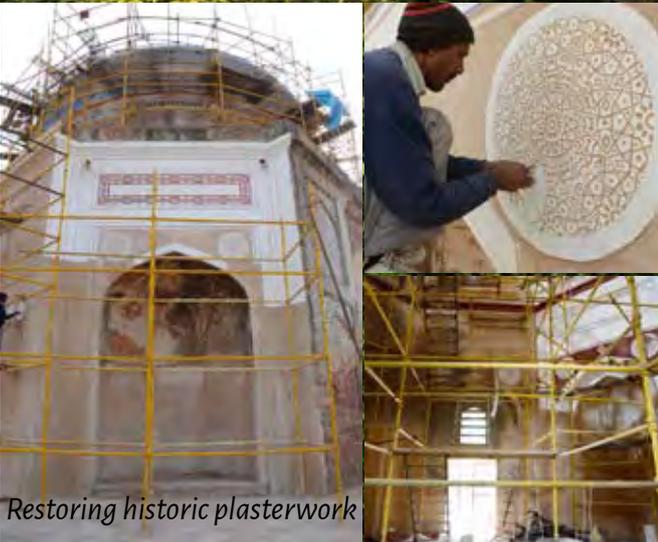
Restoring historic plasterwork
