Nizamuddin Urban Renewal Initiative

Humayun's Tomb - Sunder Nursery - Nizamuddin Basti
URBAN RENEWAL INITIATIVE

SIGNIFICANCE OF THE BAOLI AT HAZRAT NIZAMUDDIN BASTI

BAOLI WALL COLLAPSE

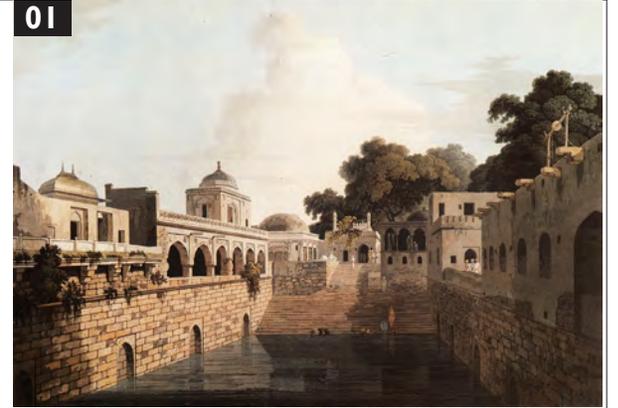
01

Year: 1802

Source: Step well (Baoli) in Delhi, Aquatint by and after Thomas and William Daniell, London, 43 cms x 60cms.

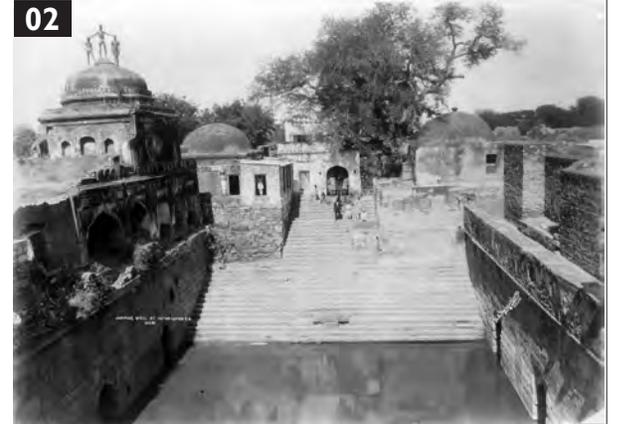
02

Year: 1903 -1920

Source: Baoli in Hazrat Nizamuddin Basti, Archaeological Survey of India Archives

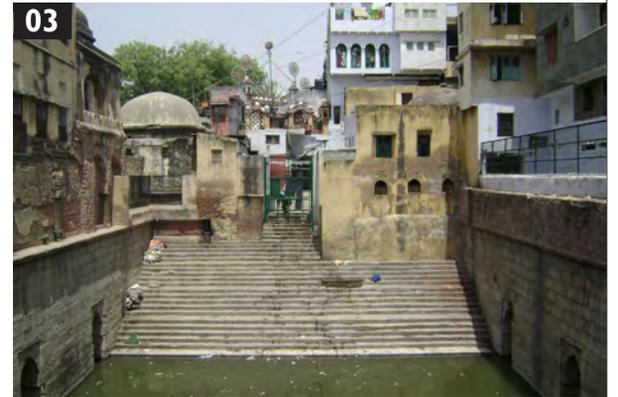
03

Year: 2008

Source: Baoli in Hazrat Nizamuddin Basti, Aga Khan Trust for culture archives

In July 2008, portions of the eastern wall collapsed, threatening safety of 18 families occupying the southern terrace and 5000 or so pilgrims who used the corridor each day to visit the Dargah. Henceforth, intervention began not only to restore the historic structure but also to improve quality of life of resident communities and pilgrims.

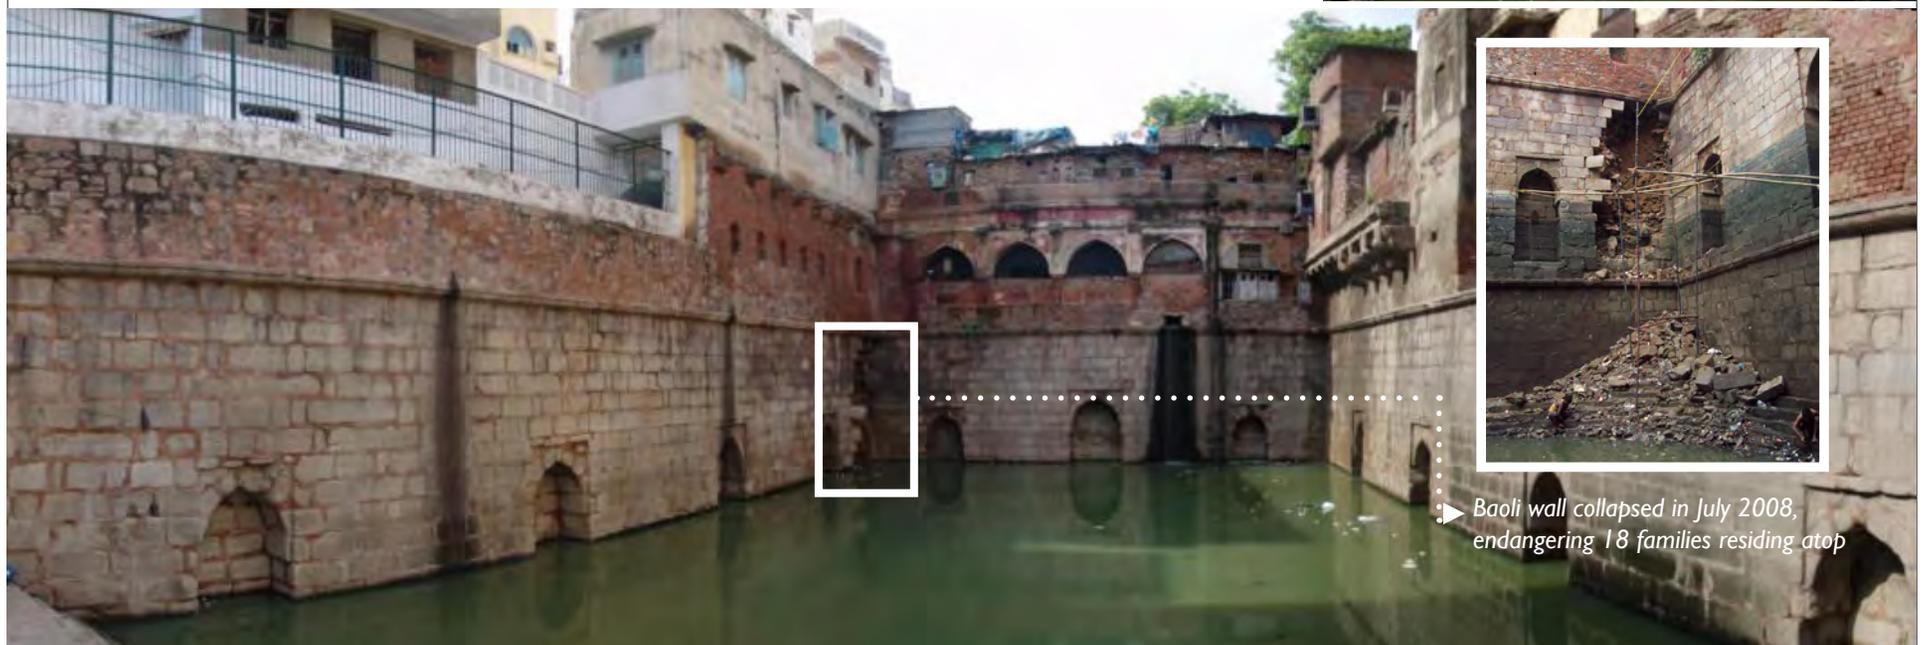
Baoli wall collapsed in July 2008, endangering 18 families residing atop

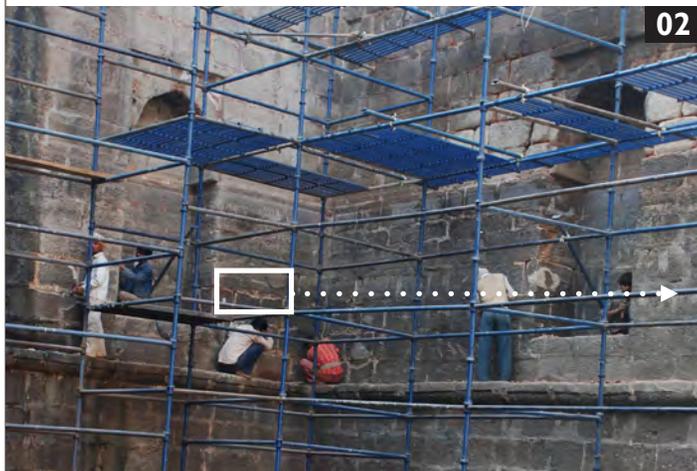
01 3D laser scan image

3D LASER SCANNING:

a detailed laser scan was carried out as was a ground penetrating radar survey – both of these were used for the first time in India for conservation.

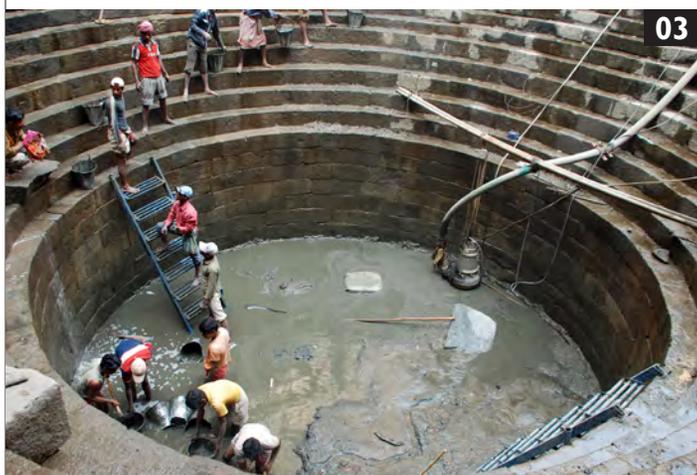
A 3-5 cm thick epoxy layer that was applied to the Baoli in 2002 by the Delhi Jal Board was carefully removed. This treatment used for concrete tanks was inappropriate as it accelerated decay of the historic structure.

Removing 2-3cm thick epoxy layers from the Baoli walls

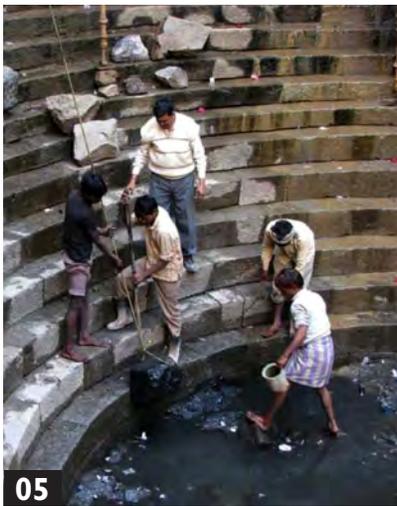
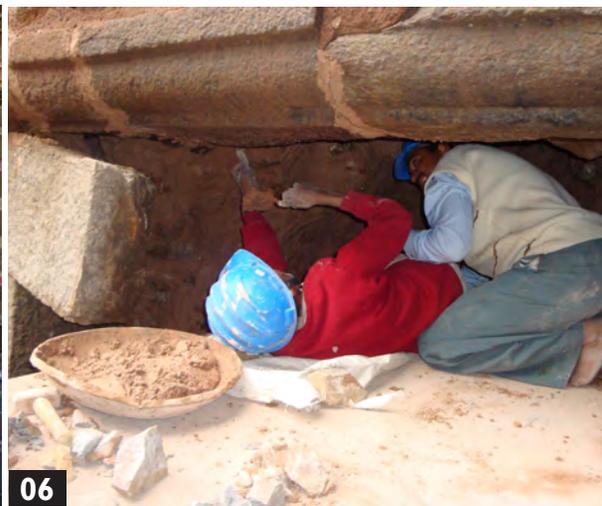
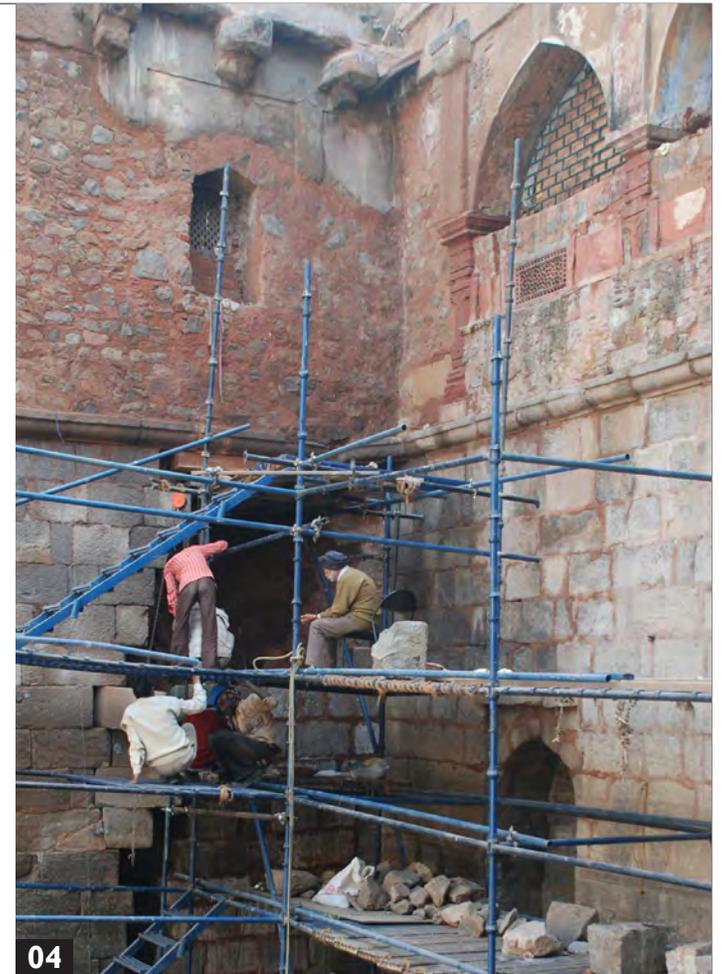
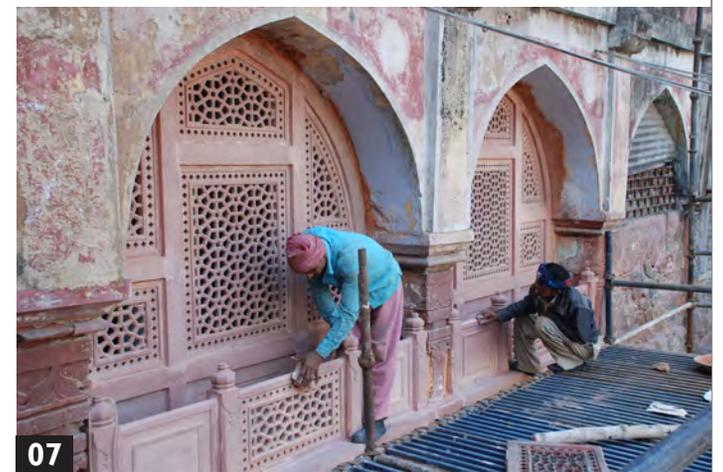
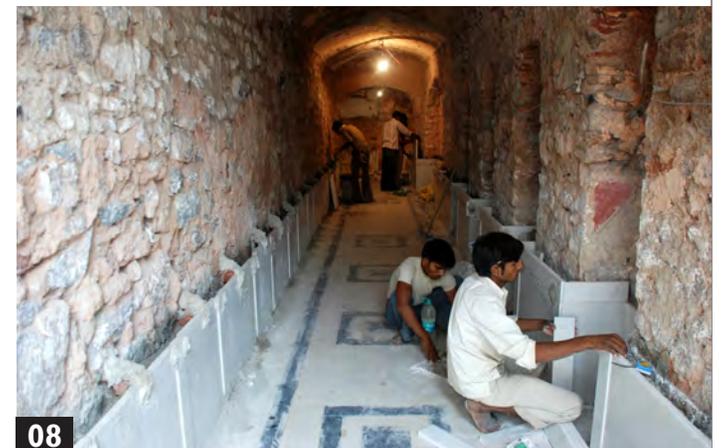
The collapsed portion was rebuilt using traditional building materials and techniques. Original Ashlar facing stones which had fallen in the Baoli and were buried in the sludge were lifted manually, collected and reused. Works were carried out from sunrise to sunset for over four months.

- 04** Structural supervision during Baoli wall reconstruction
- 05** Masonry stones which had fallen in the Baoli and buried in the sludge, were manually collected, washed and dressed again before reuse
- 06** Stone masons reconstruct the top layer of the Baoli wall
- 07** Installing sandstone jali
- 08** Repair works in the corridor

Archway along the passage was rebuilt with red sandstone jalis. Design of the jali took its reference from Tuglaq architecture and the existing jali parapets.

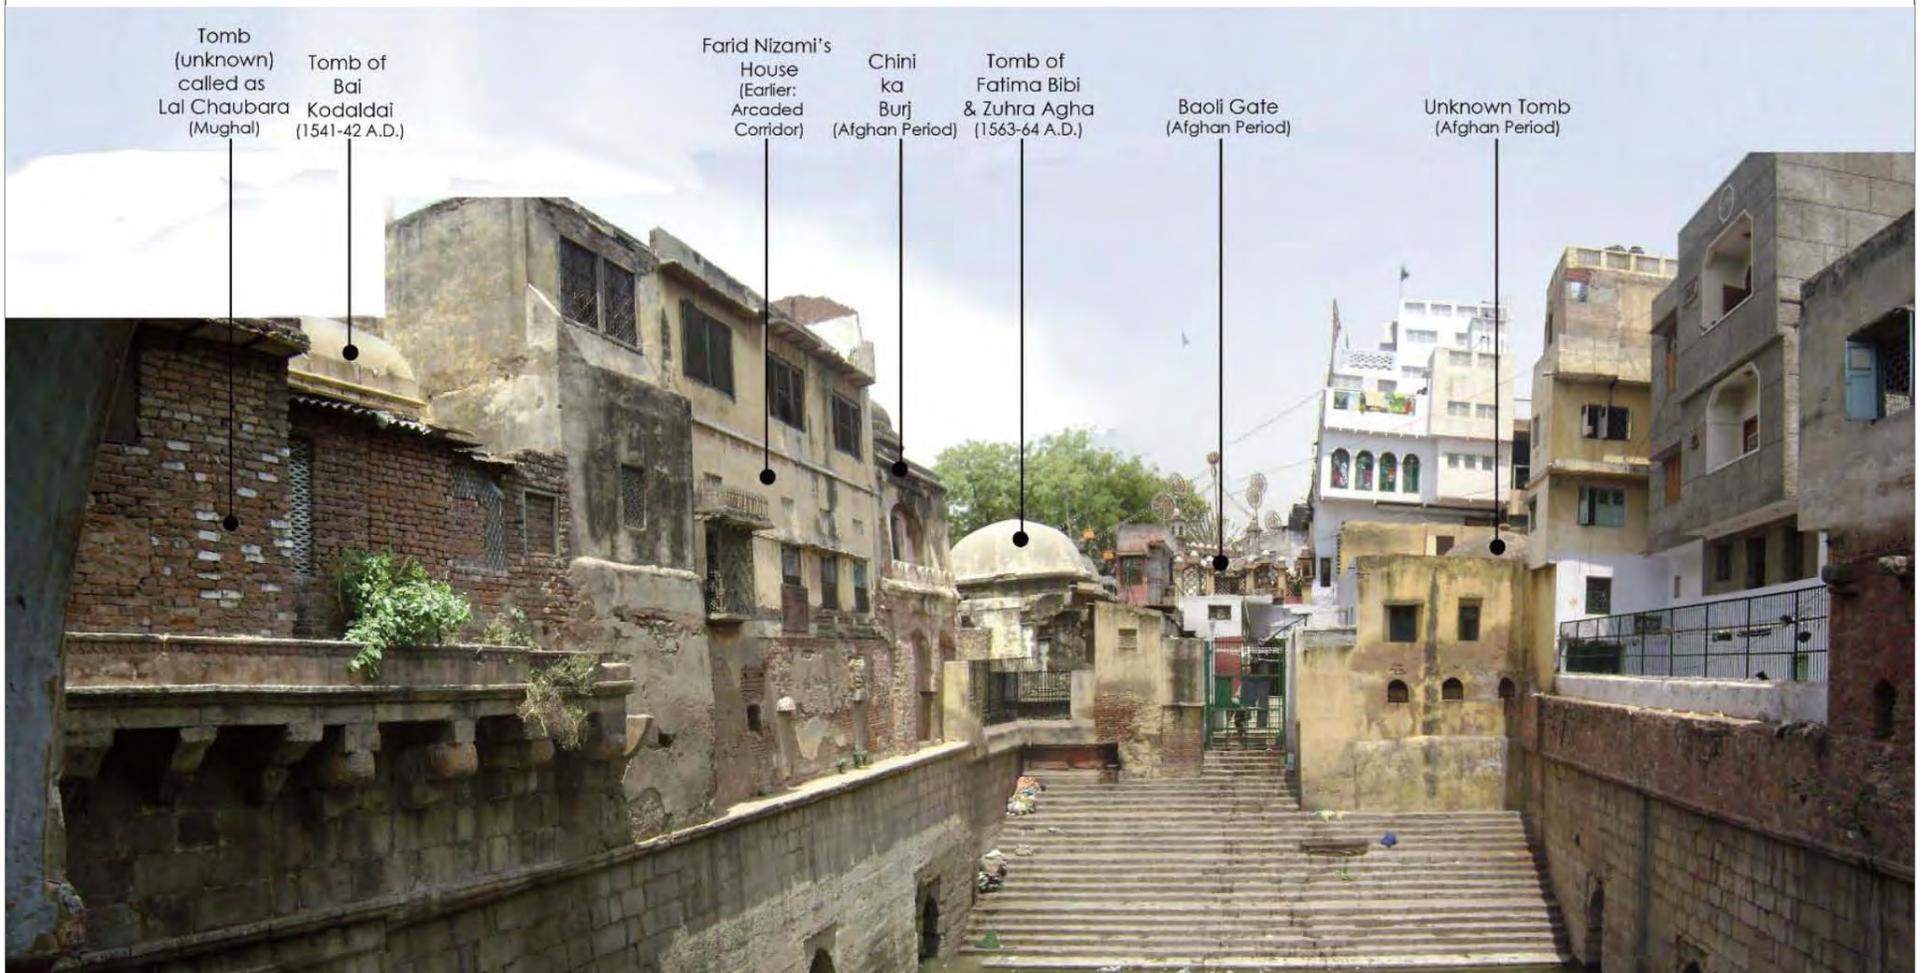
◀ Conservation works on ASI protected Chini ka Burj are now ongoing. Conservation works here required removal of cement layers to reveal glory of the original building

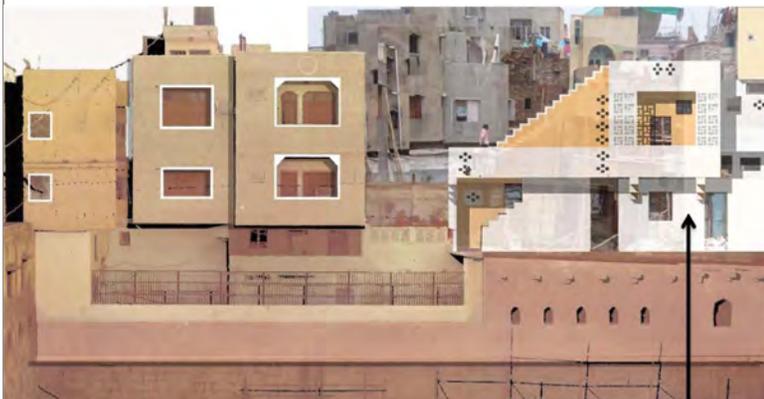
Residence of Fida Nizami was moved back by four feet from the wall of the Baoli and improved structurally. The facade along the Baoli was designed using traditional elements and colors were neutralized.

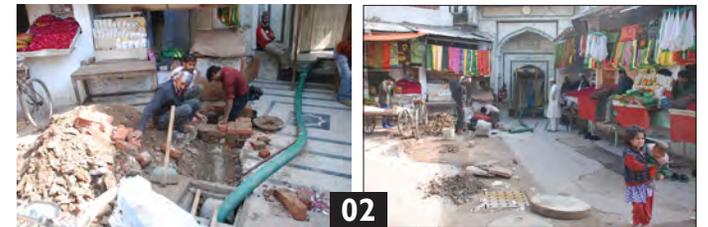
02

- 01** Street improvements include road surfacing, street lighting, sewage and water line repair works and placement of dustbins. Precast concrete blocks; 10 cm thick have been used for road surfacing.
- 02** Relaying of sewer line. Over 100m of sewer line was removed and re-laid at a depth of 2.5m from ground level.
- 03** Revitalization of Rafai Khana, a multi-activity community space.
- 04** Redevelopment of the Community Toilet. The complex is being used by residents and pilgrims. Nearly 150 daily users and an additional 25 resident families (125 people) are using it on a daily basis.

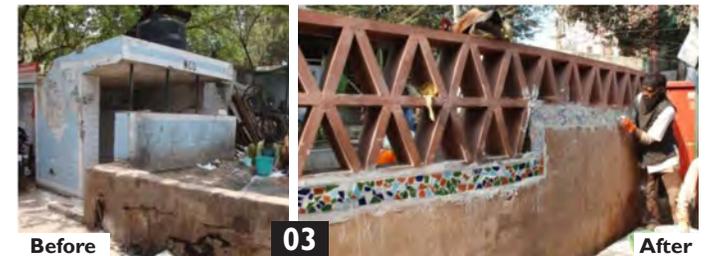
03

Enhancing Community Spaces

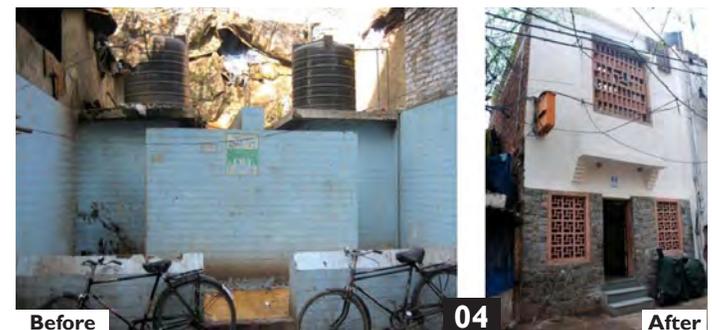
04

Upgrading Community Facilities
