Humayun's Tomb
Hazrat Nizamuddin Basti
Sundar Nursery

Urban Renewal Initiative

CONSERVATION WORKS

RECONSTRUCTION OF THE COLLAPSED WALL

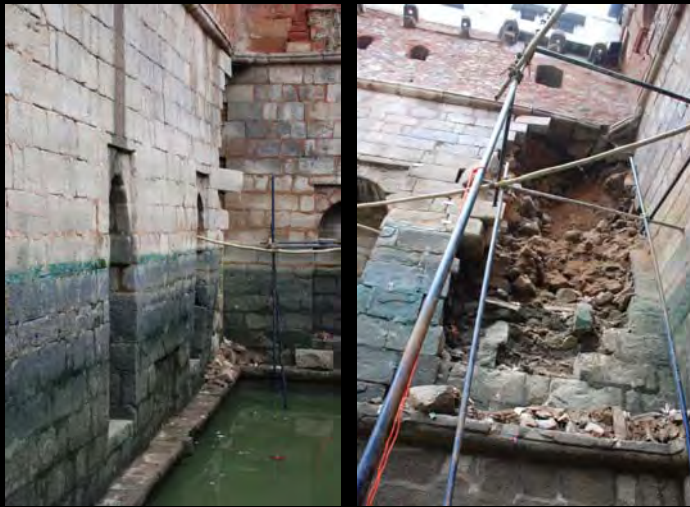
Collapsed eastern wall of the Baoli, July 2008

Conservation works commenced with the collapse of a large portion, almost 200 sq feet of the Baoli wall in July 2008 and the severe buckling of another similar area.

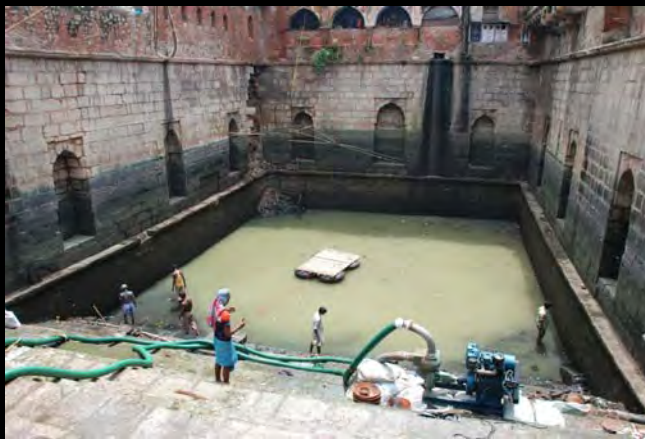
Water of the Baoli was drained out regularly to maintain the water level required for repair works

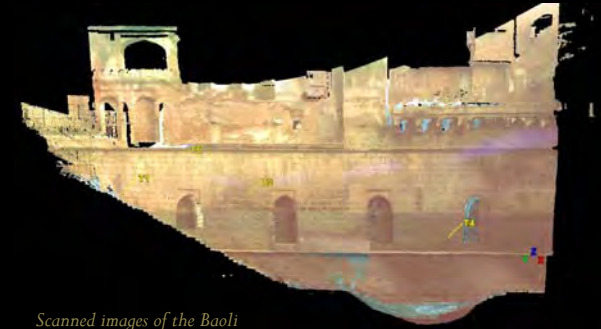
Scanned images of the Baoli

The Baoli was documented using state-of-art technology such as *High Definition Survey* with 3D Leica Laser Scanners. Stone by stone details were documented using the scanner

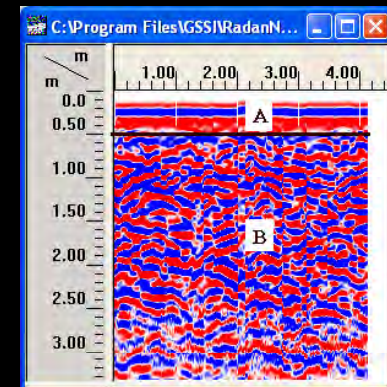
The wall section was derived using GPRS at a few locations of the eastern wall. The section shows the thickness of the filling materials behind the stone wall .

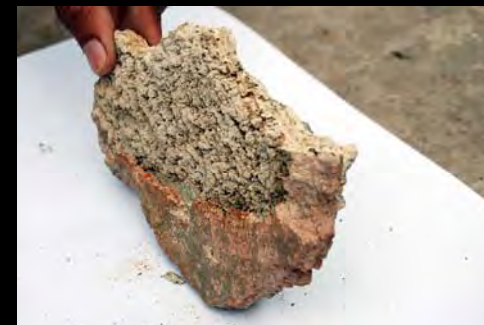
Conservation works required the removal of a 2-3 cm thick epoxy layer applied to the Baoli in 2002 by the Delhi Jal Board. This treatment used for concrete tanks was inappropriate for the historic structure and accelerated decay. This was carefully and painstakingly removed by master stone craftsmen using traditional tools

2-3 cm thick epoxy layers February 2009

Removal of 2-3 cm thick epoxy layers March 2009

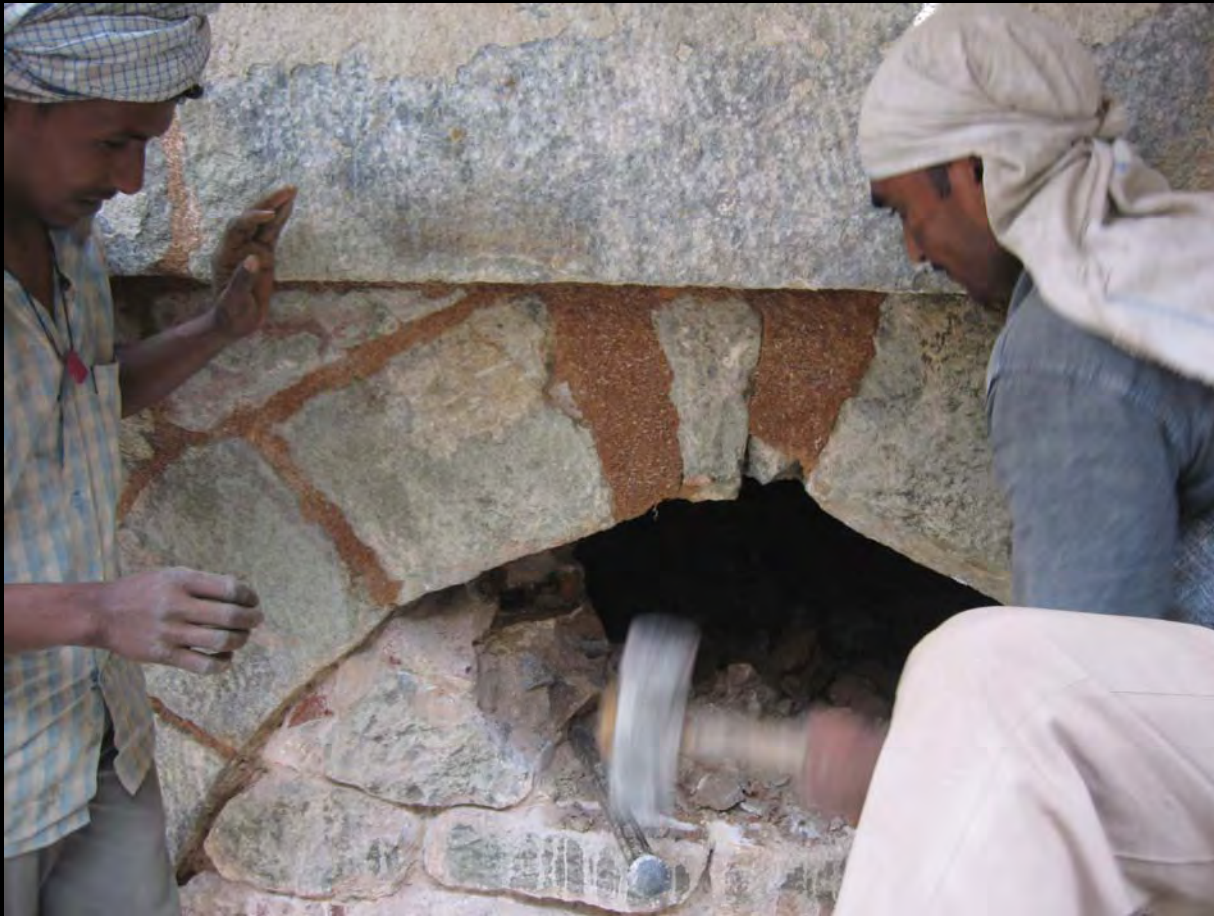
During conservation works a passage leading from the Dargah to the Baoli, possibly used by the saint, *Hazrat Nizamuddin Auliya* was discovered. Works are now ongoing to remove rubble filled in this passage and carry out required repairs to the vaulted roof of this passage – portions of which have collapsed.

Stone craftsmen are opening the closed arch passage on east wall. April 2009

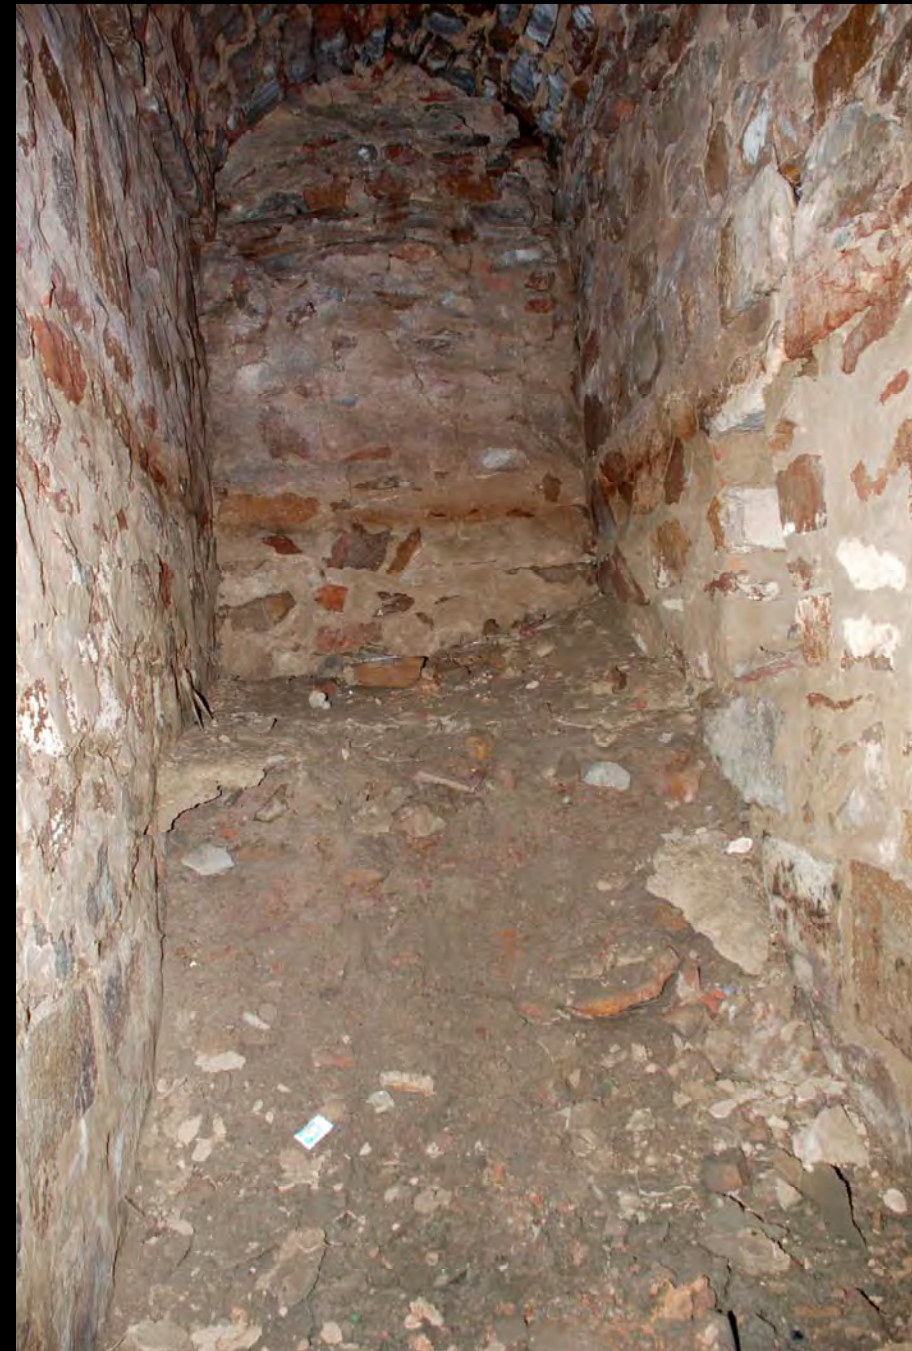
Vaulted passage from inside April 2009

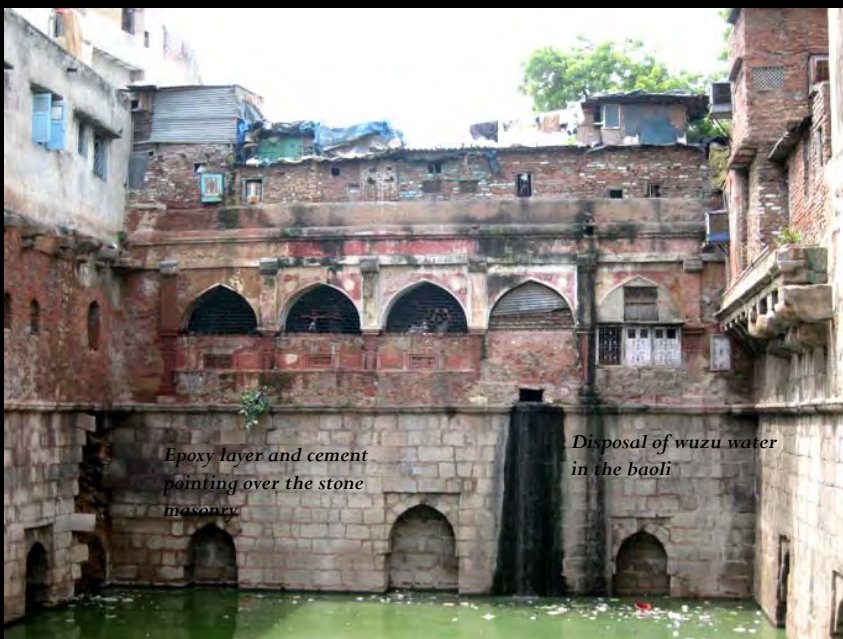
Epoxy layer and cement pointing over the stone masonry

Disposal of wuzu water in the baoli

View of the south wall Baoli, 2008 AD

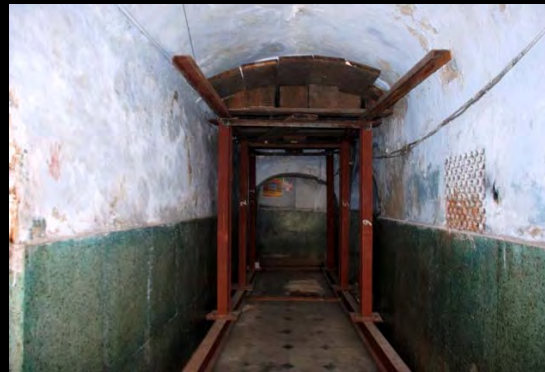
Access to Dargah along the Baoli during reconstruction of the collapsed wall below

- One of the access to the Dargah, (from the passage along the Baoli) used by hundreds daily, had to be discontinued for almost three weeks as collapsed portions were rebuilt.
- As part of conservation works, the water from the Wuzu area – draining into the Baoli – was re-routed in a complex procedure that required a pumping station to be installed in the narrow lanes leading to the Dargah.
- Similarly over 100 meters of sewer lines found to be leaking into the Baoli were replaced at a depth of 7-8 feet on the adjoining lanes.
