## CONSERVATION OF HAZRAT NIZAMUDDIN'S BAOLI

Reconstruction of the collapsed wall of the baoli and conservation of the remaining part to avoid any future decay

Conservation of Hazrat Nizamuddin Baoli

# Nizamuddin Baoli

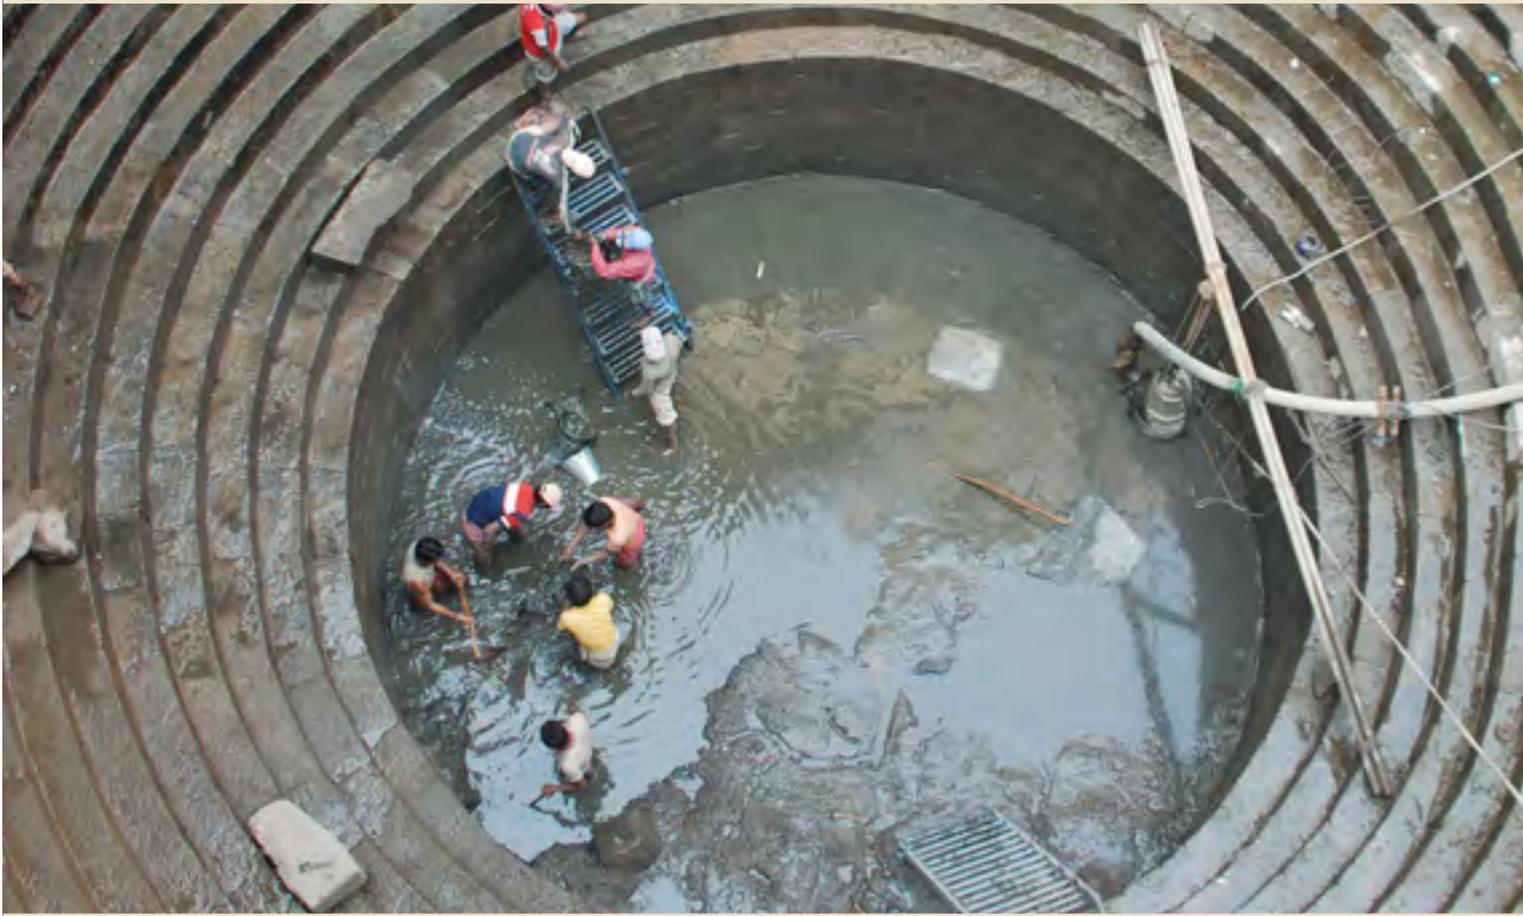
*For over seven centuries millions have used water from this stepped well; in keeping with requests from the Dargah Committee and local community, the conservation works on the collapsed portions of the baoli were coupled with a mammoth effort to clean the step-well of all debris, 700 years of accumulated dust. The manual lifting of sludge required over 8000 man-days of work.*

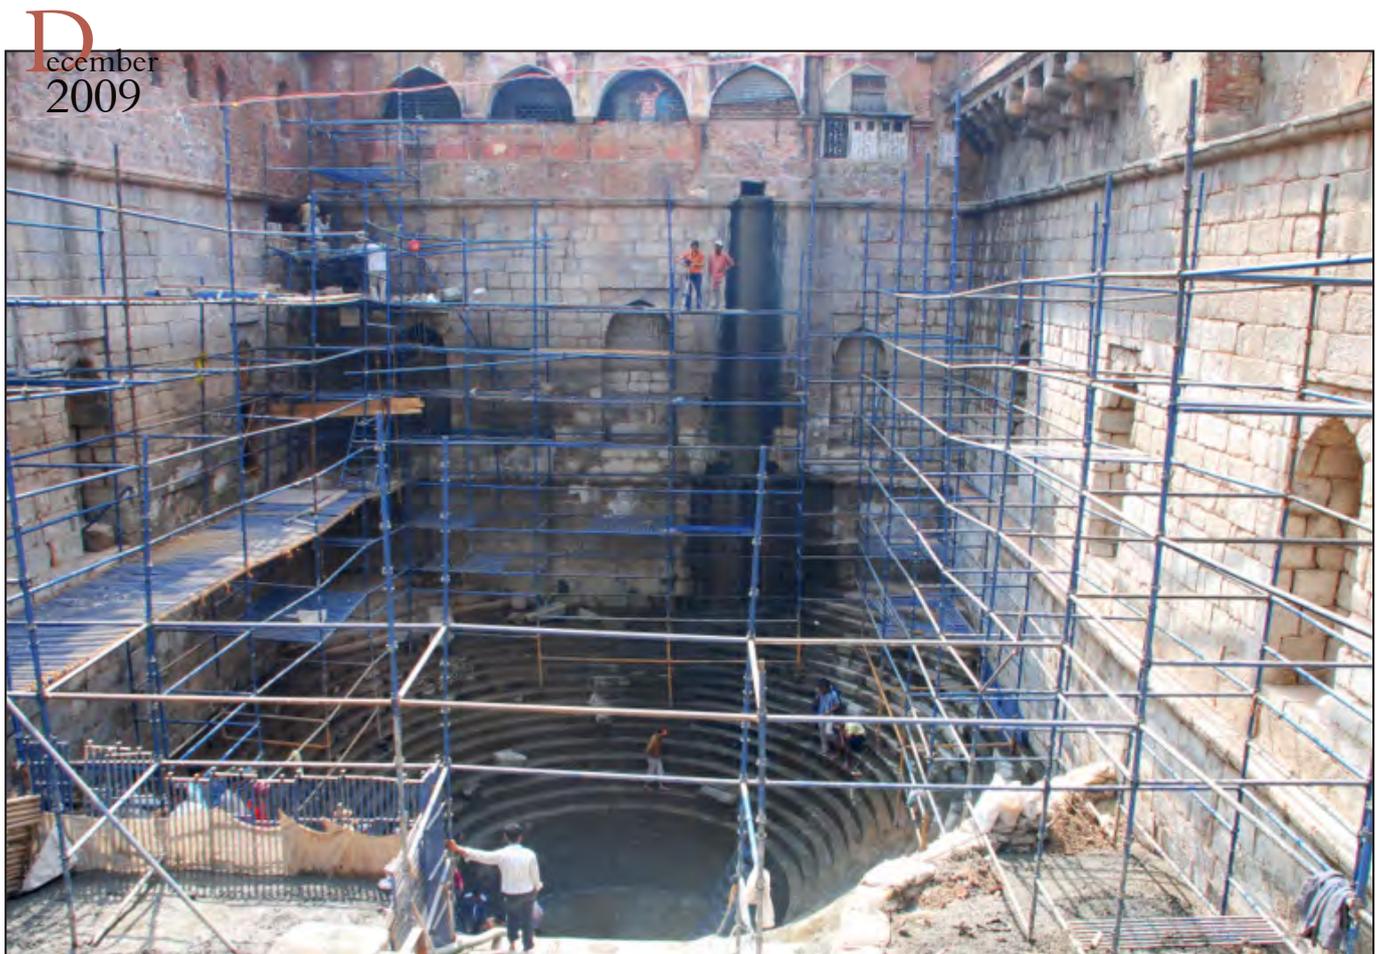
Craftsmen completing the reconstruction of the collapsed portion reusing the original stone. This required exhaustive studies, analysis, strict supervision, traditional materials and the most skilled and determined craftsmen to work tirelessly

- The collapsed portion was rebuilt and portions of the Baoli dismantled prior to rebuilding using traditional building materials and building techniques. Works were carried out from sunrise to sunset for over six months to rebuild this portion.

- Ashlar facing stones which had fallen in the Baoli and were buried in the sludge were lifted manually collected and reused.
- Conservation works also required the careful and painstaking removal of a 3-5 cm thick epoxy layer applied to the Baoli in 2002 by the Delhi Jal Board. This treatment used for concrete tanks was inappropriate for the historic structure and accelerated decay.

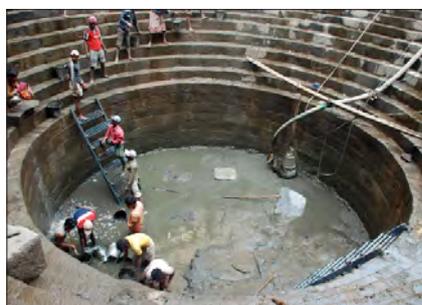
Over 700 years of accumulated debris was removed from the baoli

- Conservation works on the collapsed portion were an opportunity to de-silt the well of the debris accumulated over hundreds of years. This was done manually while ensuring that a few inches of water remained in the Baoli to respect the community sentiment and allow the fish to remain.
- A water quality test of the stagnant Baoli water before reconstruction revealed very high levels of E coli indicating sewage contamination. Following re-laying over 100 m of sewer pipes, by AKTC, as part of the conservation initiative, the ground water sources as well as the well water were retested post reconstruction and it was found that the water quality had considerably improved with a drastic reduction in E-Coli levels .

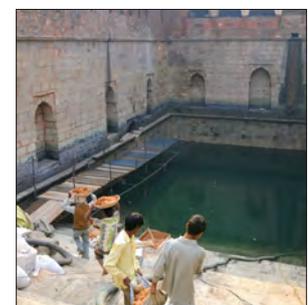
Work is now ongoing to repair vault. The underground passage was originally used to access the Baoli from the courtyard of the mosque, following wuzu. Though this passage is now, portions discovered during conservation works are being repaired, including re-installing collapsed keystones of the vaulted roof.

- The discovered passage that originally led from the Baoli to the Mosque in the Dargah complex will be repaired; this would require re-fixing keystones, several of which have collapsed, using traditional techniques.
- Once 19 families residing on the southern arcade are relocated into new houses to be built for them, the southern arcade would require urgent conservation works.
- Digital monitoring systems would be fixed at various location to monitor the structural stability of the monument for a period of at least two years.
- Stone lattice screens would replace the metal grills in the arched openings of the corridor passage leading to baoli.
- Cement plaster from the wall and the ceiling surfaces will be removed and redone with appropriate materials and designs.
- Flooring of the corridor will be redone with appropriate slopes and designs.

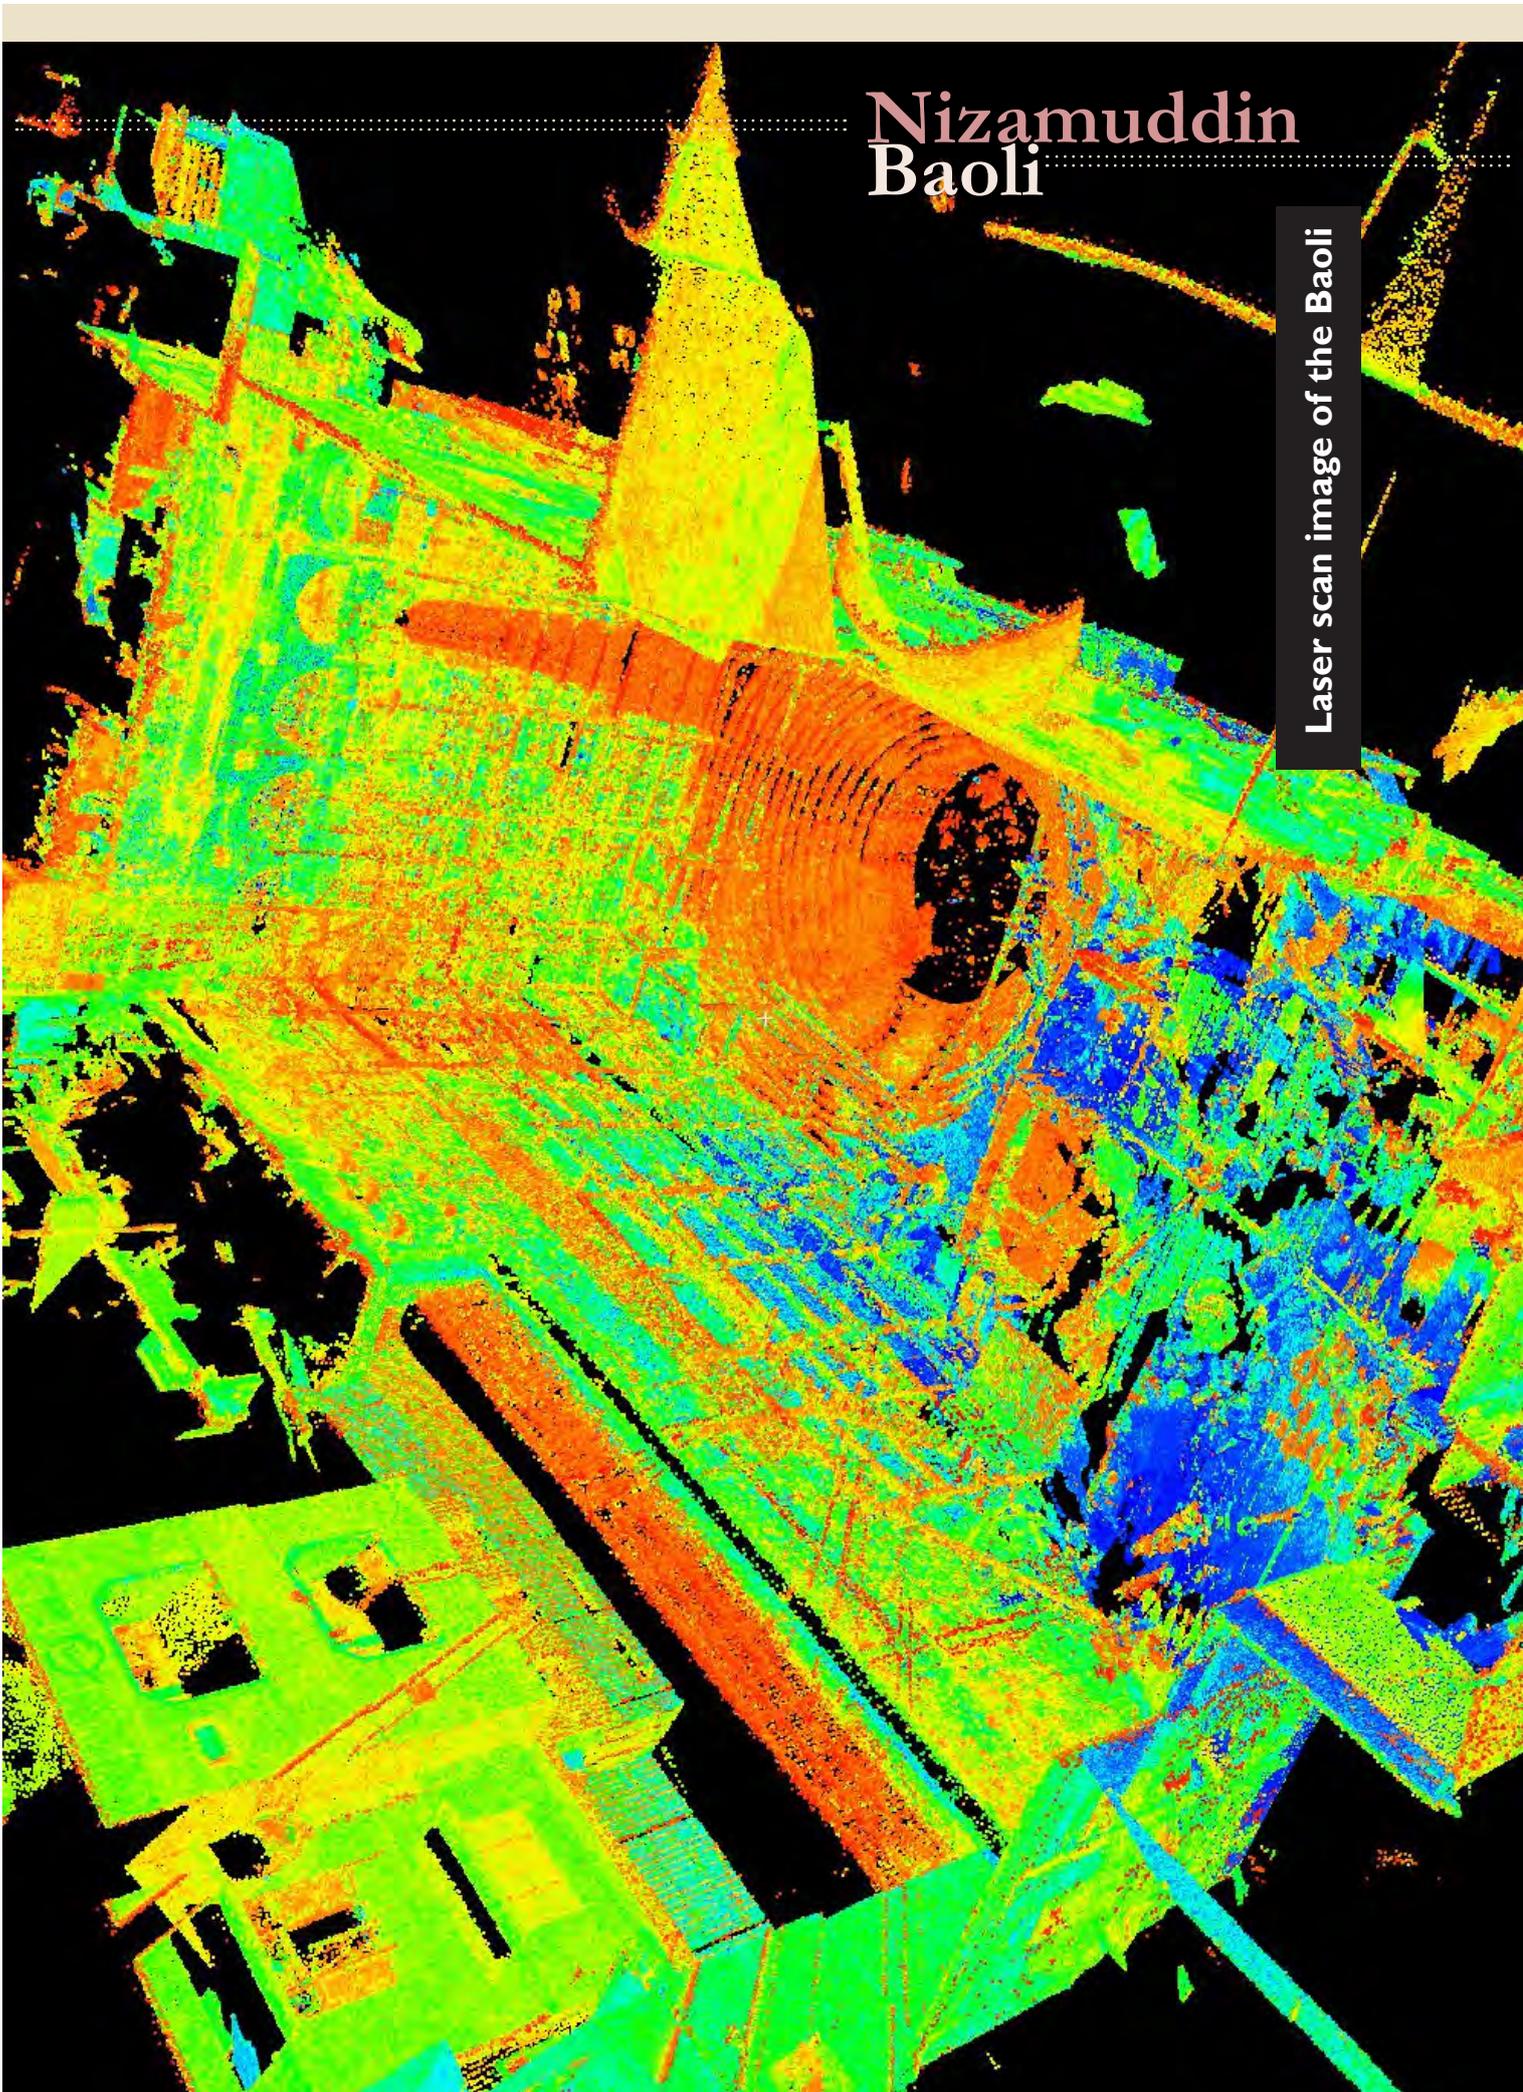
Laser scan image of the Baoli

- Following the collapse of a portion of the Baoli in July 2008, detailed geotechnical studies, structural analysis was carried out by national and international experts as a precursor to conservation works.
- To carry out an accurate condition assessment, sectional profiles were created using 3 D laser scanning data that allowed actual structural deformations to be mapped.
- A structural analysis of the structures surrounding the baoli, especially the southern arcade was also carried out.

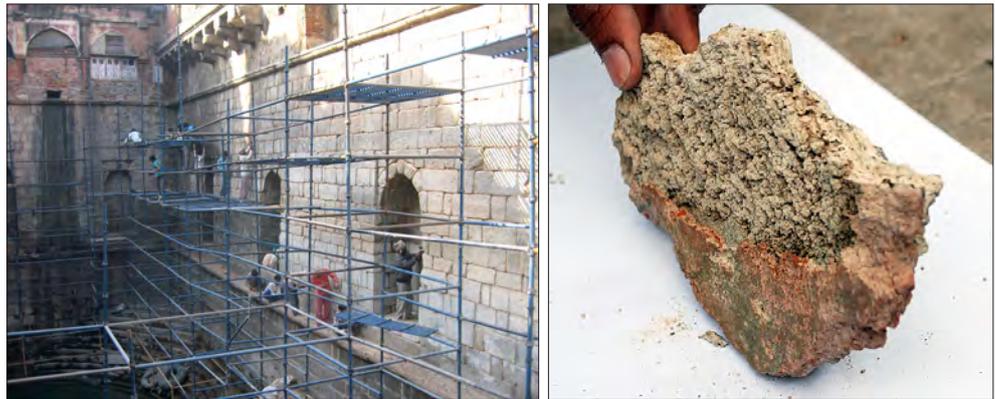
*Removing epoxy layer and cement mortar*

- Following the rebuilding of the collapsed portion and the removal of epoxy, the entire wall surface was grouted and re-pointed with lime mortar to fill the underlying voids identified in the GPRS study.
- During conservation works a passage leading from the Baoli to the Mosque at the Dargah, possibly used by the saint, Hazrat Nizamuddin Auliya was discovered.
- Works are now ongoing to remove rubble filled in this passage and carry out required repairs to the vaulted roof of this passage – portions of which have collapsed.

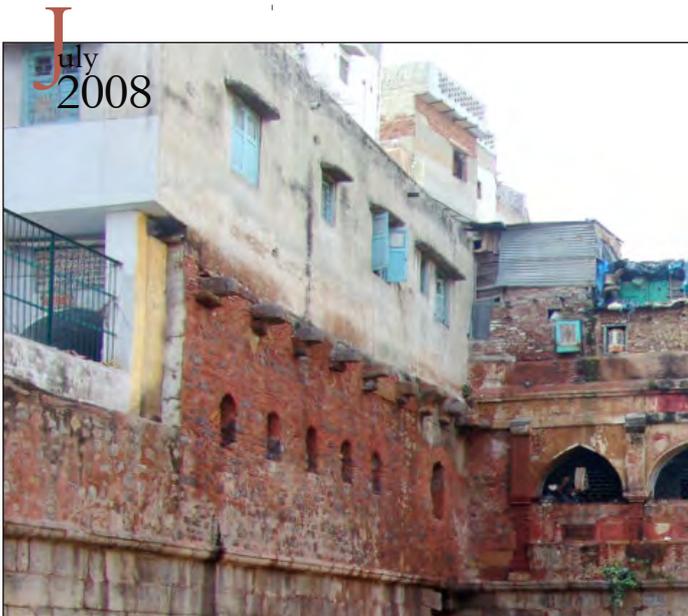
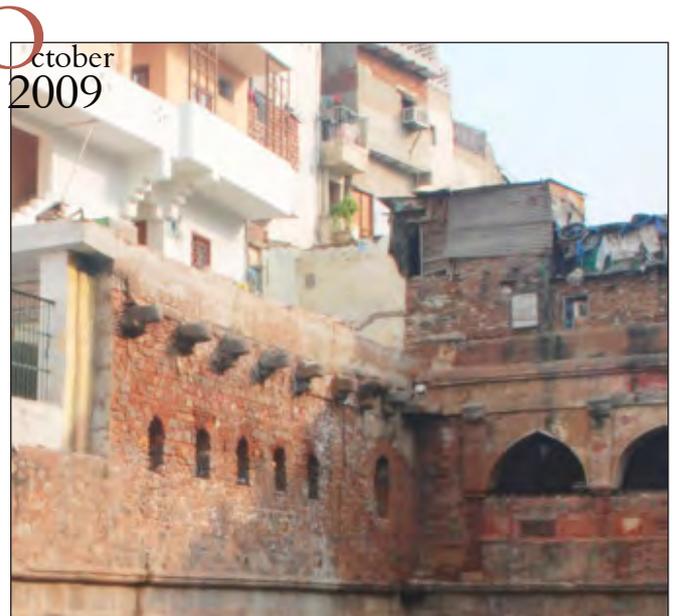
*The dwelling unit built, in the 1980's, over the covered Baoli passage was dismantled with the co-operation of the owner family and after constructing an alternate unit – recessed from the Baoli structure*

Remove concrete from over the passage of the baoli and strengthen the vaulted masonry.

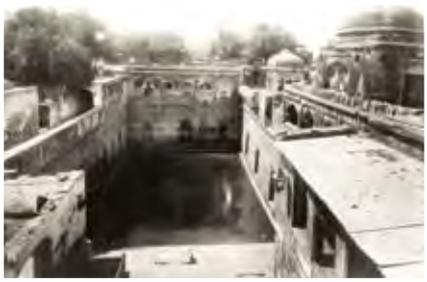
Archival view of Nizamuddin Baoli  
in early 20<sup>th</sup> century

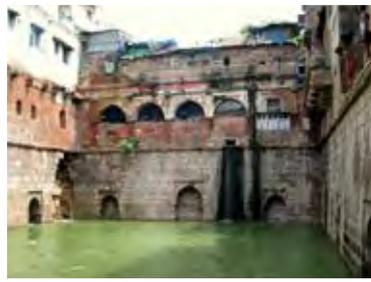
Baoli wall collapsed in July 2008

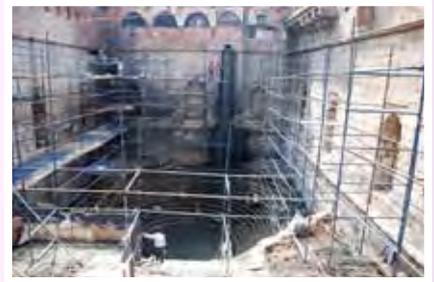
Conservation works in progress

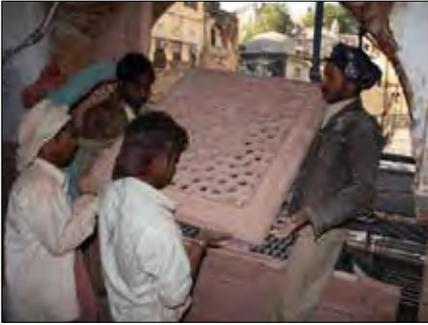
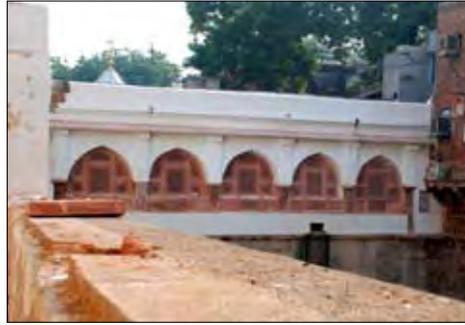
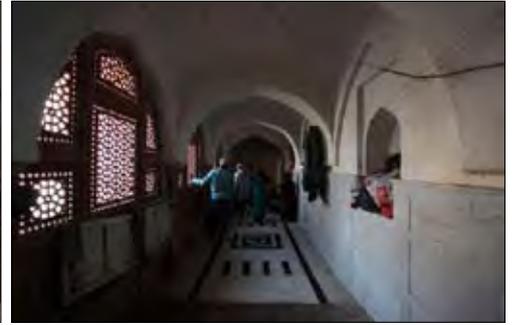
Installing Sandstone Jaali

- The portion of the Baoli that collapsed in 2008 was repaired in 2009.
- Following the relocation of families living over the southern arcade this was extensively repaired since June 2010.
- Major structural repairs on the roof were required.
- The metal screens in the five arched openings were replaced with sandstone lattice screens.
- The cement plaster on the wall surfaces was replaced with lime plaster.
- The passage running along the Baoli eastern wall and southern wall required extensive repairs including lowering floor levels by over 40 cm.
- The cement plaster and terrazzo on the walls was removed and replaced with marble dado and lime plaster on the vaulted surfaces.
- The wall on the northern half of the eastern side was lowered to original levels.
