Conservation of Tomb of Abdur Rahim Khan I Khanan c.2014-2017

Understanding the Tomb of Abdur Rahim Khan I Khanan

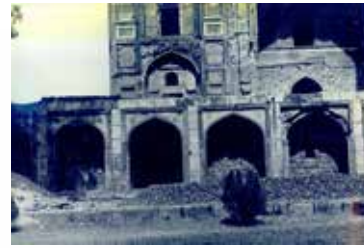
1923AD

Major repair works using Delhi Quartzite stone masonry were undertaken to stabilize portions of the tomb

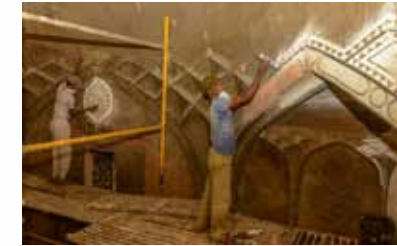
2014AD

Commencement of conservation works on the tomb of Abdur Rahim Khan I Khanan by Aga Khan Trust for Culture in partnership with Archaeological Survey of India and InterGlobe Foundation

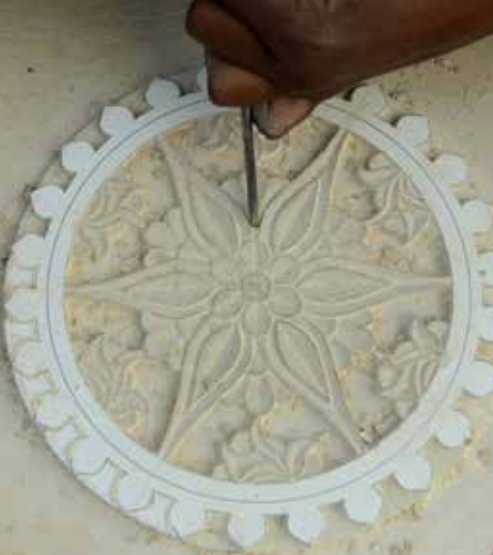
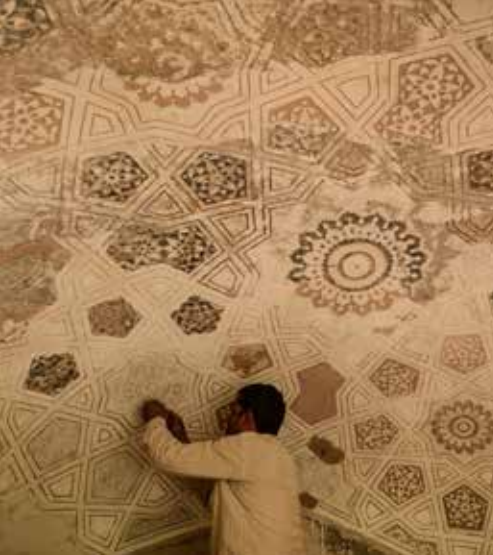
Incised Plasterwork
 The central chamber and five ground level arches on each façade, are ornamented with intricate incised plaster patterns. Original patterns were carefully consolidated and preserved prior to removing 20th century cement layers and restoring missing portions in lime mortar.

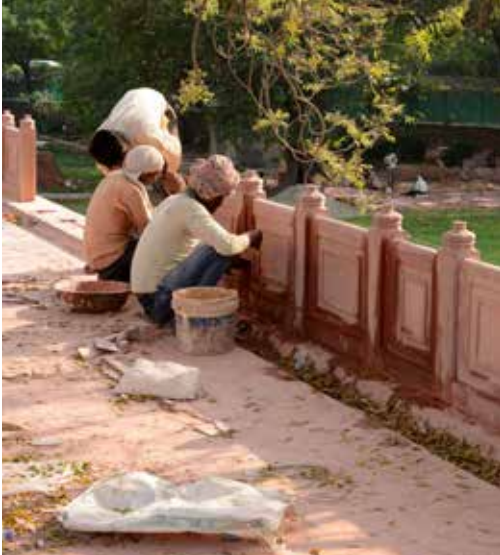
Stone Craftsmanship
 Master stone carvers used traditional tools and building crafts to carefully match the work of their forefathers. At Rahim's Tomb, each of the 68 arches on the ground level have a different carved motif on each side. Where one was missing, these motifs were restored as per the original design.

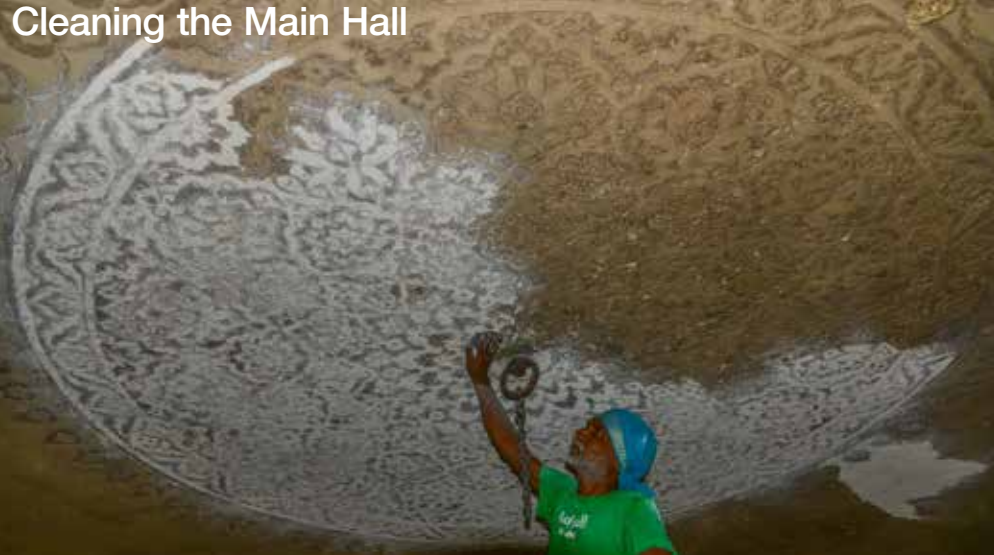
Cleaning the Main Hall

Careful cleaning
 Layers of soot and lime-wash had obliterated the 17th century patterns in most parts of the structure but especially in the main tomb chamber. In order to ensure no damage occurs to the underlying plaster patterns, craftsmen took over a year to clean the domed ceiling with soft and moist toothbrushes – with spectacular results.

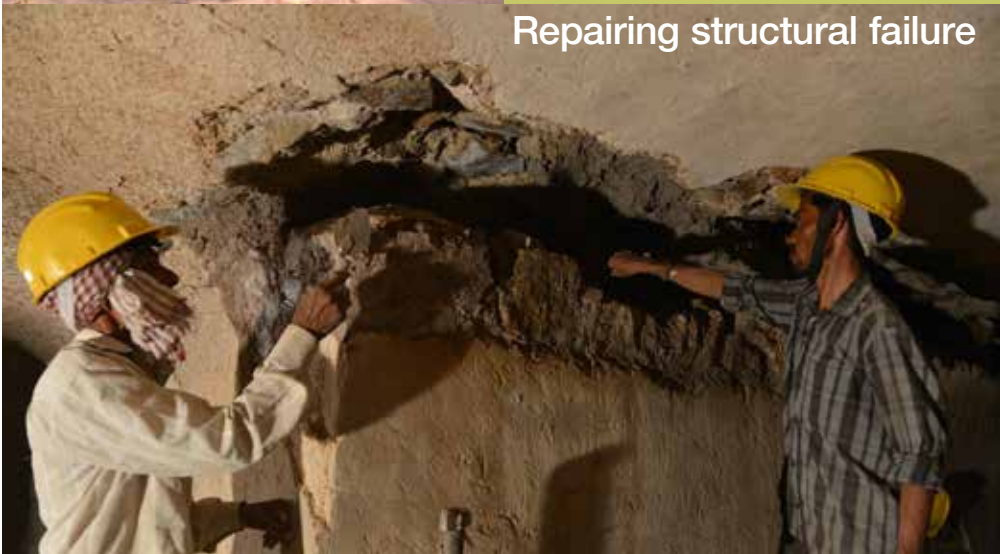
Repairing structural failure

Stitching the Cracks:
 Unequal settlement in the crypt had led to serious structural cracks all the way to the top of the dome. Master craftsmen using traditional building techniques repaired the cracks over a year long period. This required significant underpinning of the foundations and lime grout in the masonry.

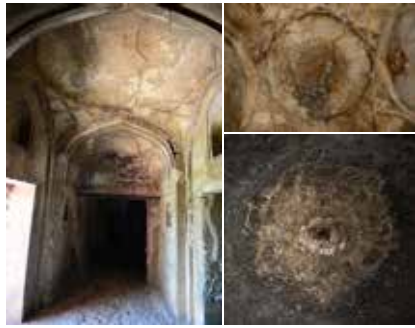
Decayed Ancillary Chambers

The tomb interiors have cement layers that has not only disfigured the decorative incised plasterwork but also significantly disfigured the historic architectural character. The cracks in the vaults and domed surfaces have been inappropriately filled in with cement mortar in places. On the four corners of the principal tomb chamber stand domed ancillary chambers, and as with the principal tomb chamber, they are profusely decorated using incised plasterwork. Layers of plain cement-surkhi plaster repairs have been carried out in these chambers disfiguring original elements. Decorative incised plasterwork has been restored where original patterns can be deciphered or have disintegrated.

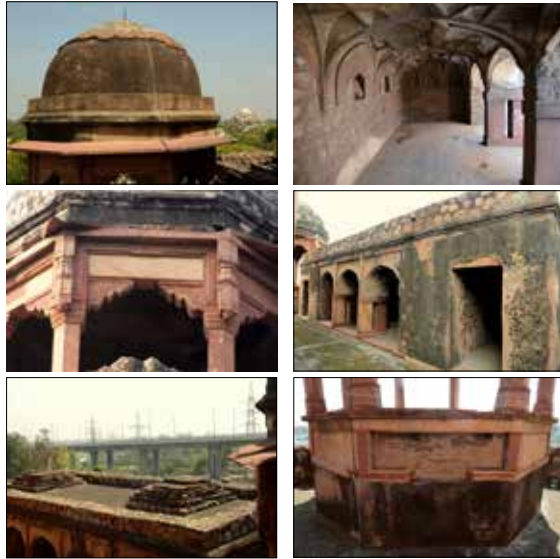
Terrace Repairs

The cement-concrete layer laid on the terrace will be carefully and manually removed as it has been causing water percolation to the lower levels. This will be replaced with a traditional lime concrete laid to original levels and slopes, ensuring long term preservation of the structure. The four corners of the roof have large octagonal canopies that stand on a raised platform. These have been covered with unnecessary layers of cement plaster/concrete, disfiguring their original character and missing elements. In the centre of the four sides stand low vaulted dalans, suffering due to water percolation from the roof above. As with Humayun's Tomb, over each of the four dalan's stood two canopies each, but now only one on the northern face can be found standing. Stone elements of the missing canopies were found at the site, and careful documentation of the stones suggests that four more canopies can be built using the pieces.

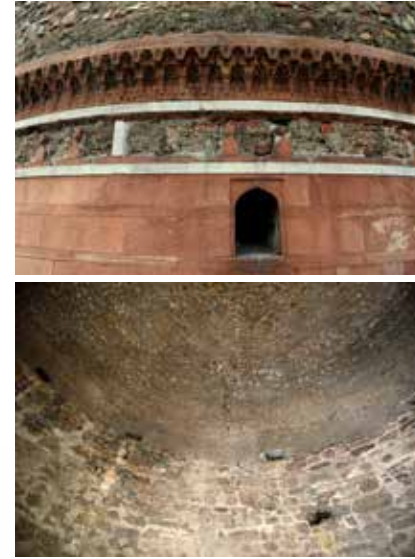
Dome

The tomb is crowned with a double dome, where the outer dome would have originally been clad with marble serving as a protective layer for the underlying masonry. This was stripped in the 19th century exposing the underlying random rubble masonry. The inner layer of the dome is in brick masonry and had significant deep cracks. Following a detailed assessment and studies by structural engineer and ASI-AKTC committee on their cause, conservation works were undertaken which included re-plastering. An important next step is addition of marble to the dome as a protective layer and important architectural element.

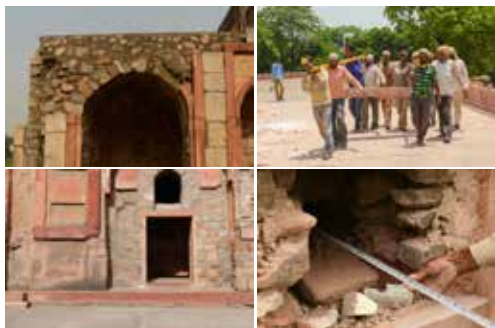
Restoring Main Facade

On account of the mausoleum being used as a quarry in the 18th century, marble and sandstone blocks have been stripped from here, and the structure presents a ruinous appearance. With the protective stone cladding removed from large parts of the structure, the building is today in a poor state of preservation. Major repairs to portions of the building have been carried out in the 20th century that have ensured preservation. These repairs are being retained as examples of good repairs.

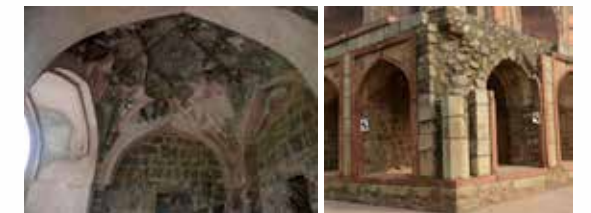
The corner chambers of the arcade and three deep chamber are plastered with decorative incised plasterwork. Modern cement-surkhi plaster was applied to the arches in the ground level arcade during 2002-05 disfiguring the historic character and damaging original lime plaster. The four corners were restored using Delhi quartzite stone, one of the hardest stones known, as per the original details to strengthen the corners and tie-together the plinth base structurally.

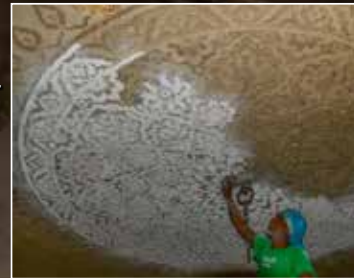
Cleaning of the Main Tomb's ceiling

Soft cleaning of ornamental motifs and plasterwork

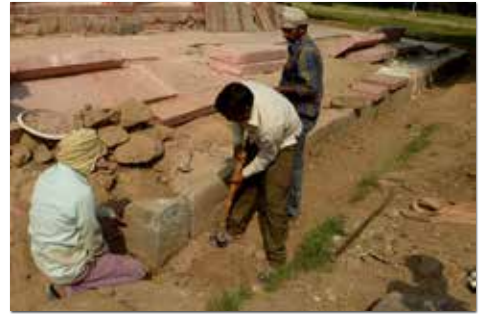
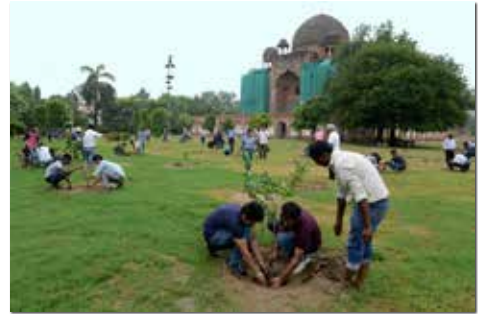
(Top) Excavation of Delhi Quartzite lower plinth revealed the original garden levels; (Bottom) Volunteers from InterGlobe Foundation participating in tree planting at the site
