**Humayun's Tomb - Sunder Nursery - Hazrat Nizamuddin Basti
URBAN RENEWAL INITIATIVE**

SABZ BURJ

CONSERVATION

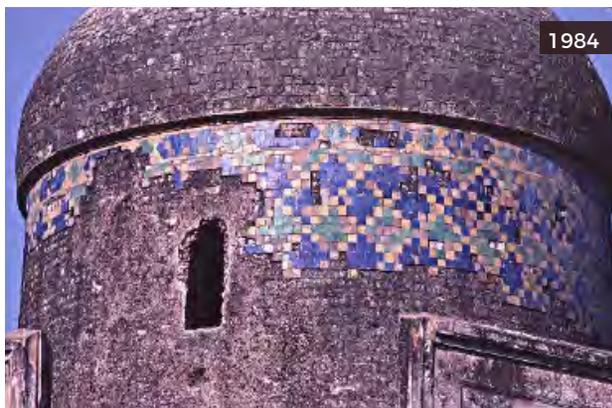
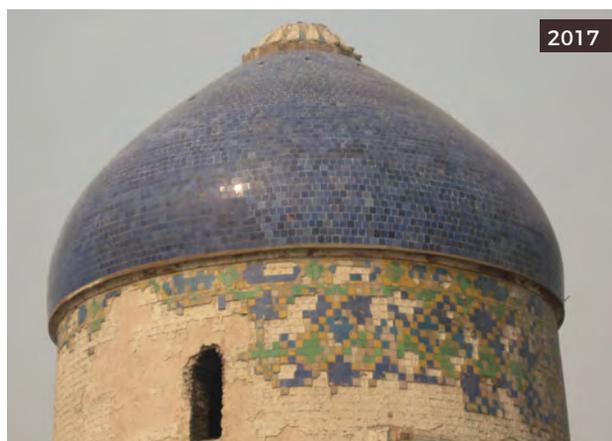
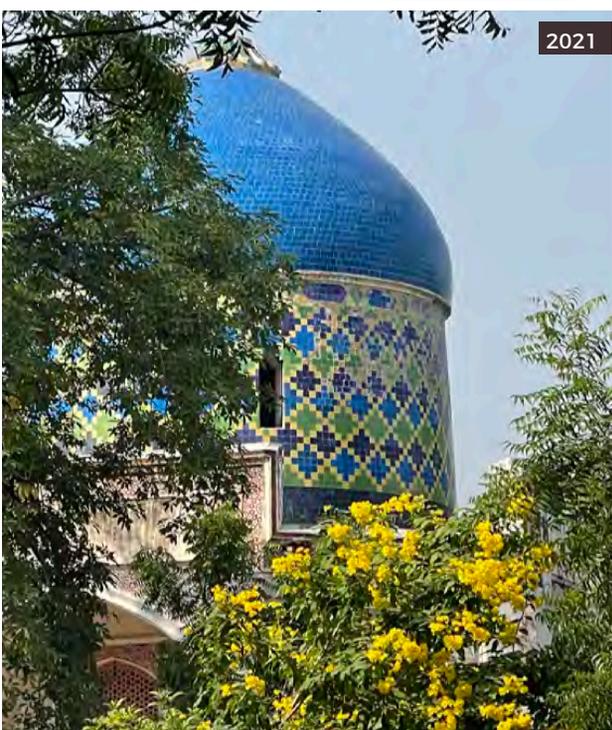
(top): Courtesy Ebba Koch: By 1984, much of the times on the dome had fallen or lost their glaze.(centre): tilework on the dome was restored by the Archaeological Survey of India in 1985-6.

(Bottom): The present conservation effort has included replacing the 1986 tiles on the dome to stop water penetration and restore tiles on the drum where these were missing.

At Sabz Burj, the 1980's tiles and all cement mortar was removed and the dome exposed for several months to allow the dampness to dry out prior to restoring tiles matching the original 16th century tiles, fixed with lime mortar. While all original tiles on the drum were retained, even when these had lost their glaze, missing tiles on the drum were restored.

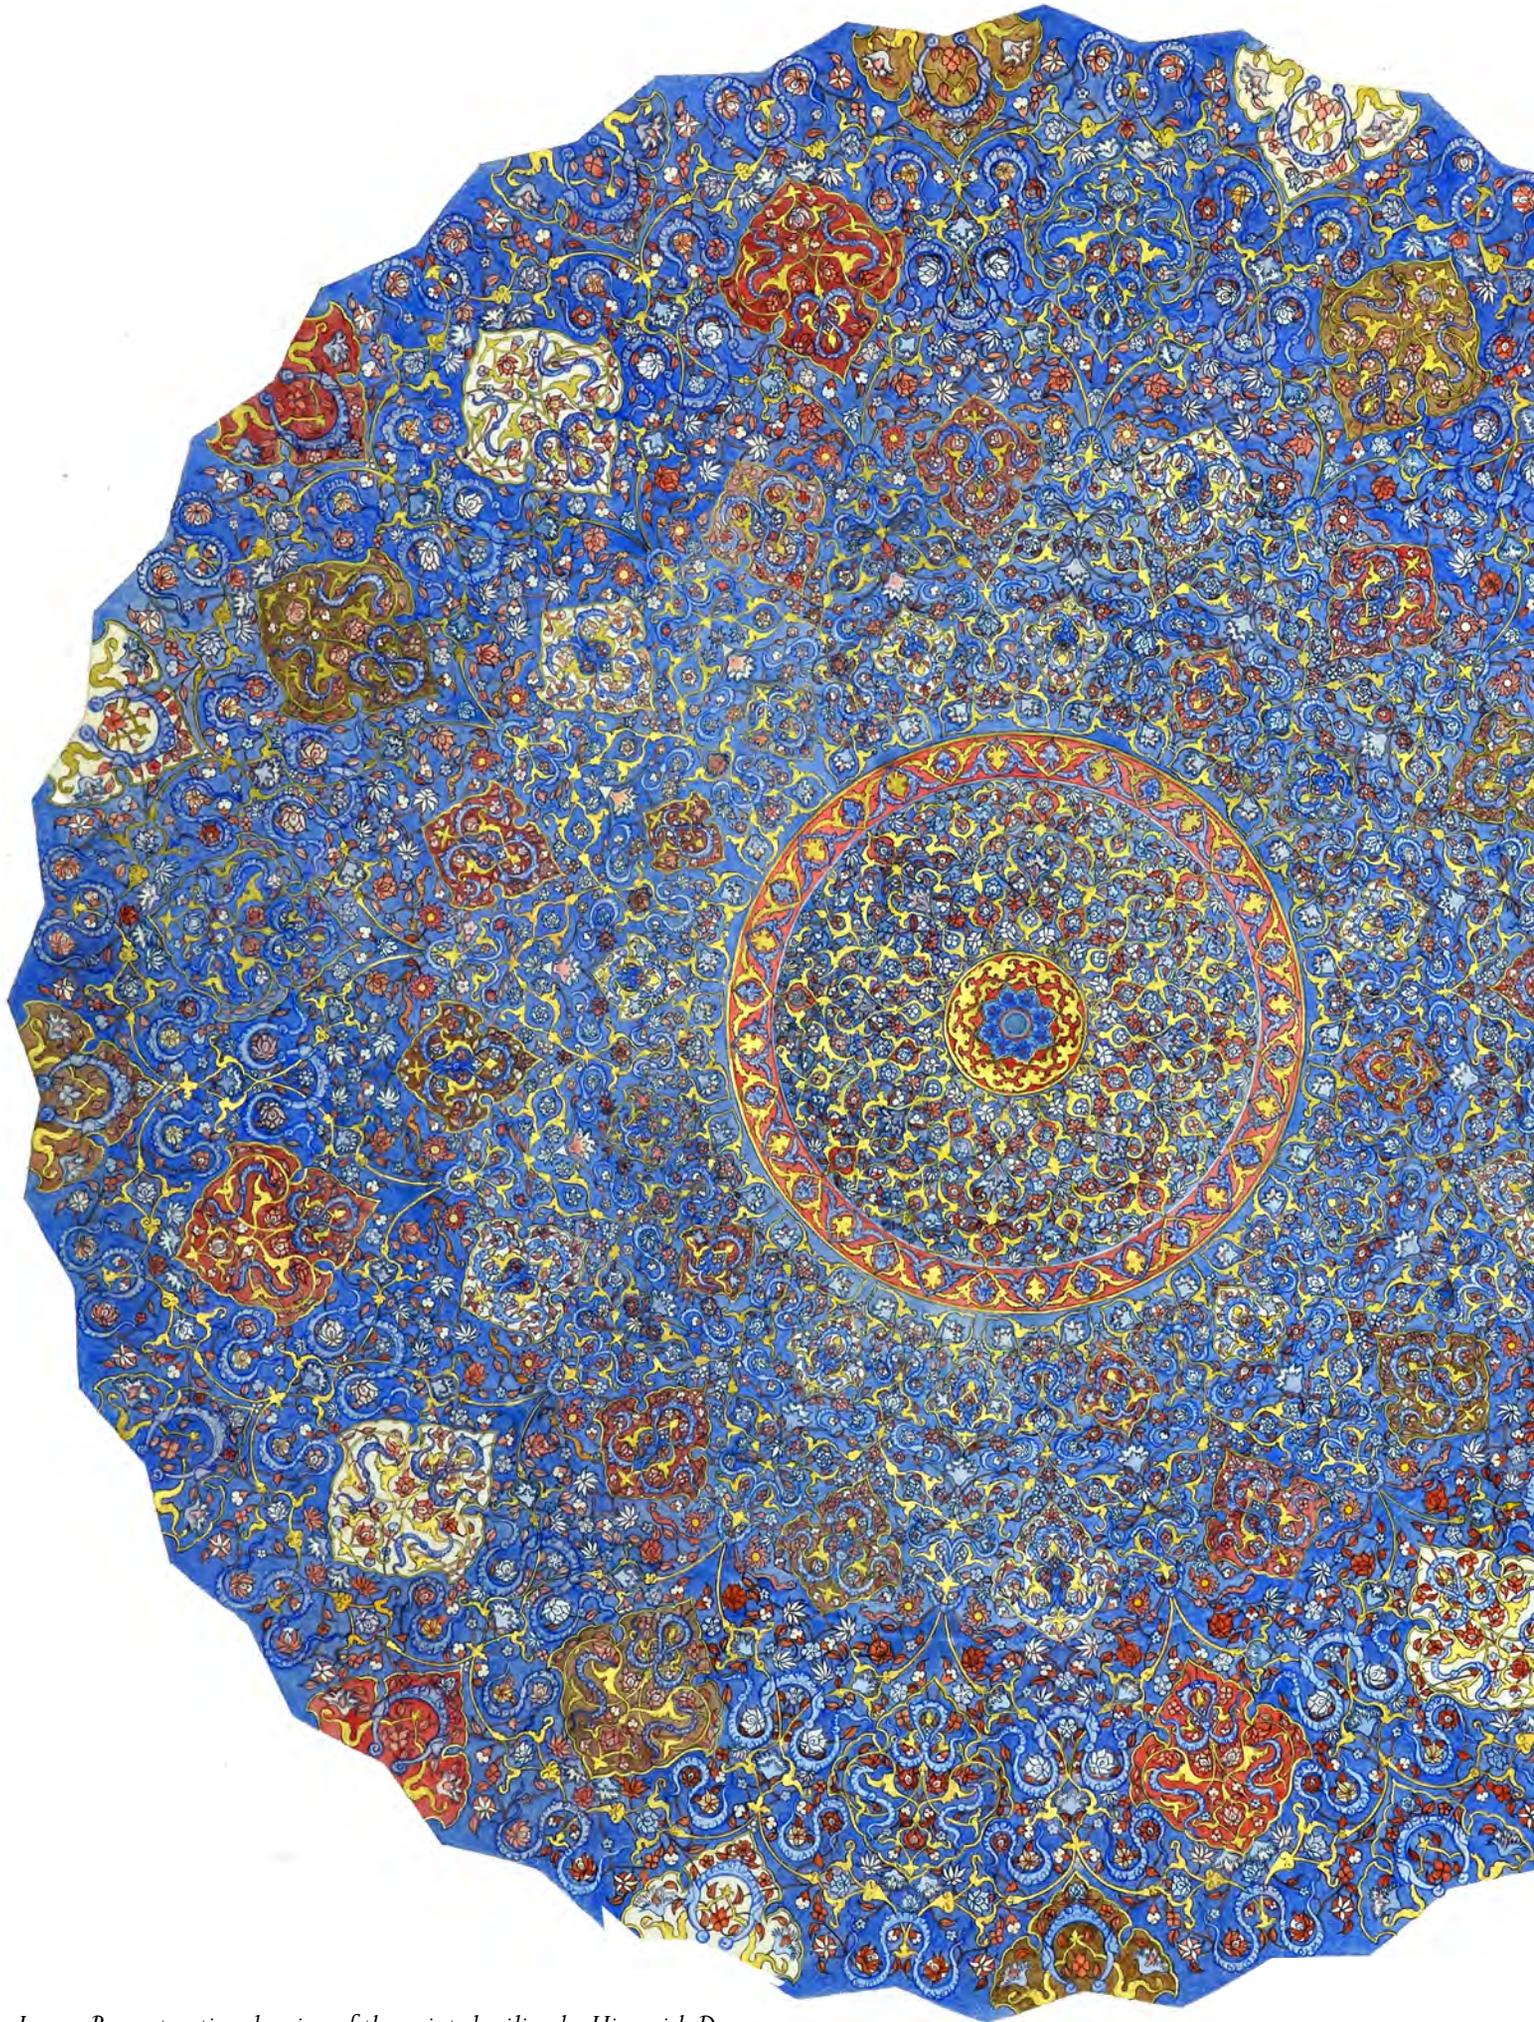
Image: Reconstruction drawing of the painted ceiling by Himanish Das

Unfortunately, water ingress from the dome above has permanently damaged much of the peripheral edge of the domed ceiling. On account of the high value and significance of the painted ceiling, the conservation effort stopped at revealing the original painted surface and no attempt at restoration of missing portions was attempted. However, based on the condition mapping of the ceiling patterns by the AKTC team, architect Himanish Das has produced a painting depicting the full extent of the painted ceiling.

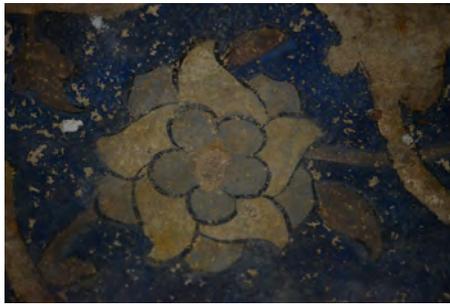
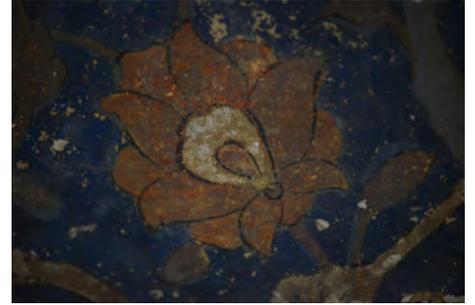
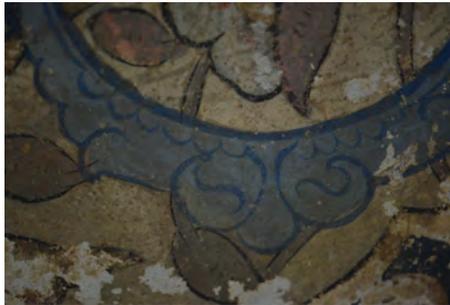
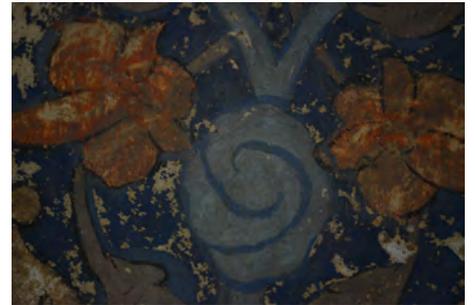
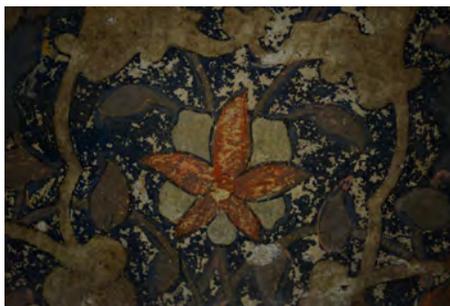
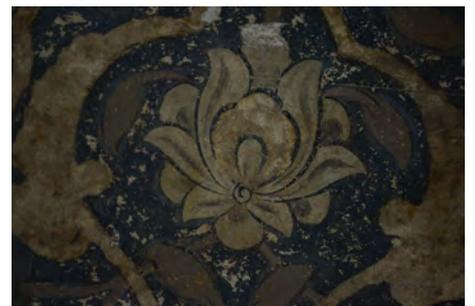
On removal of 20th century paint and plaster layers, a most incredible and rare painted ceiling was revealed. The 16th century painters used pure gold, lapis, red ochre to create a series of delightful floral motifs, often seen on later day miniature paintings and even textiles.

The ceiling seems to have been covered with plaster in the 20th century, possibly when the structure was used as a police station and later attempts at removing sections of this plaster with a chisel caused further loss of painted surfaces.

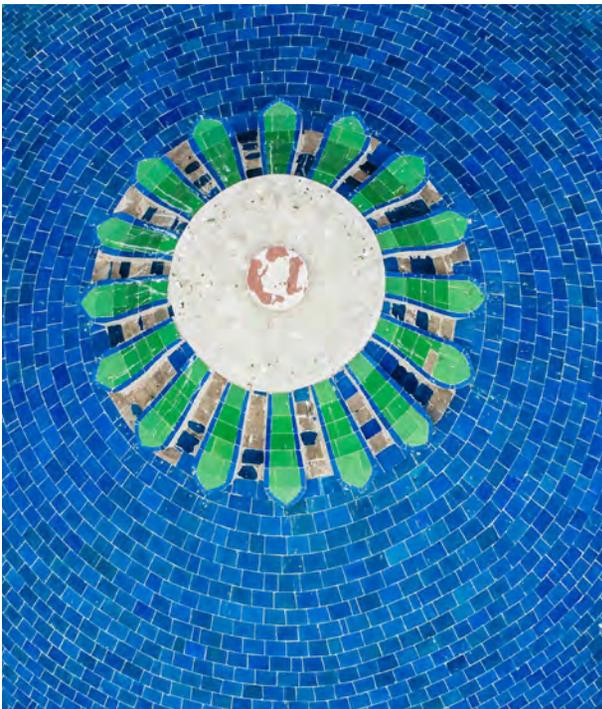
Sabz Burj was used as a Police Station in the early 20th century, the painted interiors plastered over, much of the incised plaster decoration of the façade lost and replaced with cement layers. By the 1980's much of the tile work on the dome had fallen away and was re-tiled with modern tiles fixed with cement mortar. The Mughal splendour turned to ruin. Since 2017 – 2021, with the support of Havells, conservation works here have been undertaken by an inter-disciplinary Aga Khan Trust for Culture team under the supervision of the Archaeological Survey of India.

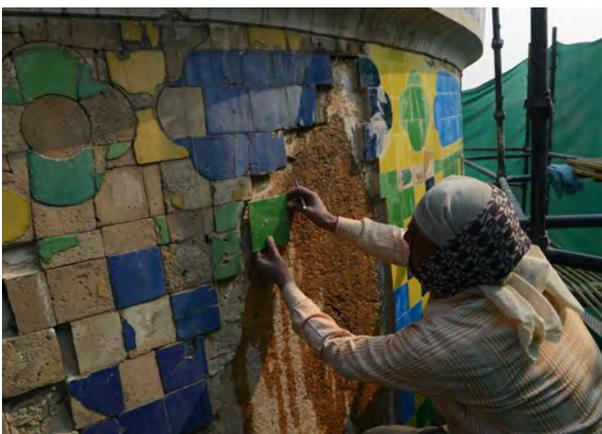
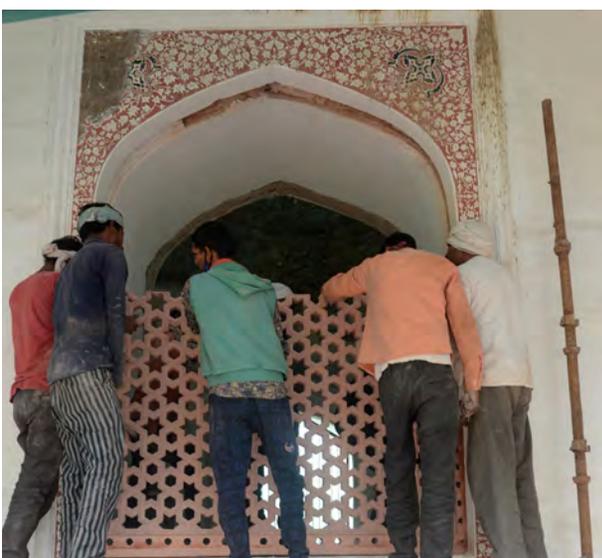
(Top): the Lotus finial atop the dome boasts of the green (sabz) coloured tiles that lend the structure its name. (Centre): the craft of glazed tileworks was revived during the conservation of Humayun's Tomb and craftsmen have painstakingly restored missing tiles on the drum of Sabz Burj. (Bottom): the missing sandstone lattice screens have been restored to all four arched openings of the monument.

Stone carvers, using hand tools and techniques passed down over centuries have prepared sandstone jallies now restored to all the openings. Significantly, these also prevent the entry of birds into the tomb chamber.

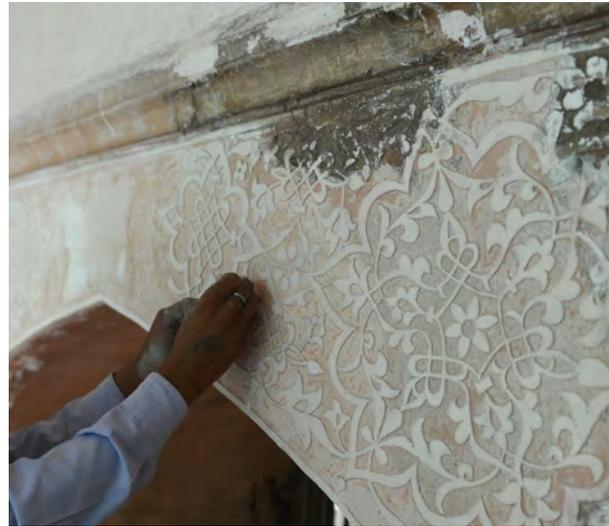
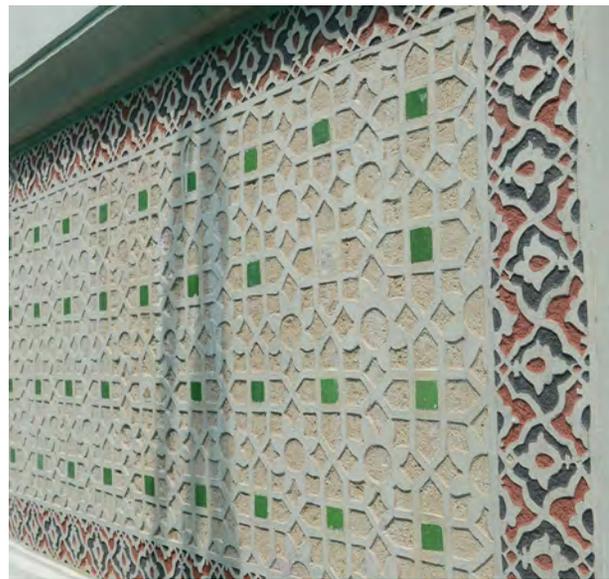
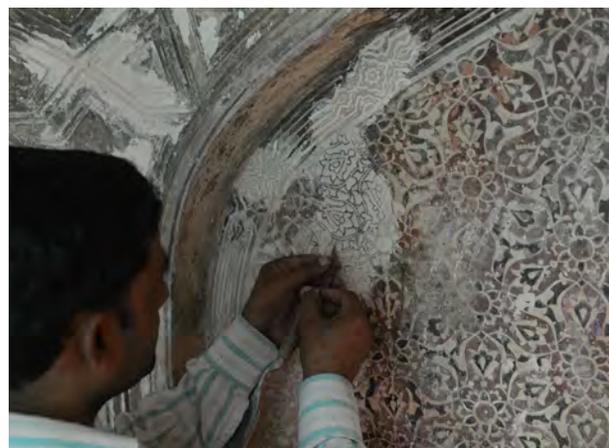
The Sabz Burj boasts of a variety of intricate incised plaster patterns of floral and geometric design. Missing incised plaster decorative patterns have been restored on the basis of available evidence on each of the eight facades.

Though several patterns are visible on the façade, each unique, enough of the original patterns had survived to enable architects to discern the original pattern and thus enable its complete restoration.

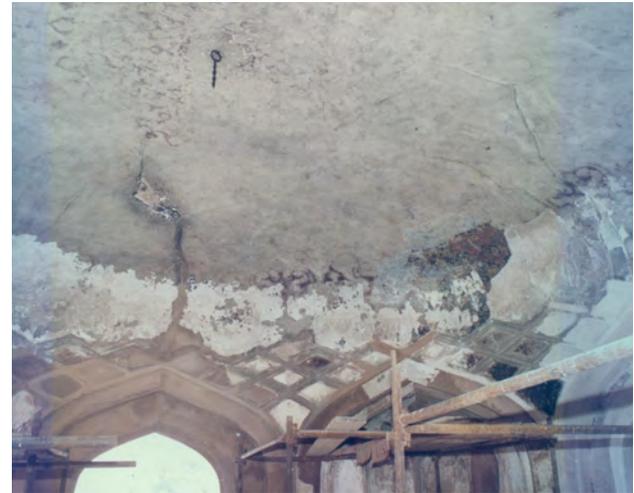
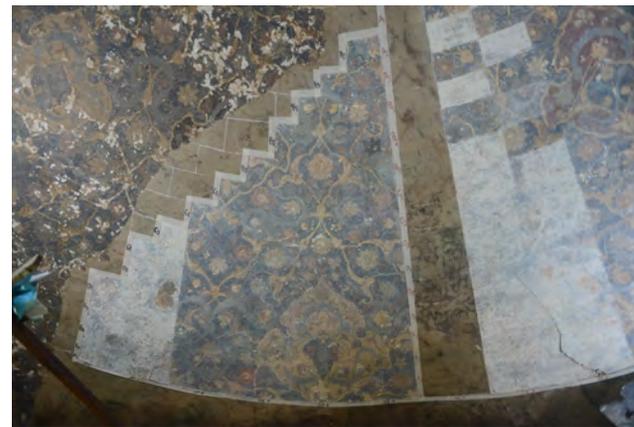
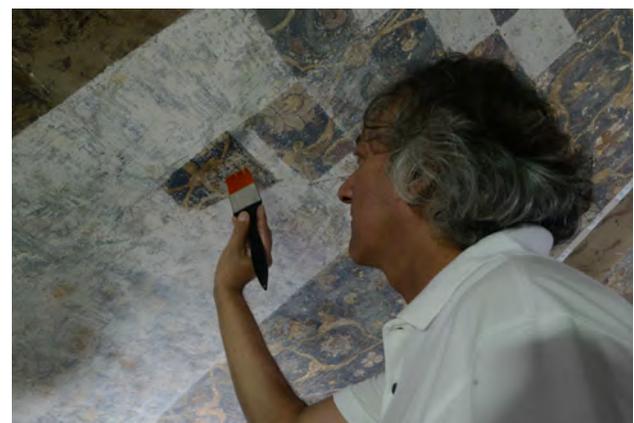
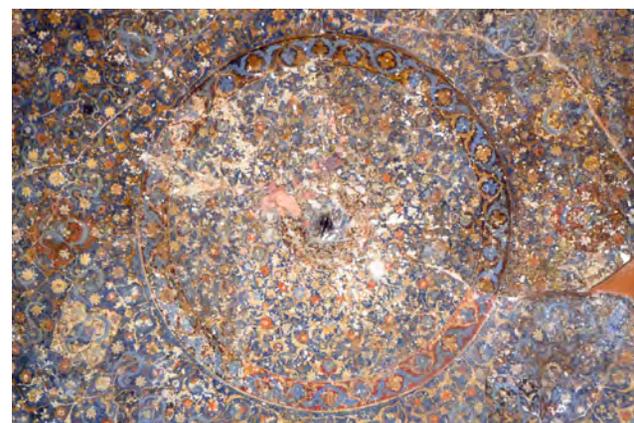
The most significant and unique element is the domed ceiling, painted, amongst other elements with real gold and lapis. Here considerable effort was required to be made by conservators to reveal the painted ceiling and the peripheral edge was found to have been lost due to water ingress. In view of this being amongst the earliest surviving painted ceiling in India.

Art conservators spent three years in a most painstaking scientific cleaning to remove plaster and chemical layers to reveal the total extent of the surviving painted ceiling – the earliest existing painted ceiling for a Mughal era structure. Never before seen myriad patterns in blue, red and gold have been now revealed. The significant painted ceiling can be associated with royal patronage for the mausoleum and indicates the Sabz Burj to be a mausoleum of an important Mughal royal.
