# 08 ARAB SARAI GATEWAY

# 05 Arab Serai Gateway

This 48' high gateway served as the southern entrance of the Arab Serai - built to accommodate the 300 Persian craftsmen whom Hamida Banu Begum, had brought with her on her return from pilgrimage to Mecca. These craftsmen were involved in the building of Humayun's Garden-Tomb. The integrity of the whole complex is now disturbed as the major portion of the Arab Serai is today the Industrial Training Institute and is inaccessible to visitors. Over the last century the portions of this lofty gateway had collapsed including the domed entrance chamber thus severely compromising the structural stability of the remaining structure like front façade, portions on the upper levels etc. The collapsed portions of the gateway suggest that half of the entrance chamber was not able to bear the load of the dome which should be uniformly transferred to the piers. Conservation works includes conservation of the main wooden doorway, conservation of the Stone façade, reconstruction of the partially collapsed entrance chamber, conservation of the chambers at ground floor, reconstruction of the upper chambers and providing adequate flooring.

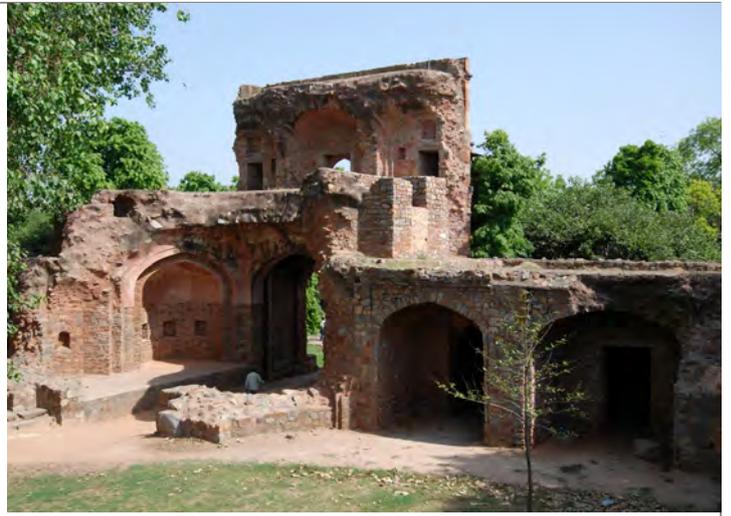
## THE ENTRANCE CHAMBER

*Following the collapse of the dome, the southern half of the gateway had largely collapsed and portions required to be reconstructed on the basis of the northern portion that had remained standing.*

- The collapsed two arched alcoves are reconstructed as per existing alcove's design and profile using traditional materials and techniques.
- Clearance of earth was carried out to expose the original foundation of the collapsed wall of the south façade. Missing masonry wall was reconstructed over the original foundation using similar materials and construction techniques.

- The missing arch of the south façade is reconstructed to match the northern arch.
- The two missing arched alcoves on the east and west sides are reconstructed as per existing two alcoves on the same façades. Existing profile of the alcoves were traced and transferred to the new construction to maintain the original architectural detail.

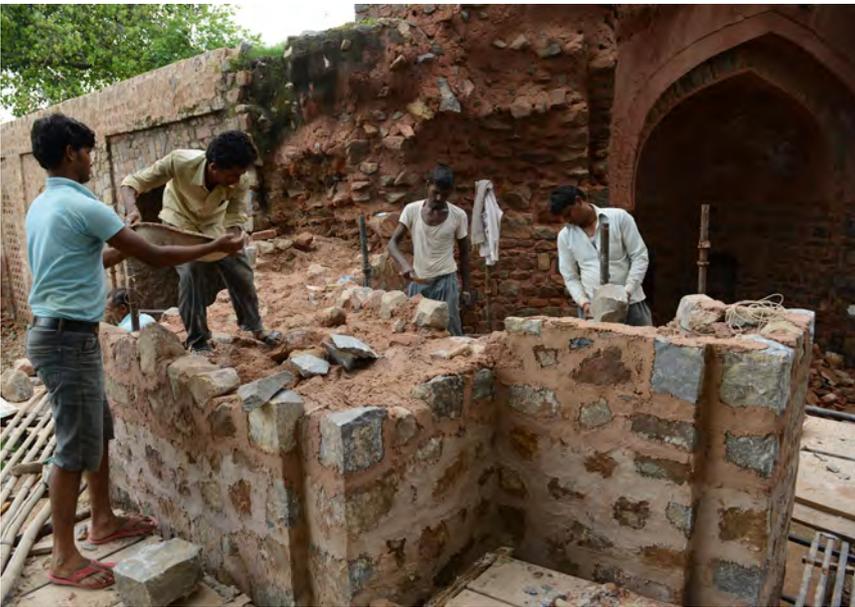
- The arched chambers on both the sides of the entrance chamber were in extremely dilapidated condition posing a great threat to the structure above.
- The external arched chambers had collapsed over the years due to a combination of vegetation damage, neglect, and structural failure.

- The wall surfaces were cleaned to remove later repair-works and other deposits. The cement and dead pointing works were raked out and replaced with lime mortar. The consolidation of the existing masonry was done using the lime based grouting.

- The structural repairs include stitching of the cracks, grouting and anchoring took place.
- The inappropriate past preservation works on the southern façade was carefully dismantled followed by reconstructing the arched profiles on each of the six bays. The wall surfaces were built on the original foundations that required to be strengthened by grouting of lime mortar.

(Right) Internal chamber during conservation works

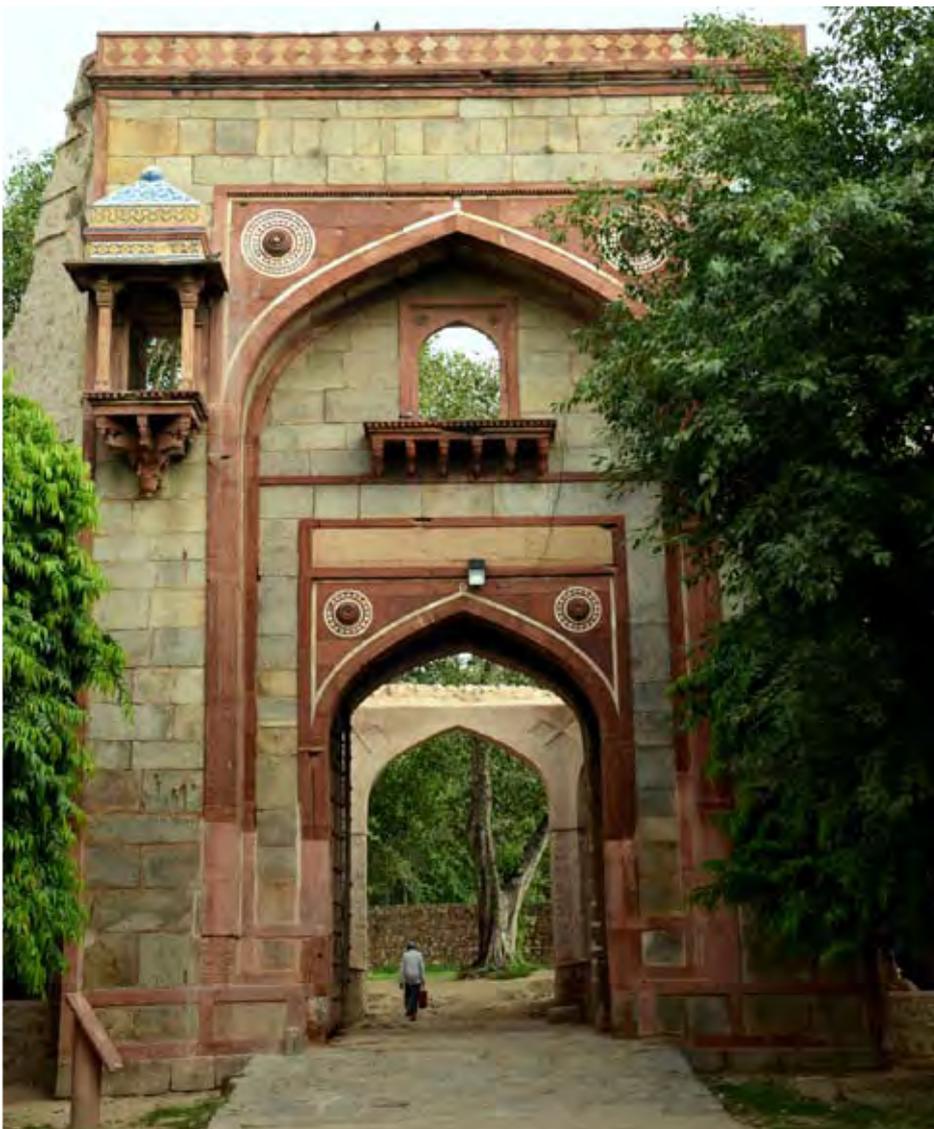
*Arab Serai Gateway: after conservation. Conservation works on the Arab Serai Gateway were undertaken with a grant from the **German Embassy**.*

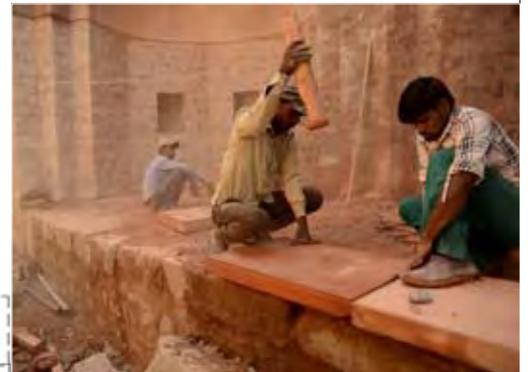
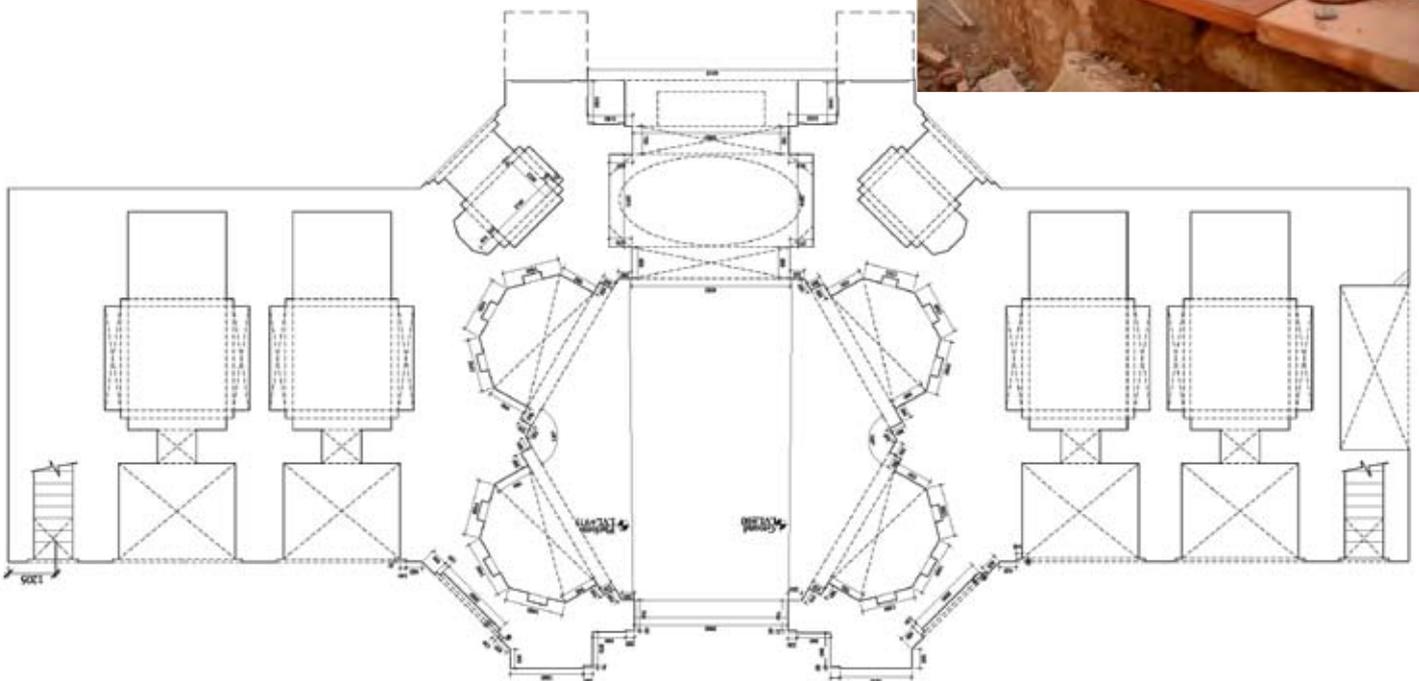
*(Above) All chambers on the eastern and western side of the main gateway were in various states of collapse; (Right Top) Architectural documentation of the Gateway*
