17 BU-HALIMA'S TOMB - GARDEN

Garden Restoration

09 BU-HALIMA GARDEN-TOMB

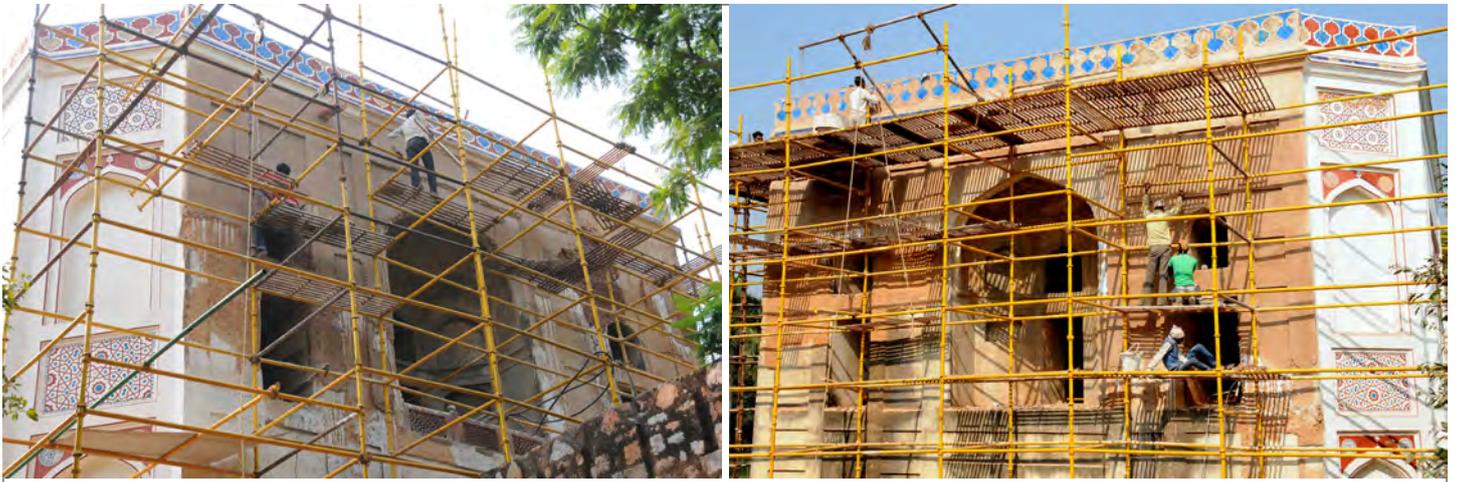
(Below) Restoration of the exquisite tilework on the medallion, parapet and spandrel of Bu Halima's Gateway

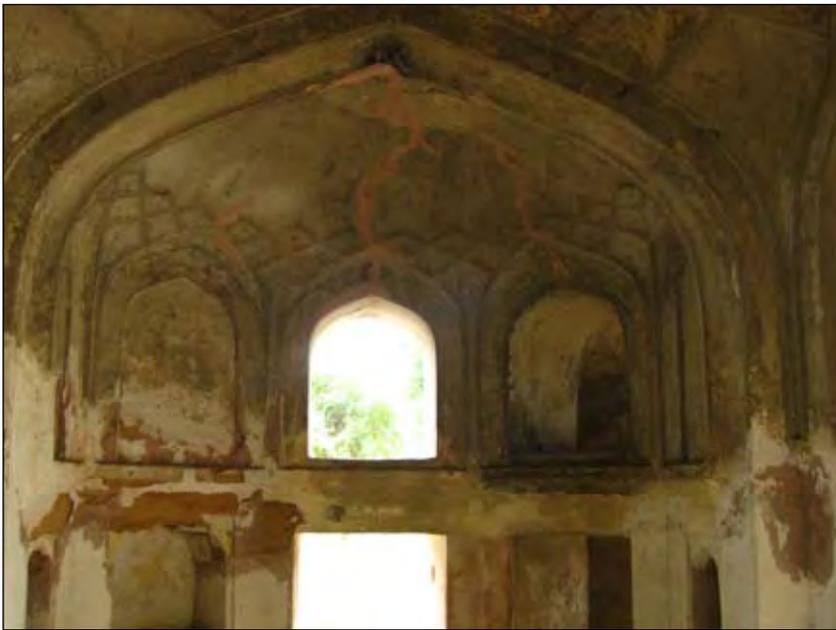
(Above) Tilework and polychromy works at Bu Halima's Gateway suffered deterioration; (Left) Following detailed architectural documentation and condition assesment, tilework, where missing was restored (Below)

- Portions of exquisite glazed tile work on the Bu-Halima Gateway (Above) were still present on the eastern façade in the form of tiled medallions in the spandrels of the central large recessed arch, tile inlay work in the panels of chamfered surfaces and on the parapet.
- The extensive documentation of the tile remains, of the large medallions comprising of small pieces of tiles beautifully put together, were carried out and the shapes and sizes of missing tiles were comprehended.
- The tiles were then prepared using the original materials and techniques.
- The tiles were then arranged in the original position by the craftsmen and now tile restoration work is completed on the Bu-Halima Gateway.
- The spandrels of all the arches and parapet were then finished with the Red polychromy work.

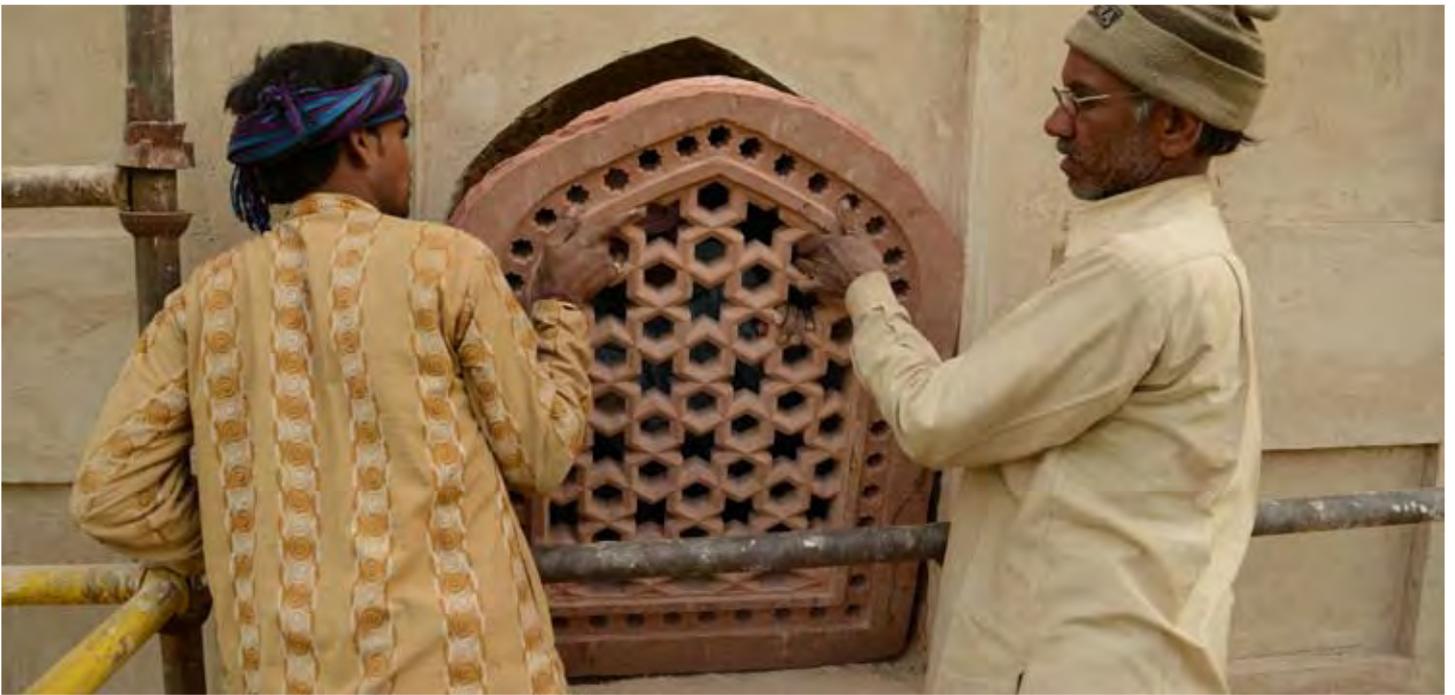
- These decorated surfaces were repaired in plain cement plaster which leads to the loss of most of the decorated plasterworks.
- After careful documentation of the existing remains, the original patterns were discerned and the restoration works were carried out by the master craftsmen by replicating the existing patterns.

(Above) The Gateway walls had been covered with cement plaster which was required to be removed; (Right) Restoration of historic lime plaster on the walls and arches

- After allowing the masonry to dry out the portions where modern plaster layers were removed, the surface was re-plastered in lime mortar.
- The roof has a raised platform over the central dome and the remaining portions have, like most other buildings in the complex, been laid with additional layer/s of concrete. The parapet ornamented with the Kangura motif, which had collapsed in portions and poorly rebuilt, are now reconstructed and tiles are laid where they were missing.

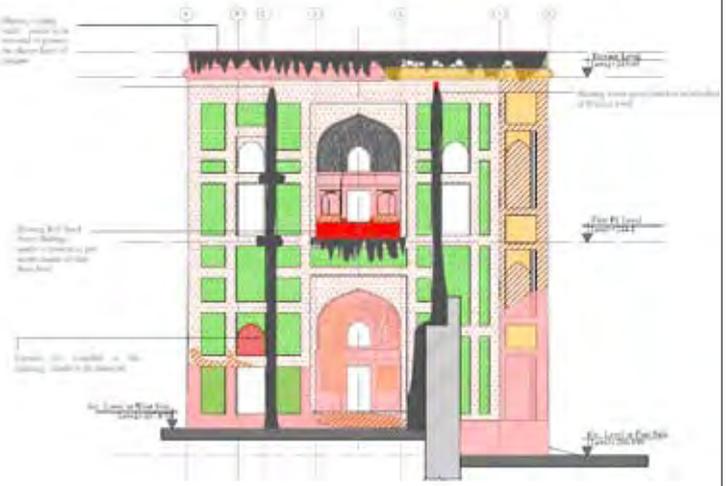
- On the lower level, alterations to the plinth had been carried out in the past to prevent water ingress once earth levels on the west, north and south of the gateway had increased significantly due to earth in-fill. The inappropriately built internal platforms were broken to understand the original levels; and it was found that the original floor level is about 50cm lower than the existing level.
- The levels of the internal platforms were then restored by lowering the platform and it was finished by providing sandstone paving on these platforms.
- This allowed the central portion to be widened by about 60 cm on either side thereby significantly enhancing the historical character of the space.
