ABOUT THE PROJECT

Nizamuddin Urban Renewal Initiative

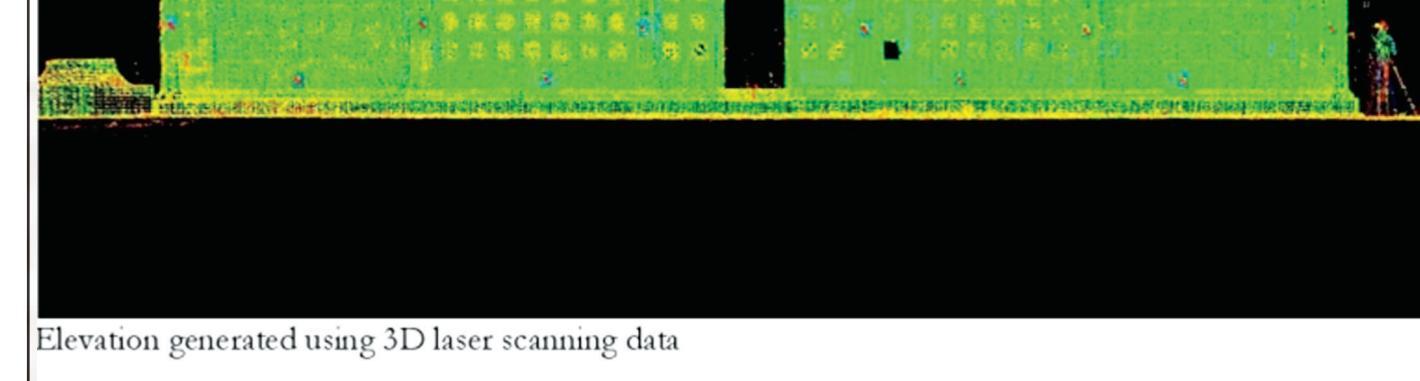
(Above) 3D Laser Scan images; and (Below)Condition Assesment drawings of Chausath Khamba
