PROJECT CONSERVATION

Nizamuddin Urban Renewal Initiative

a People Public | Private Partnership

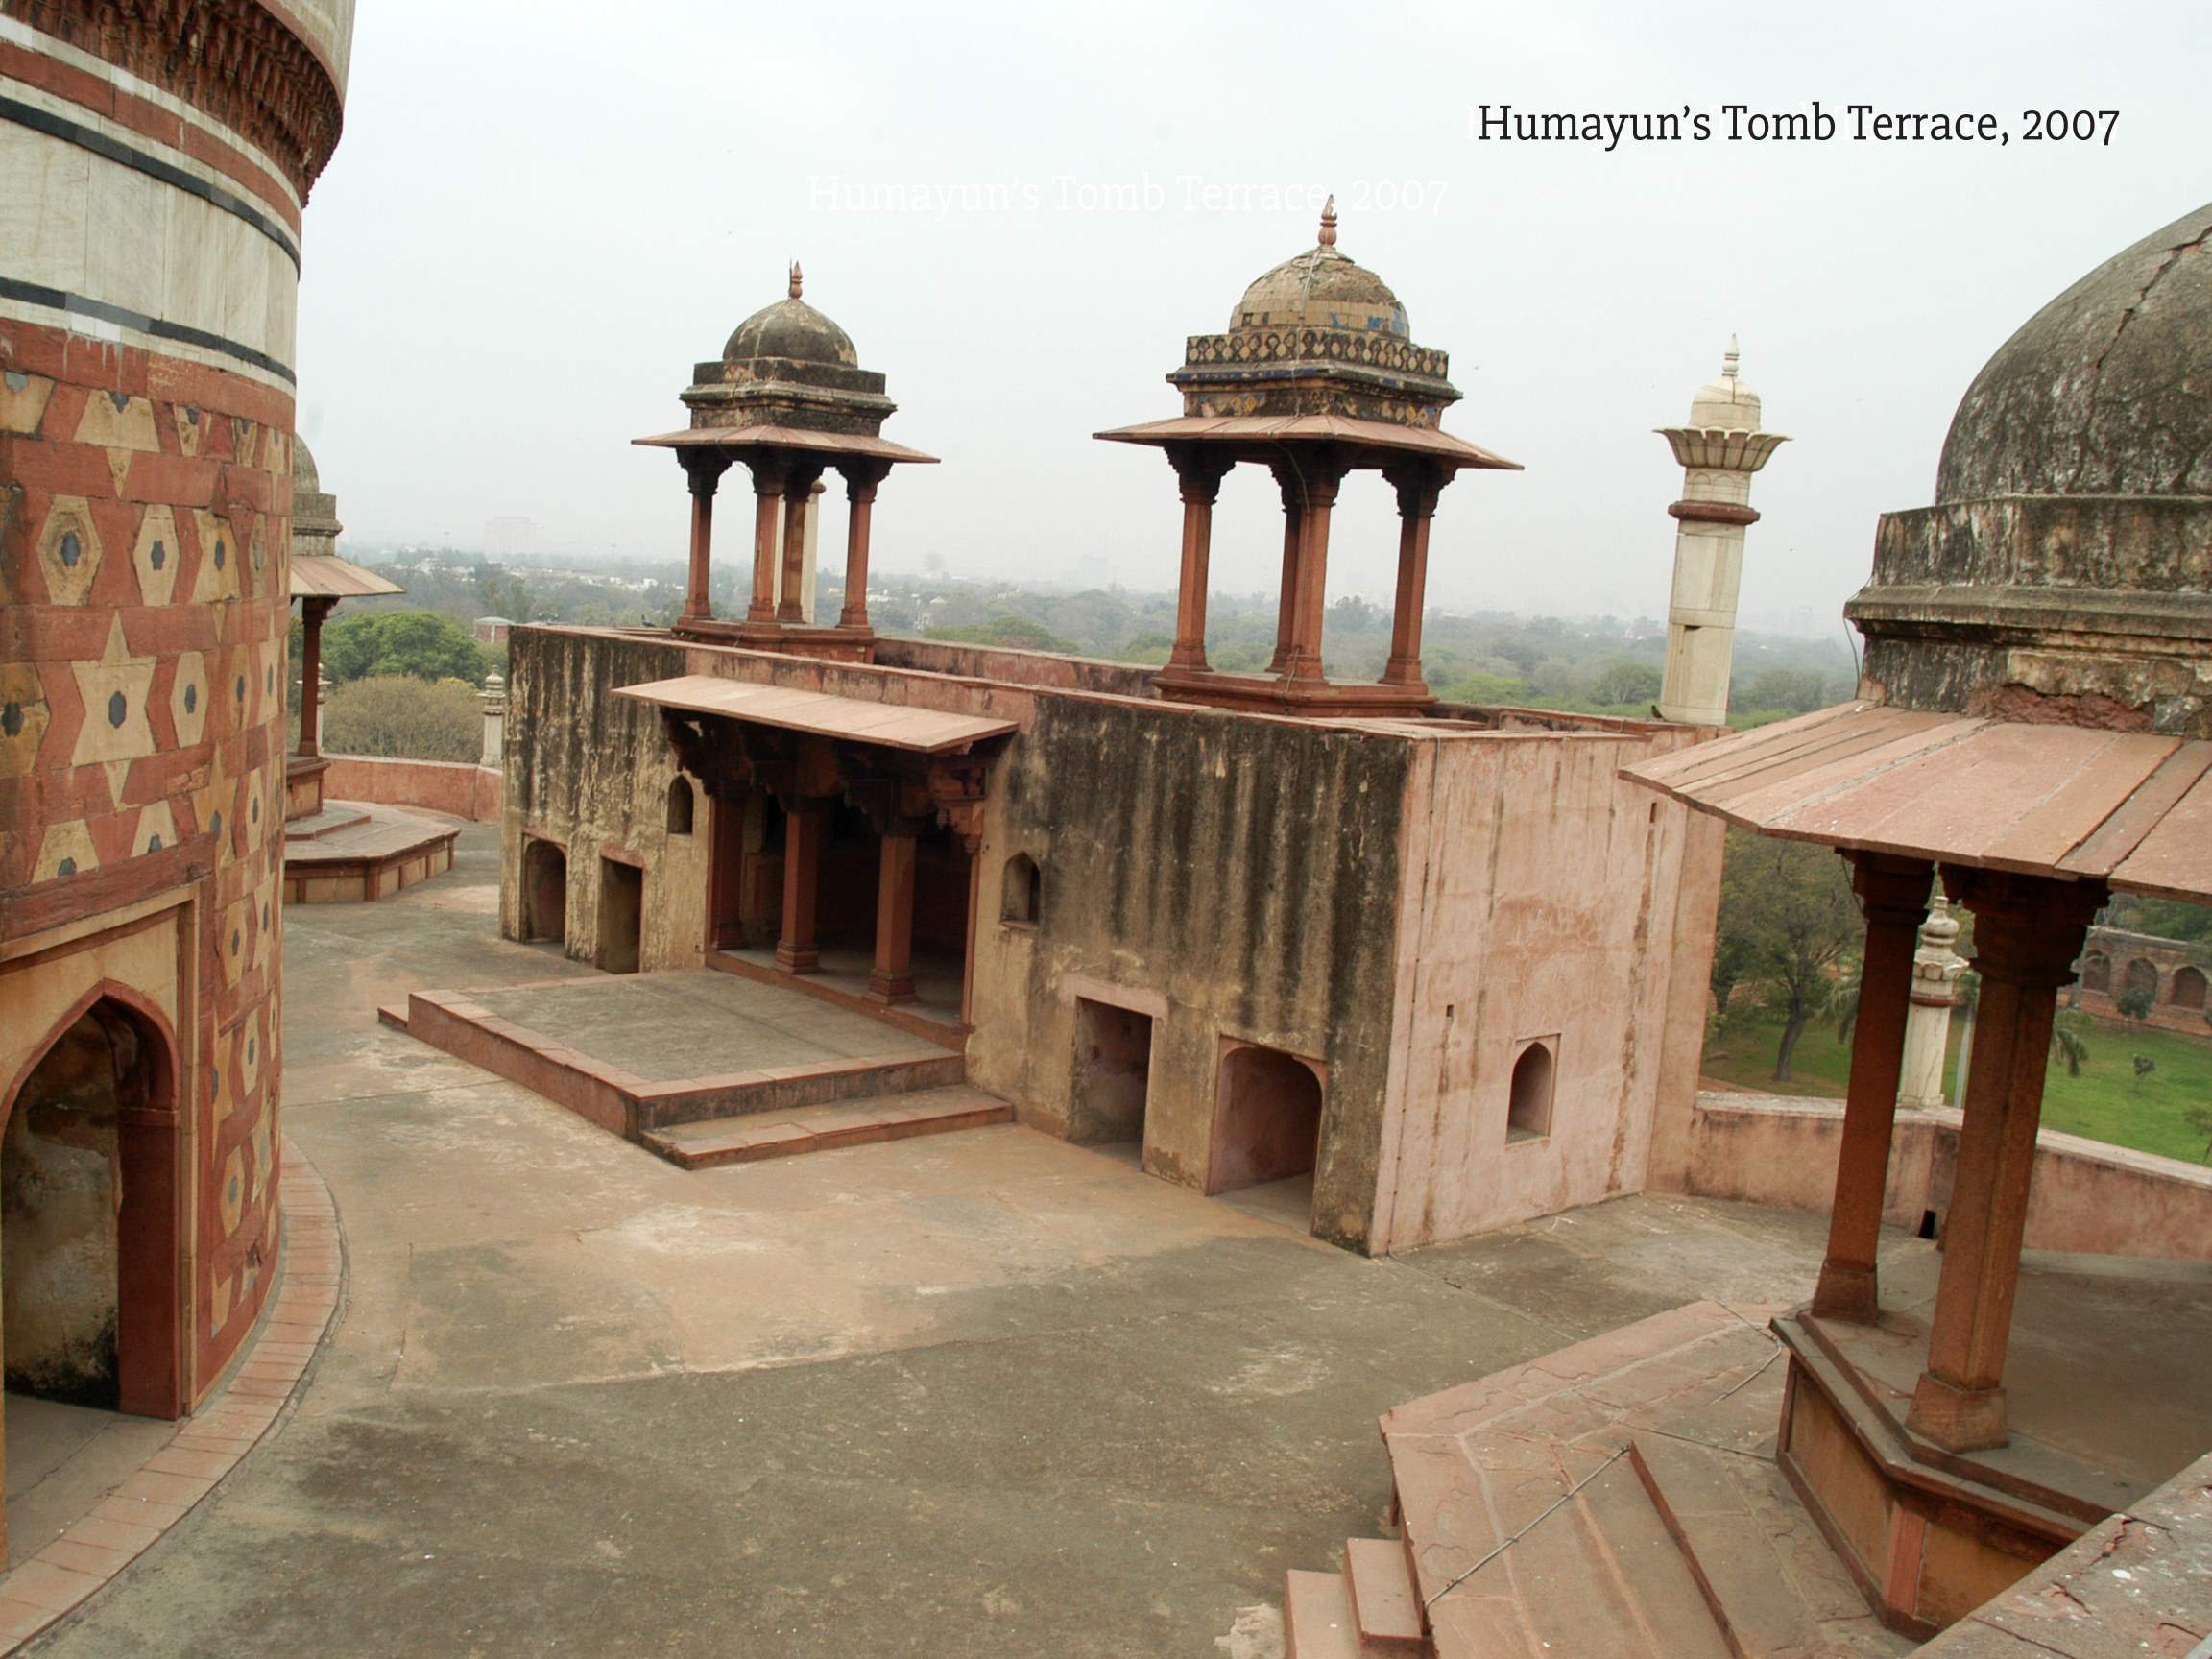
Humayun's Tomb Terrace, 2007

Removing over a million kilos of concrete from the terrace, which was laid in the 20th century, allowing easy rain-water and lifting unnecessary dead weight off the building.

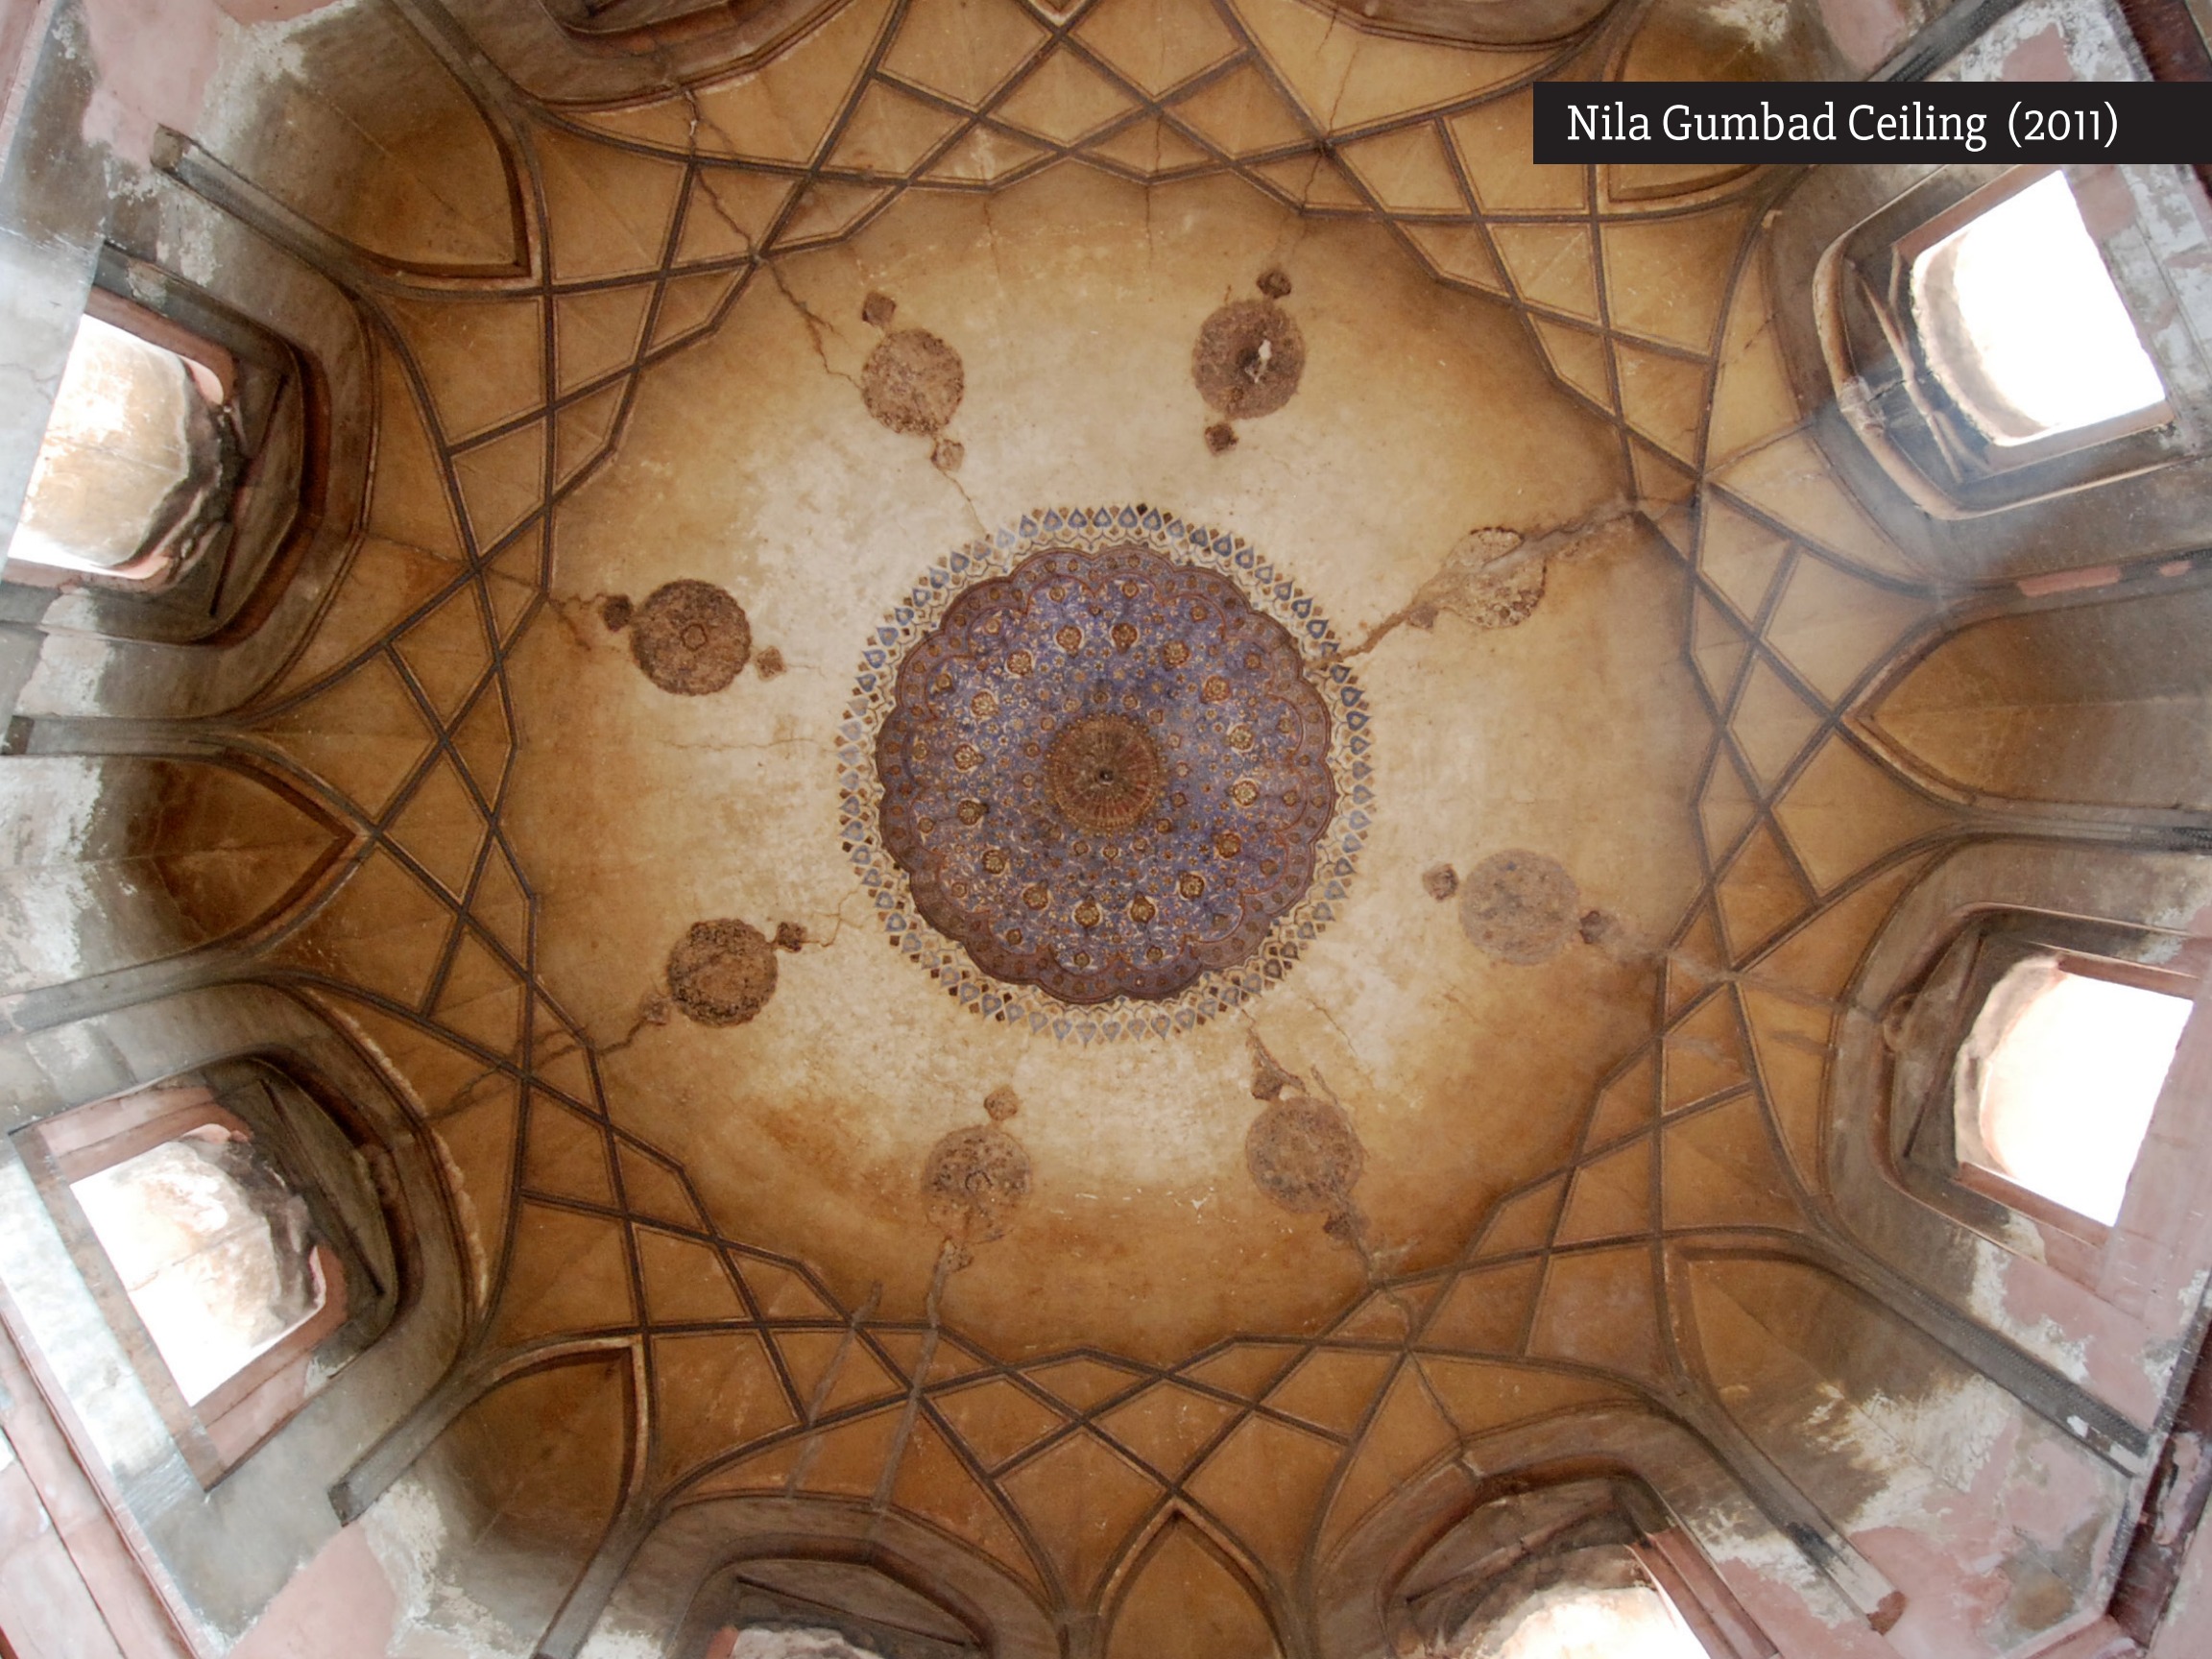
Nila Gumbad Ceiling (2011)

Several layers of cement plasters had replaced much of the lime plasters on both interior and exterior building surfaces, thereby accelerating the decay process and disfiguring the historic character.

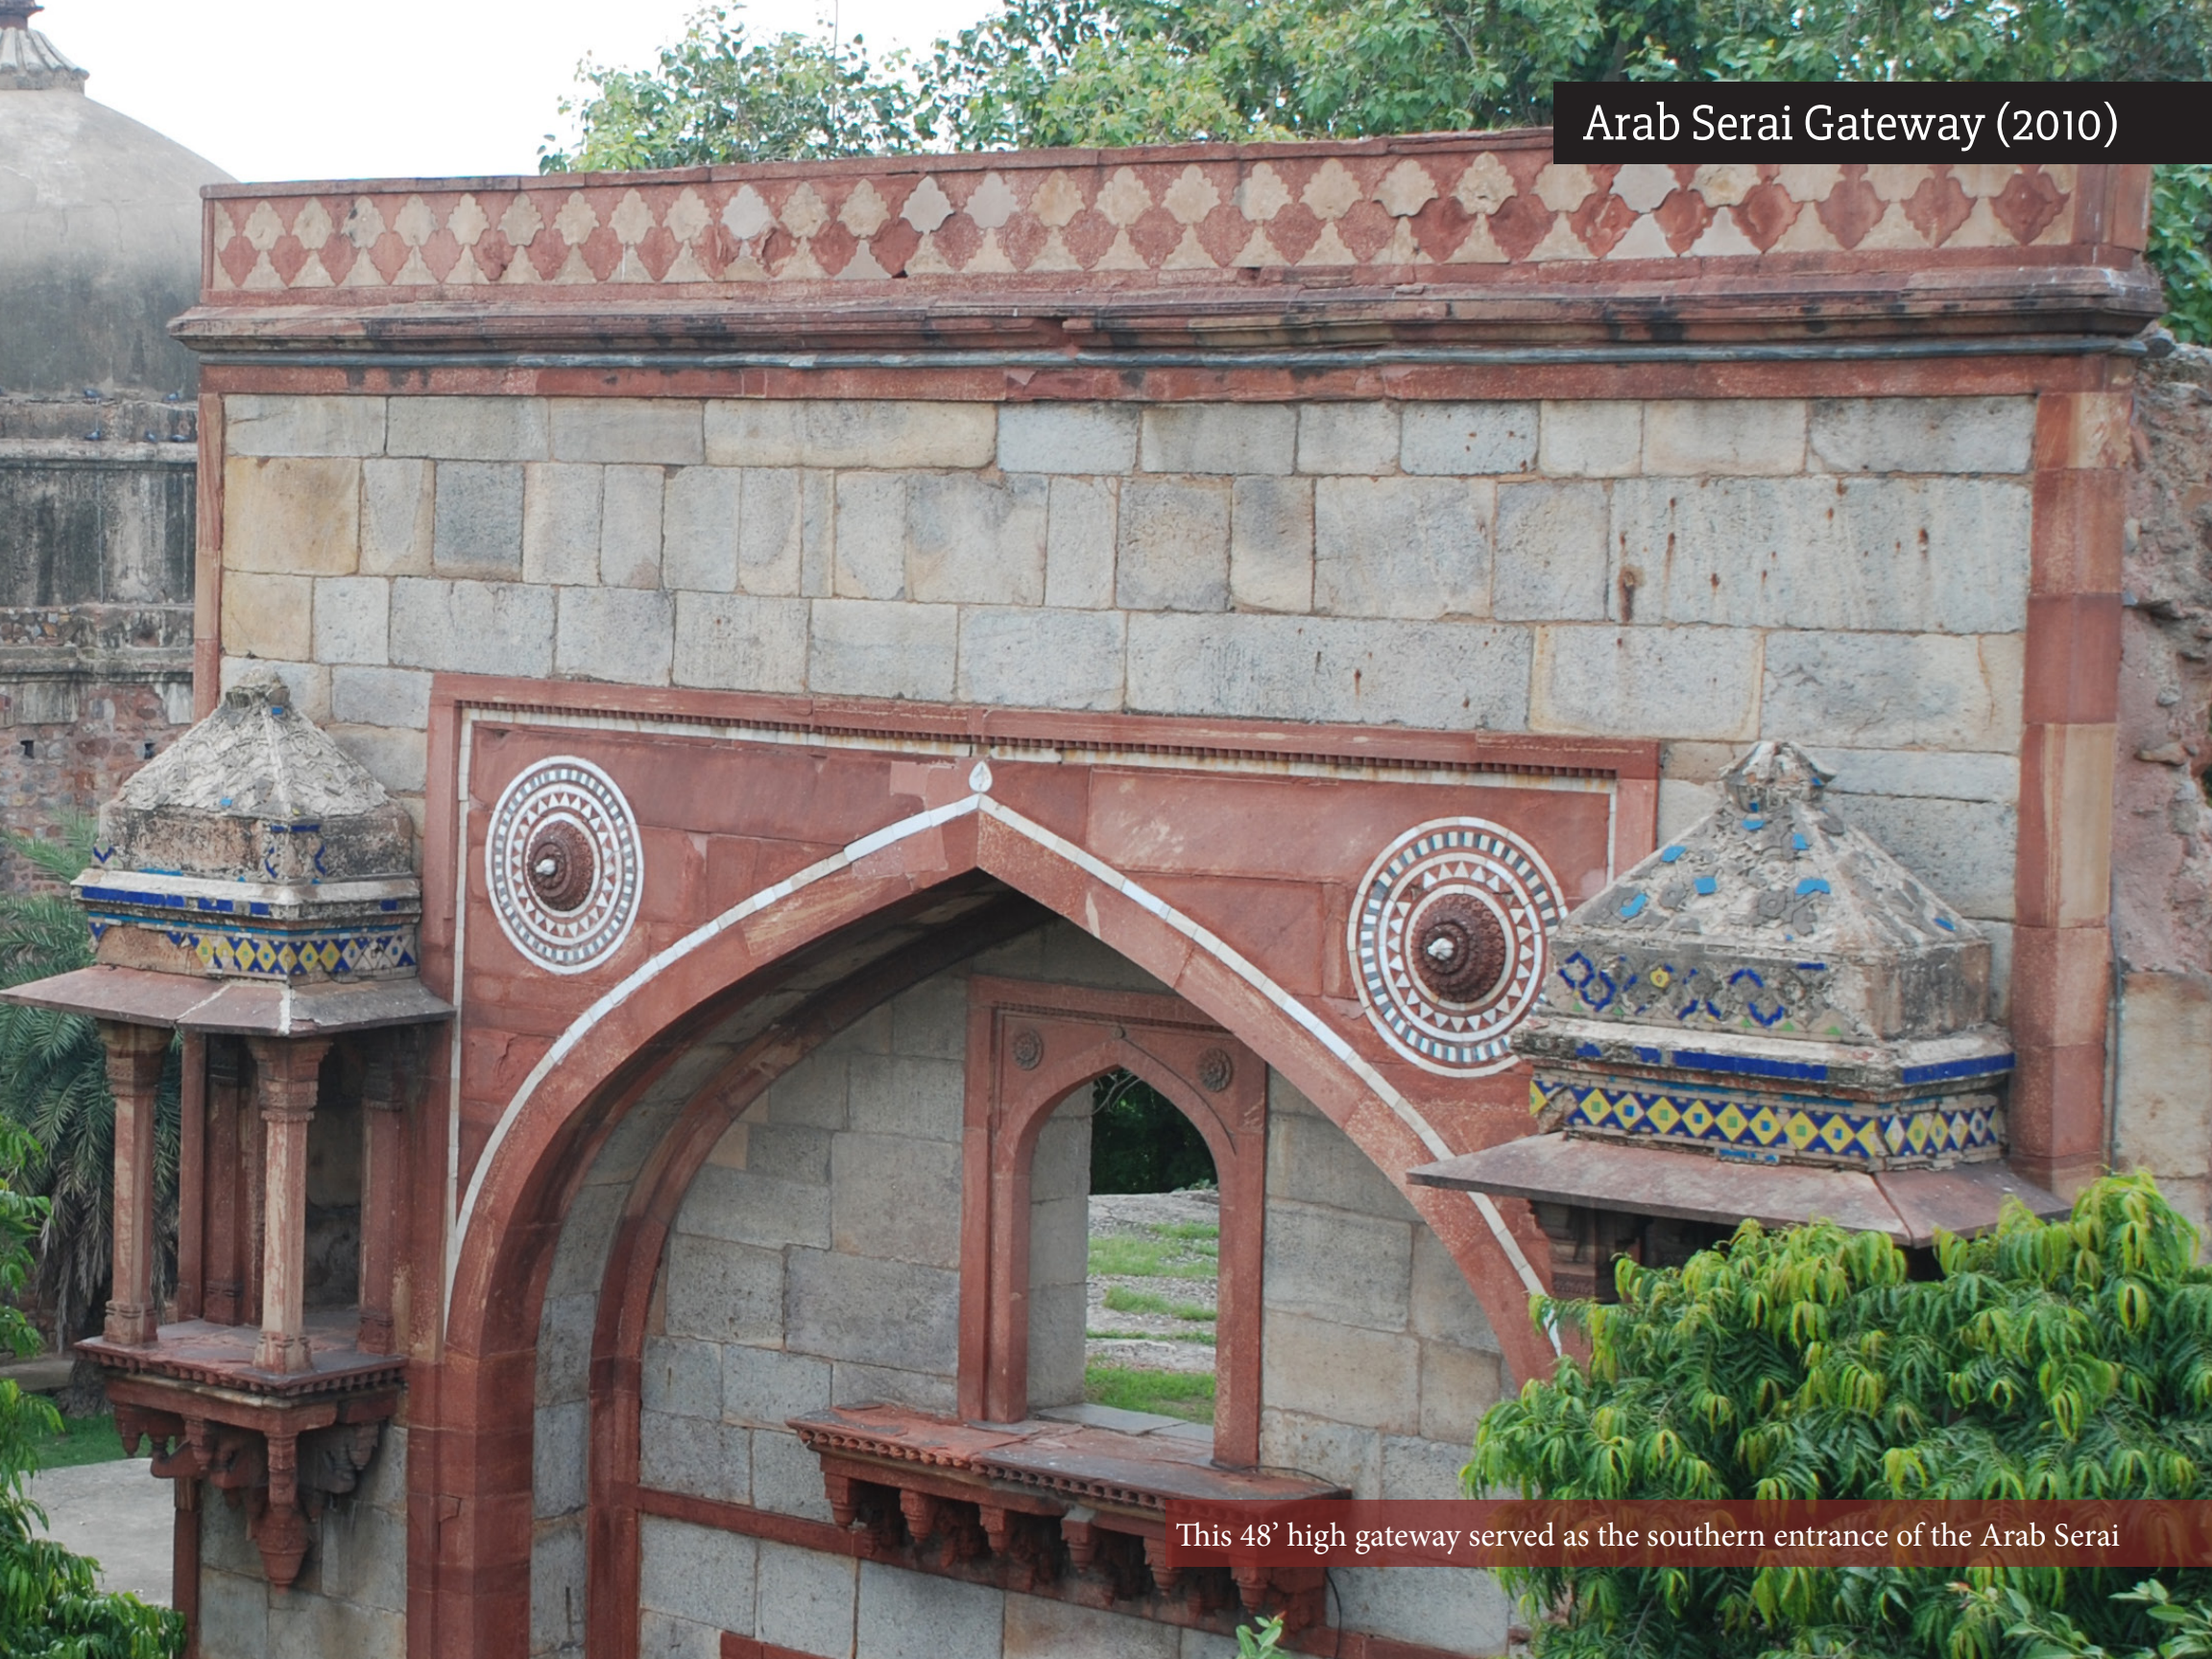
Arab Serai Gateway (2010)

This 48' high gateway served as the southern entrance of the Arab Serai

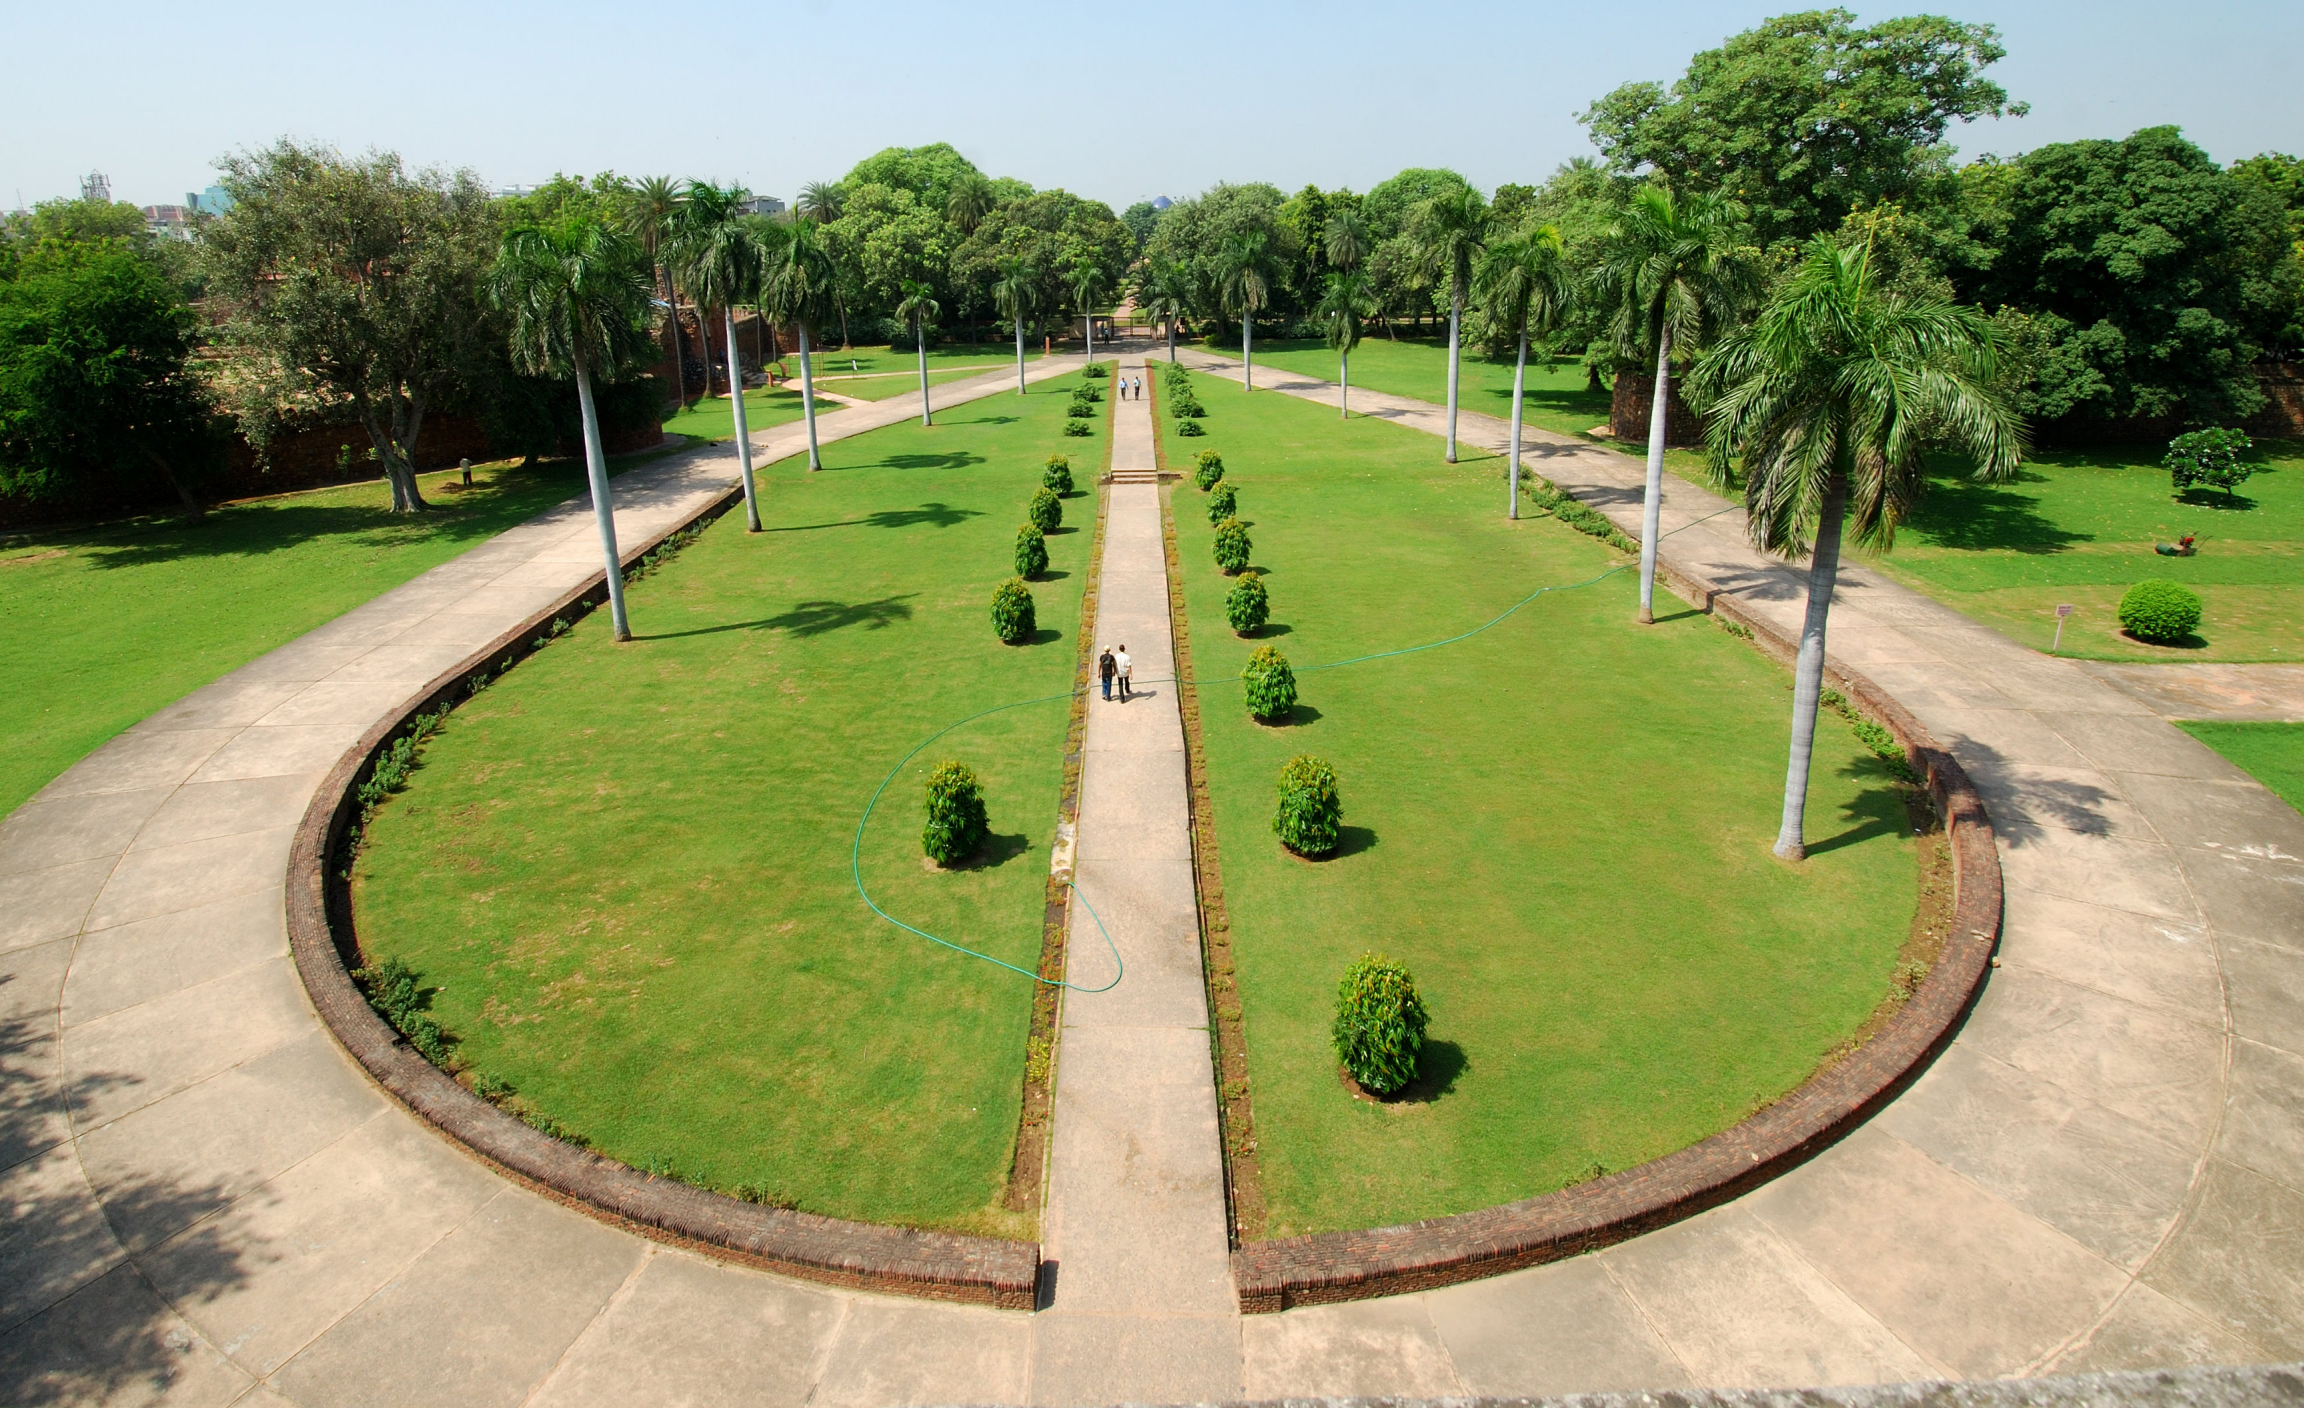
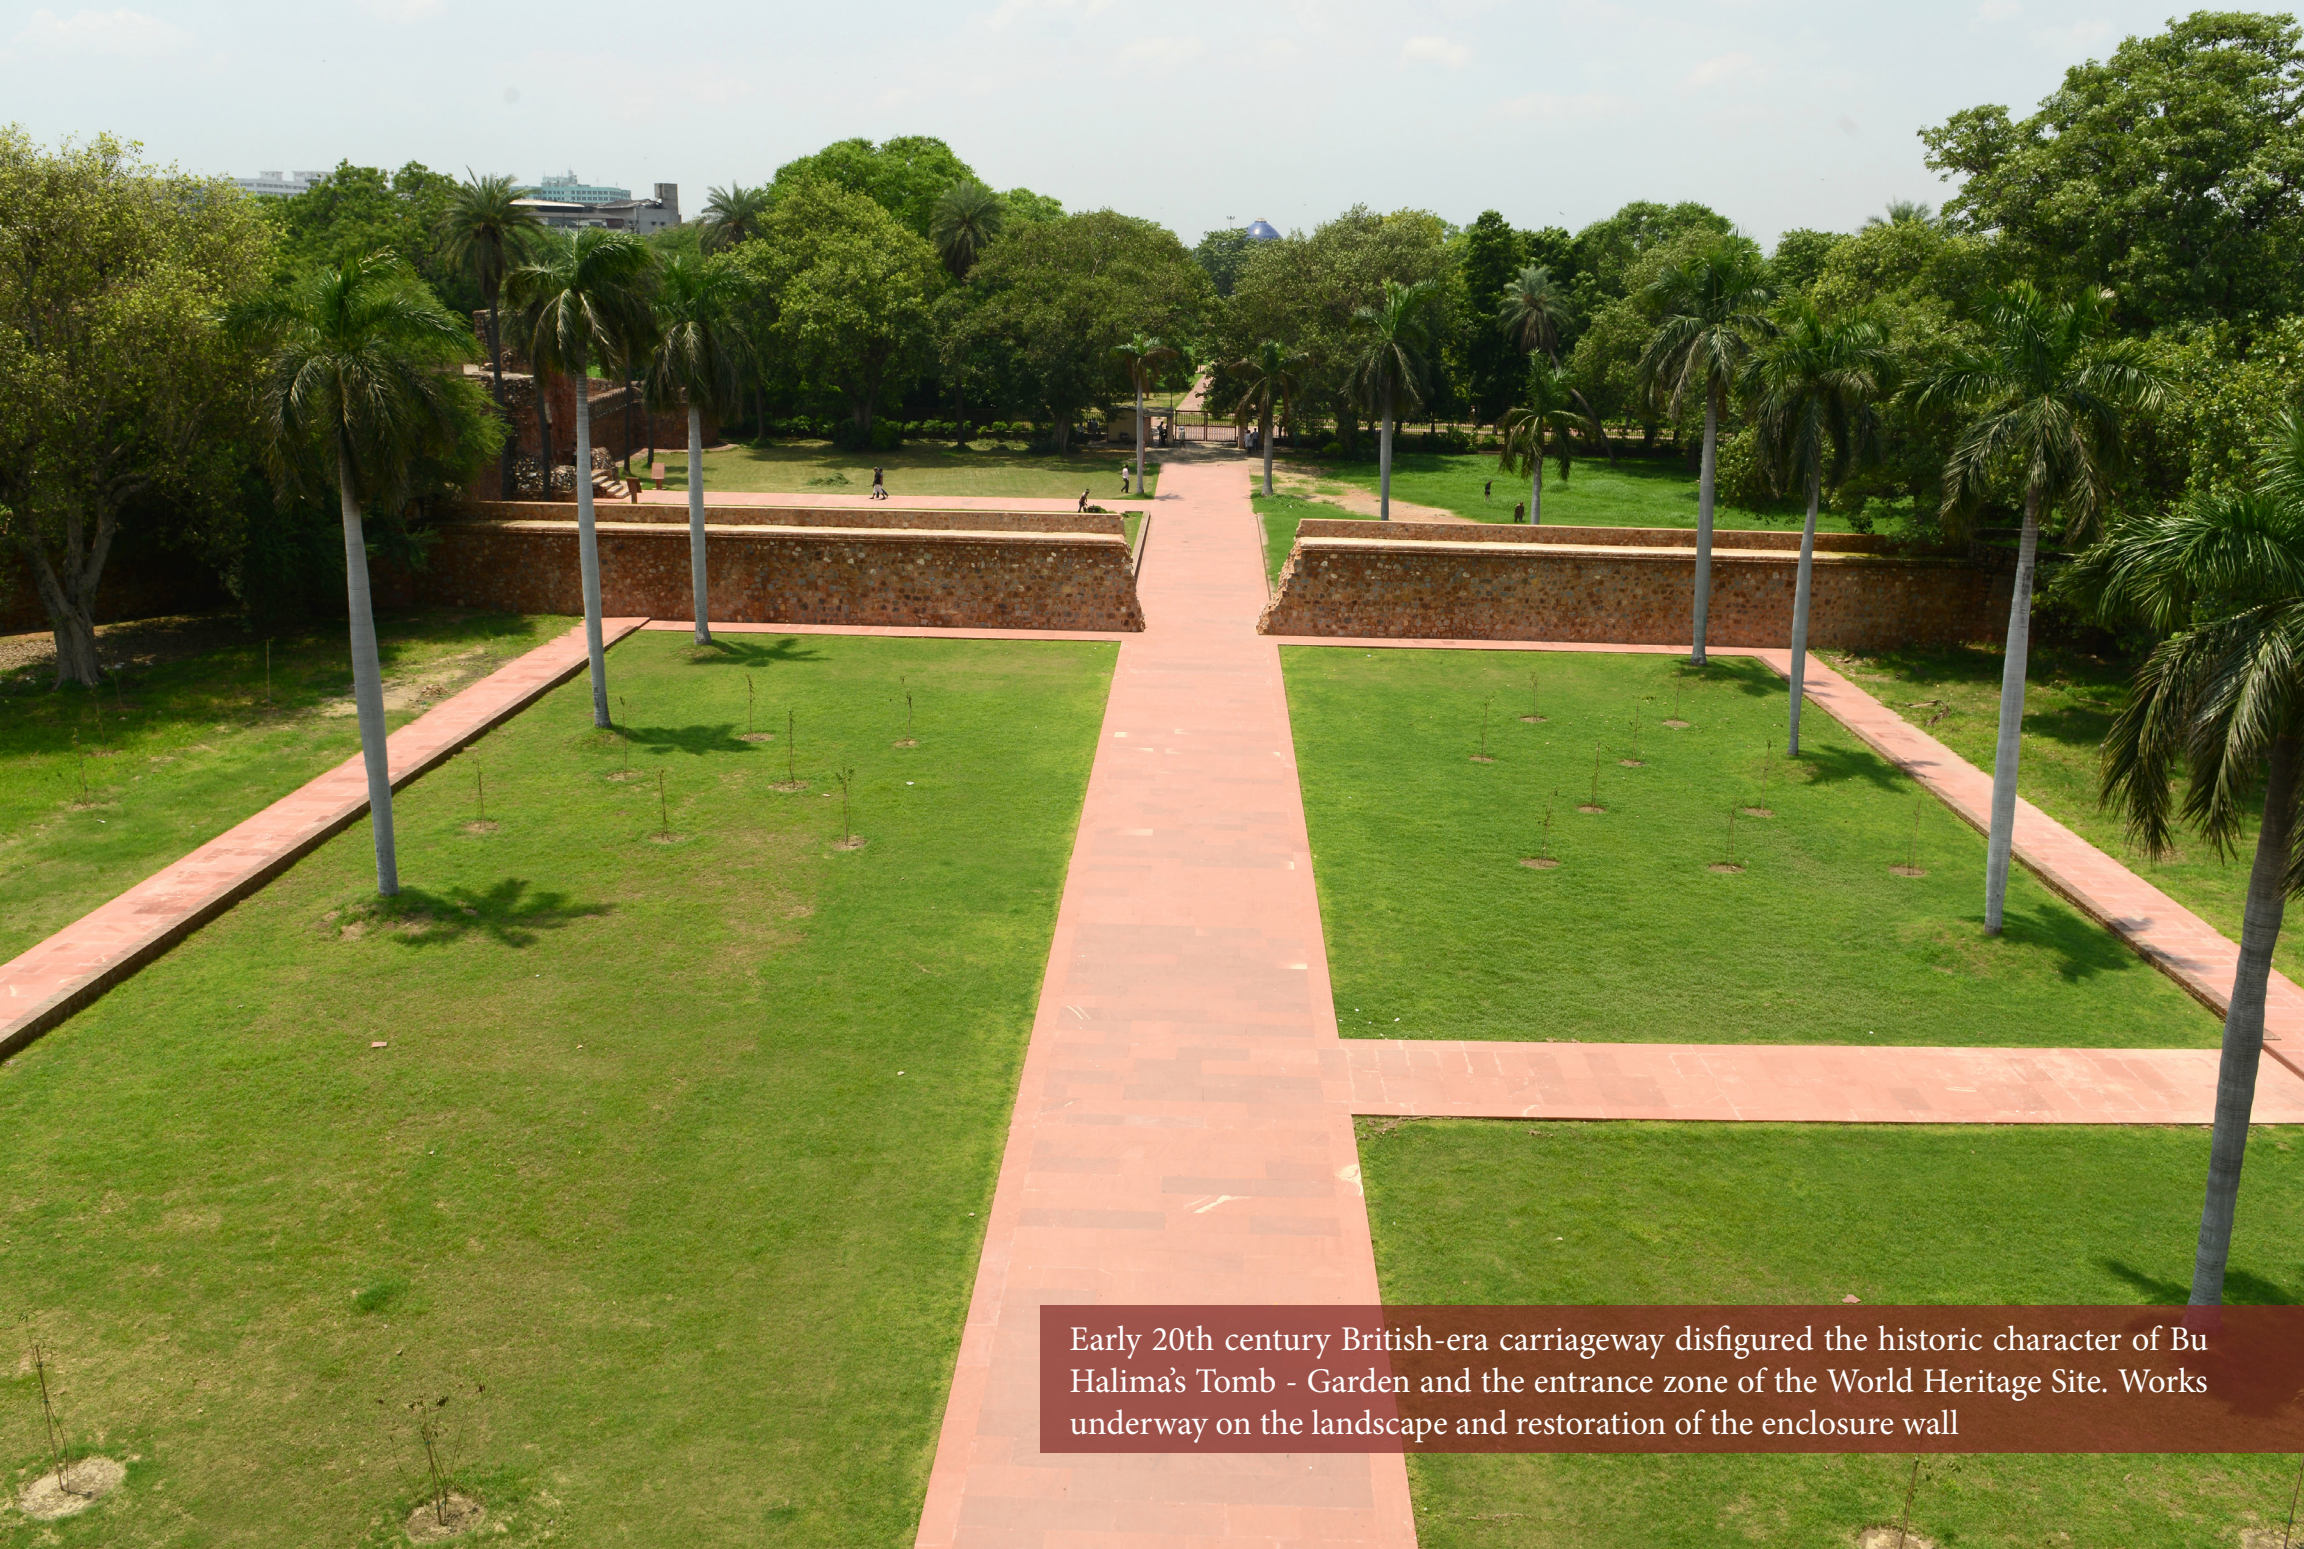
Bu Halima Garden (2011)

Early 20th century British-era carriageway disfigured the historic character of Bu Halima's Tomb - Garden and the entrance zone of the World Heritage Site. Works underway on the landscape and restoration of the enclosure wall
