PROJECT CONSERVATION

Nizamuddin Urban Renewal Initiative

a People Public | Private Partnership

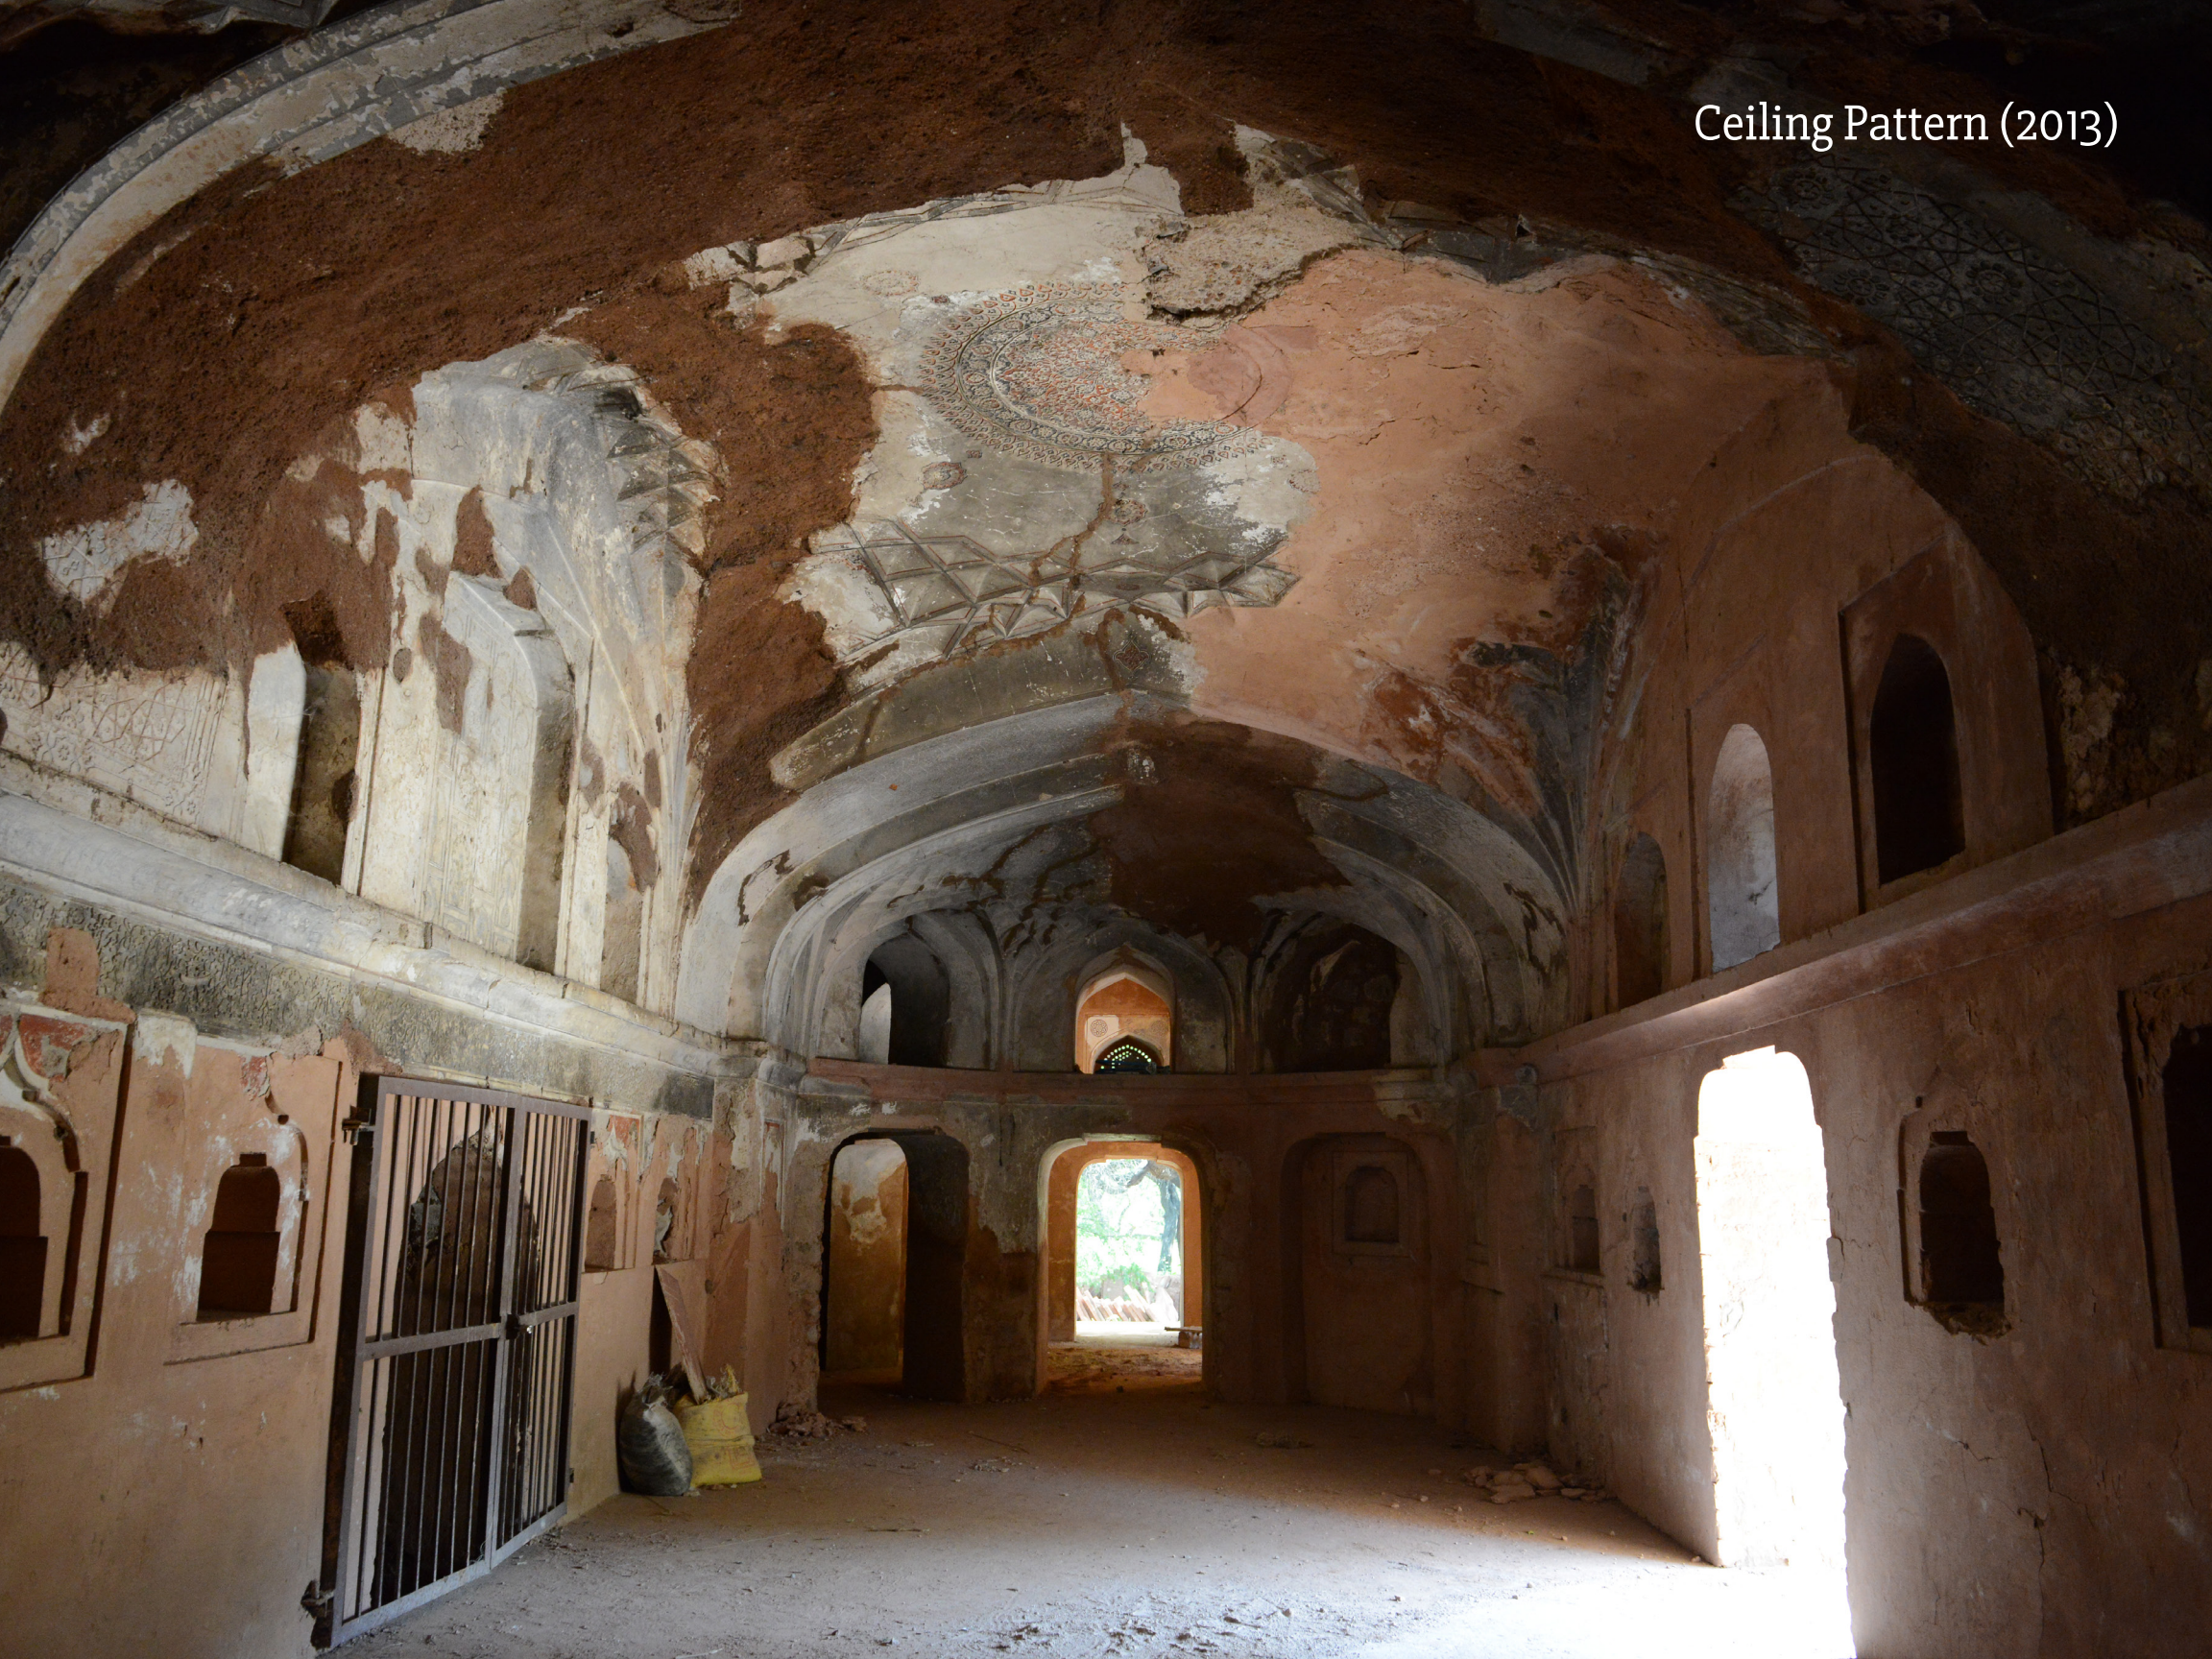
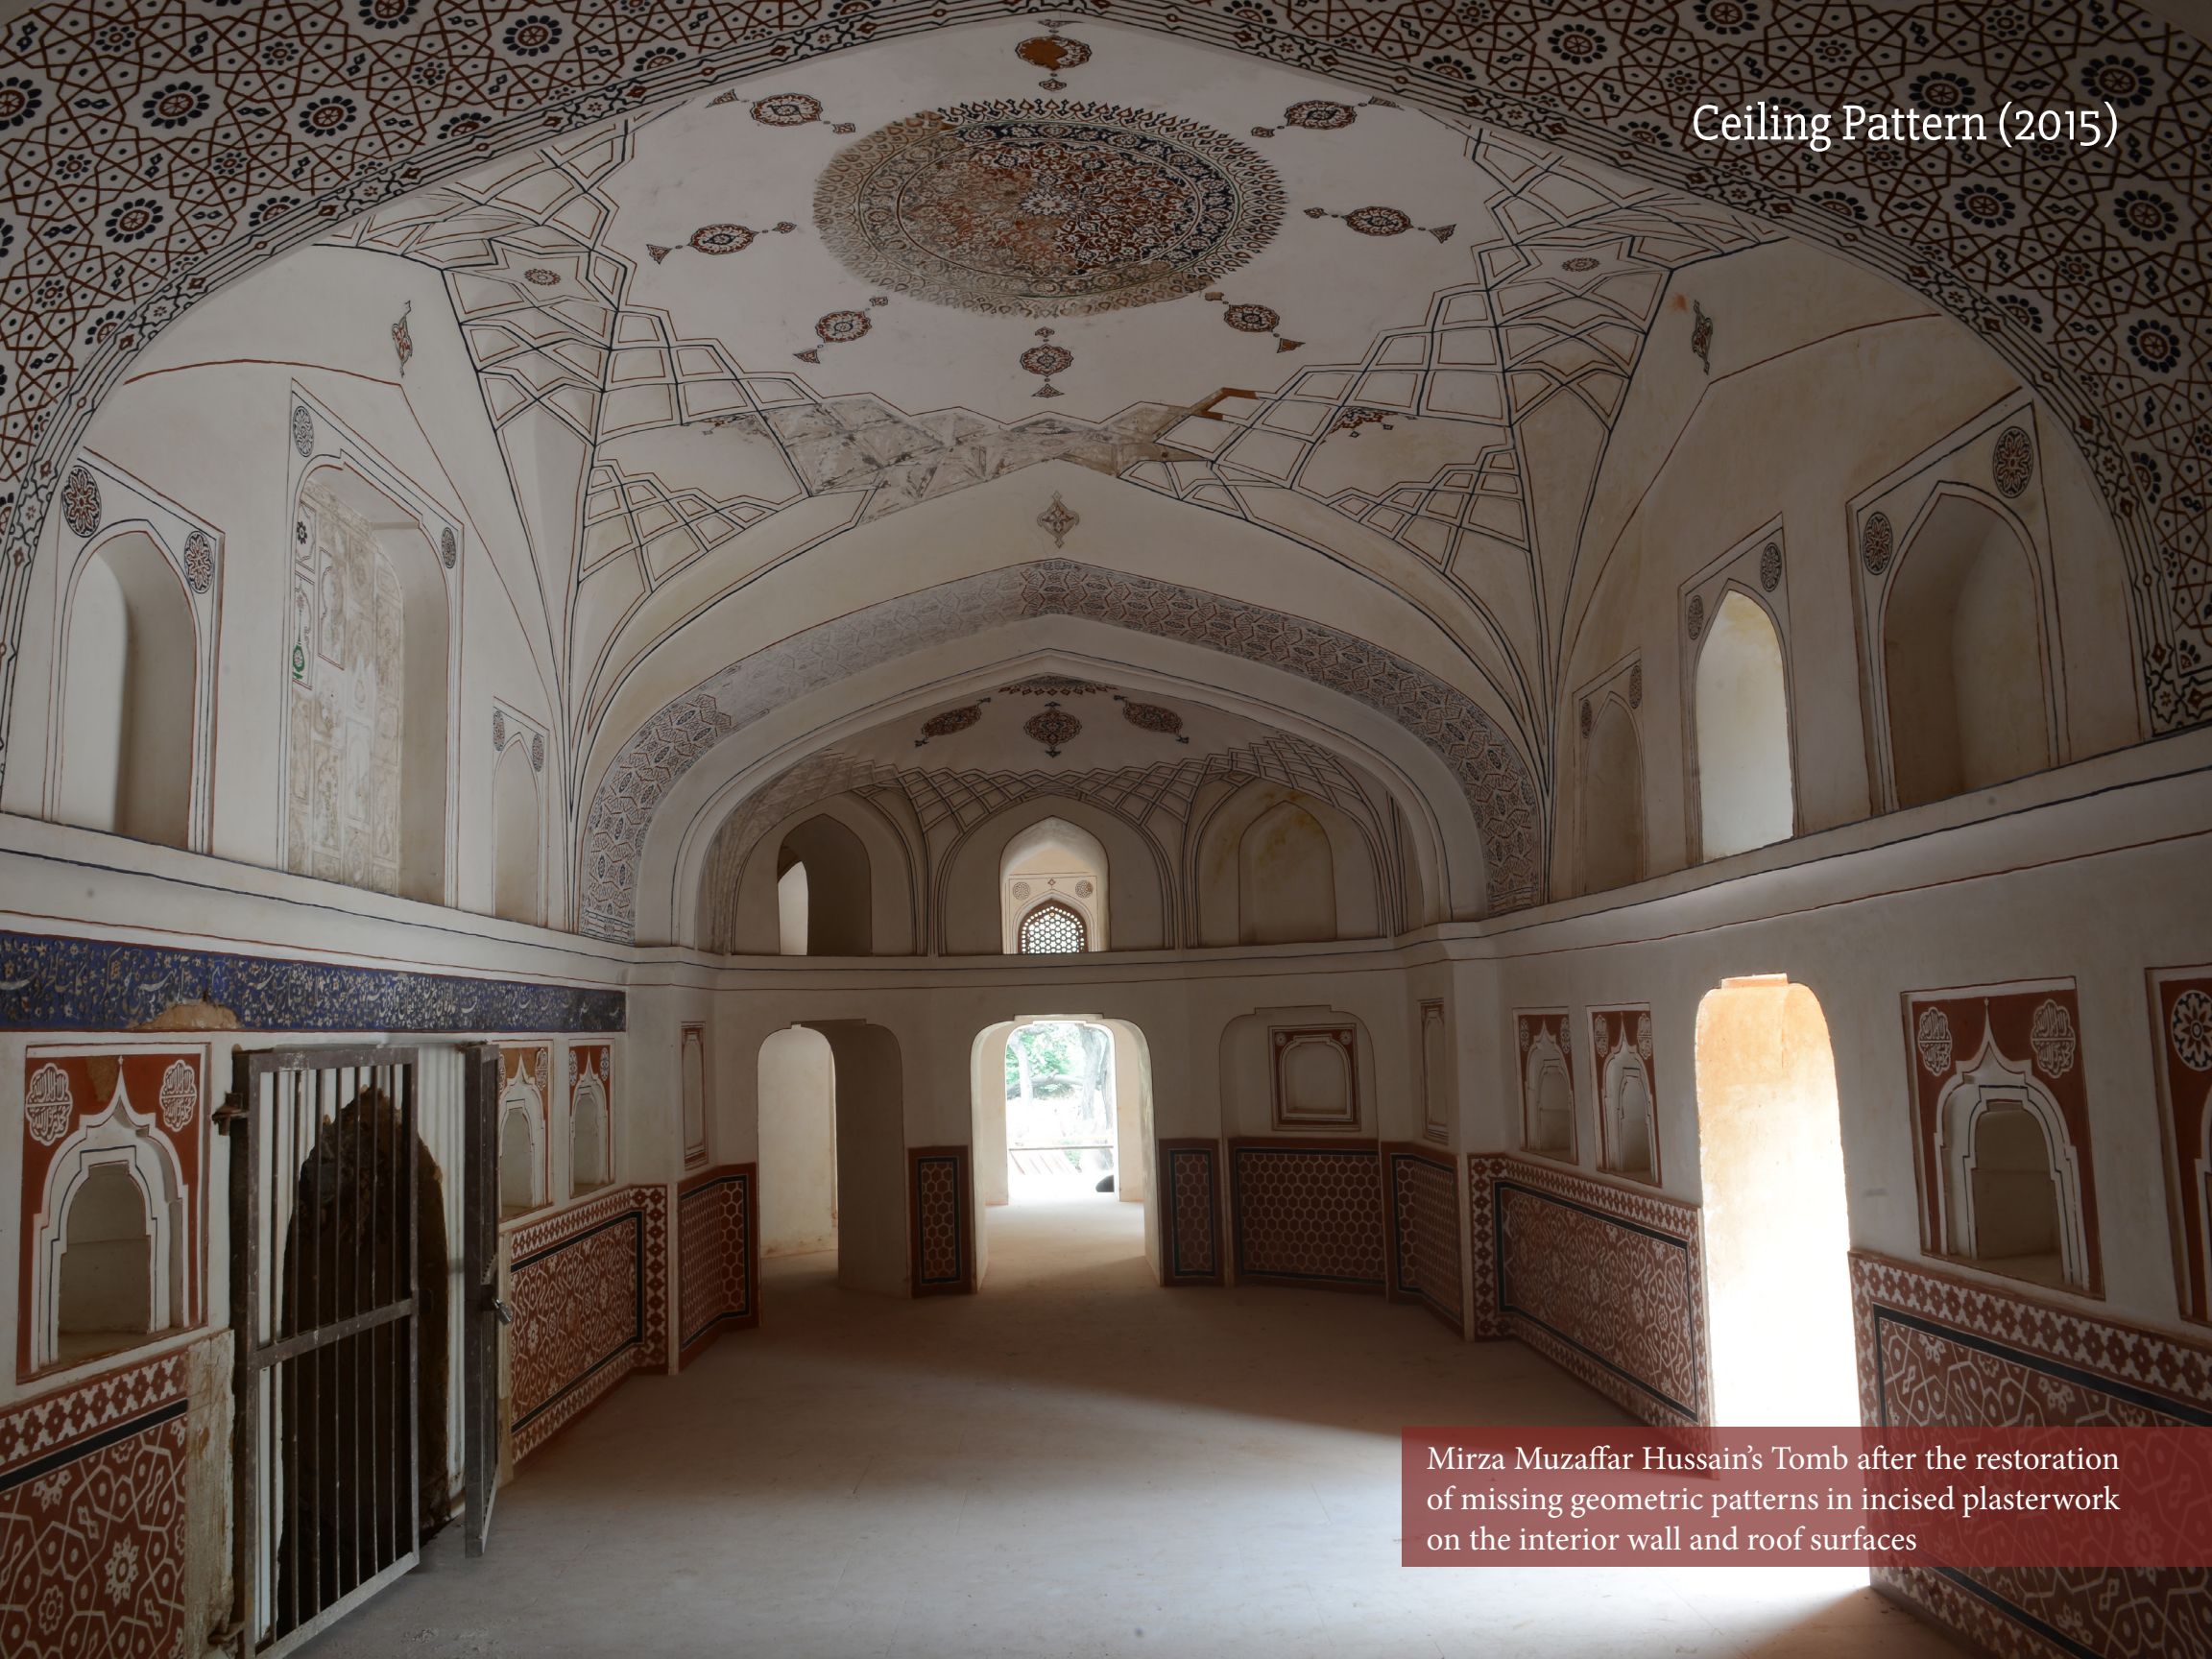
Mirza Muzaffar Hussain's Tomb after the restoration of missing geometric patterns in incised plasterwork on the interior wall and roof surfaces

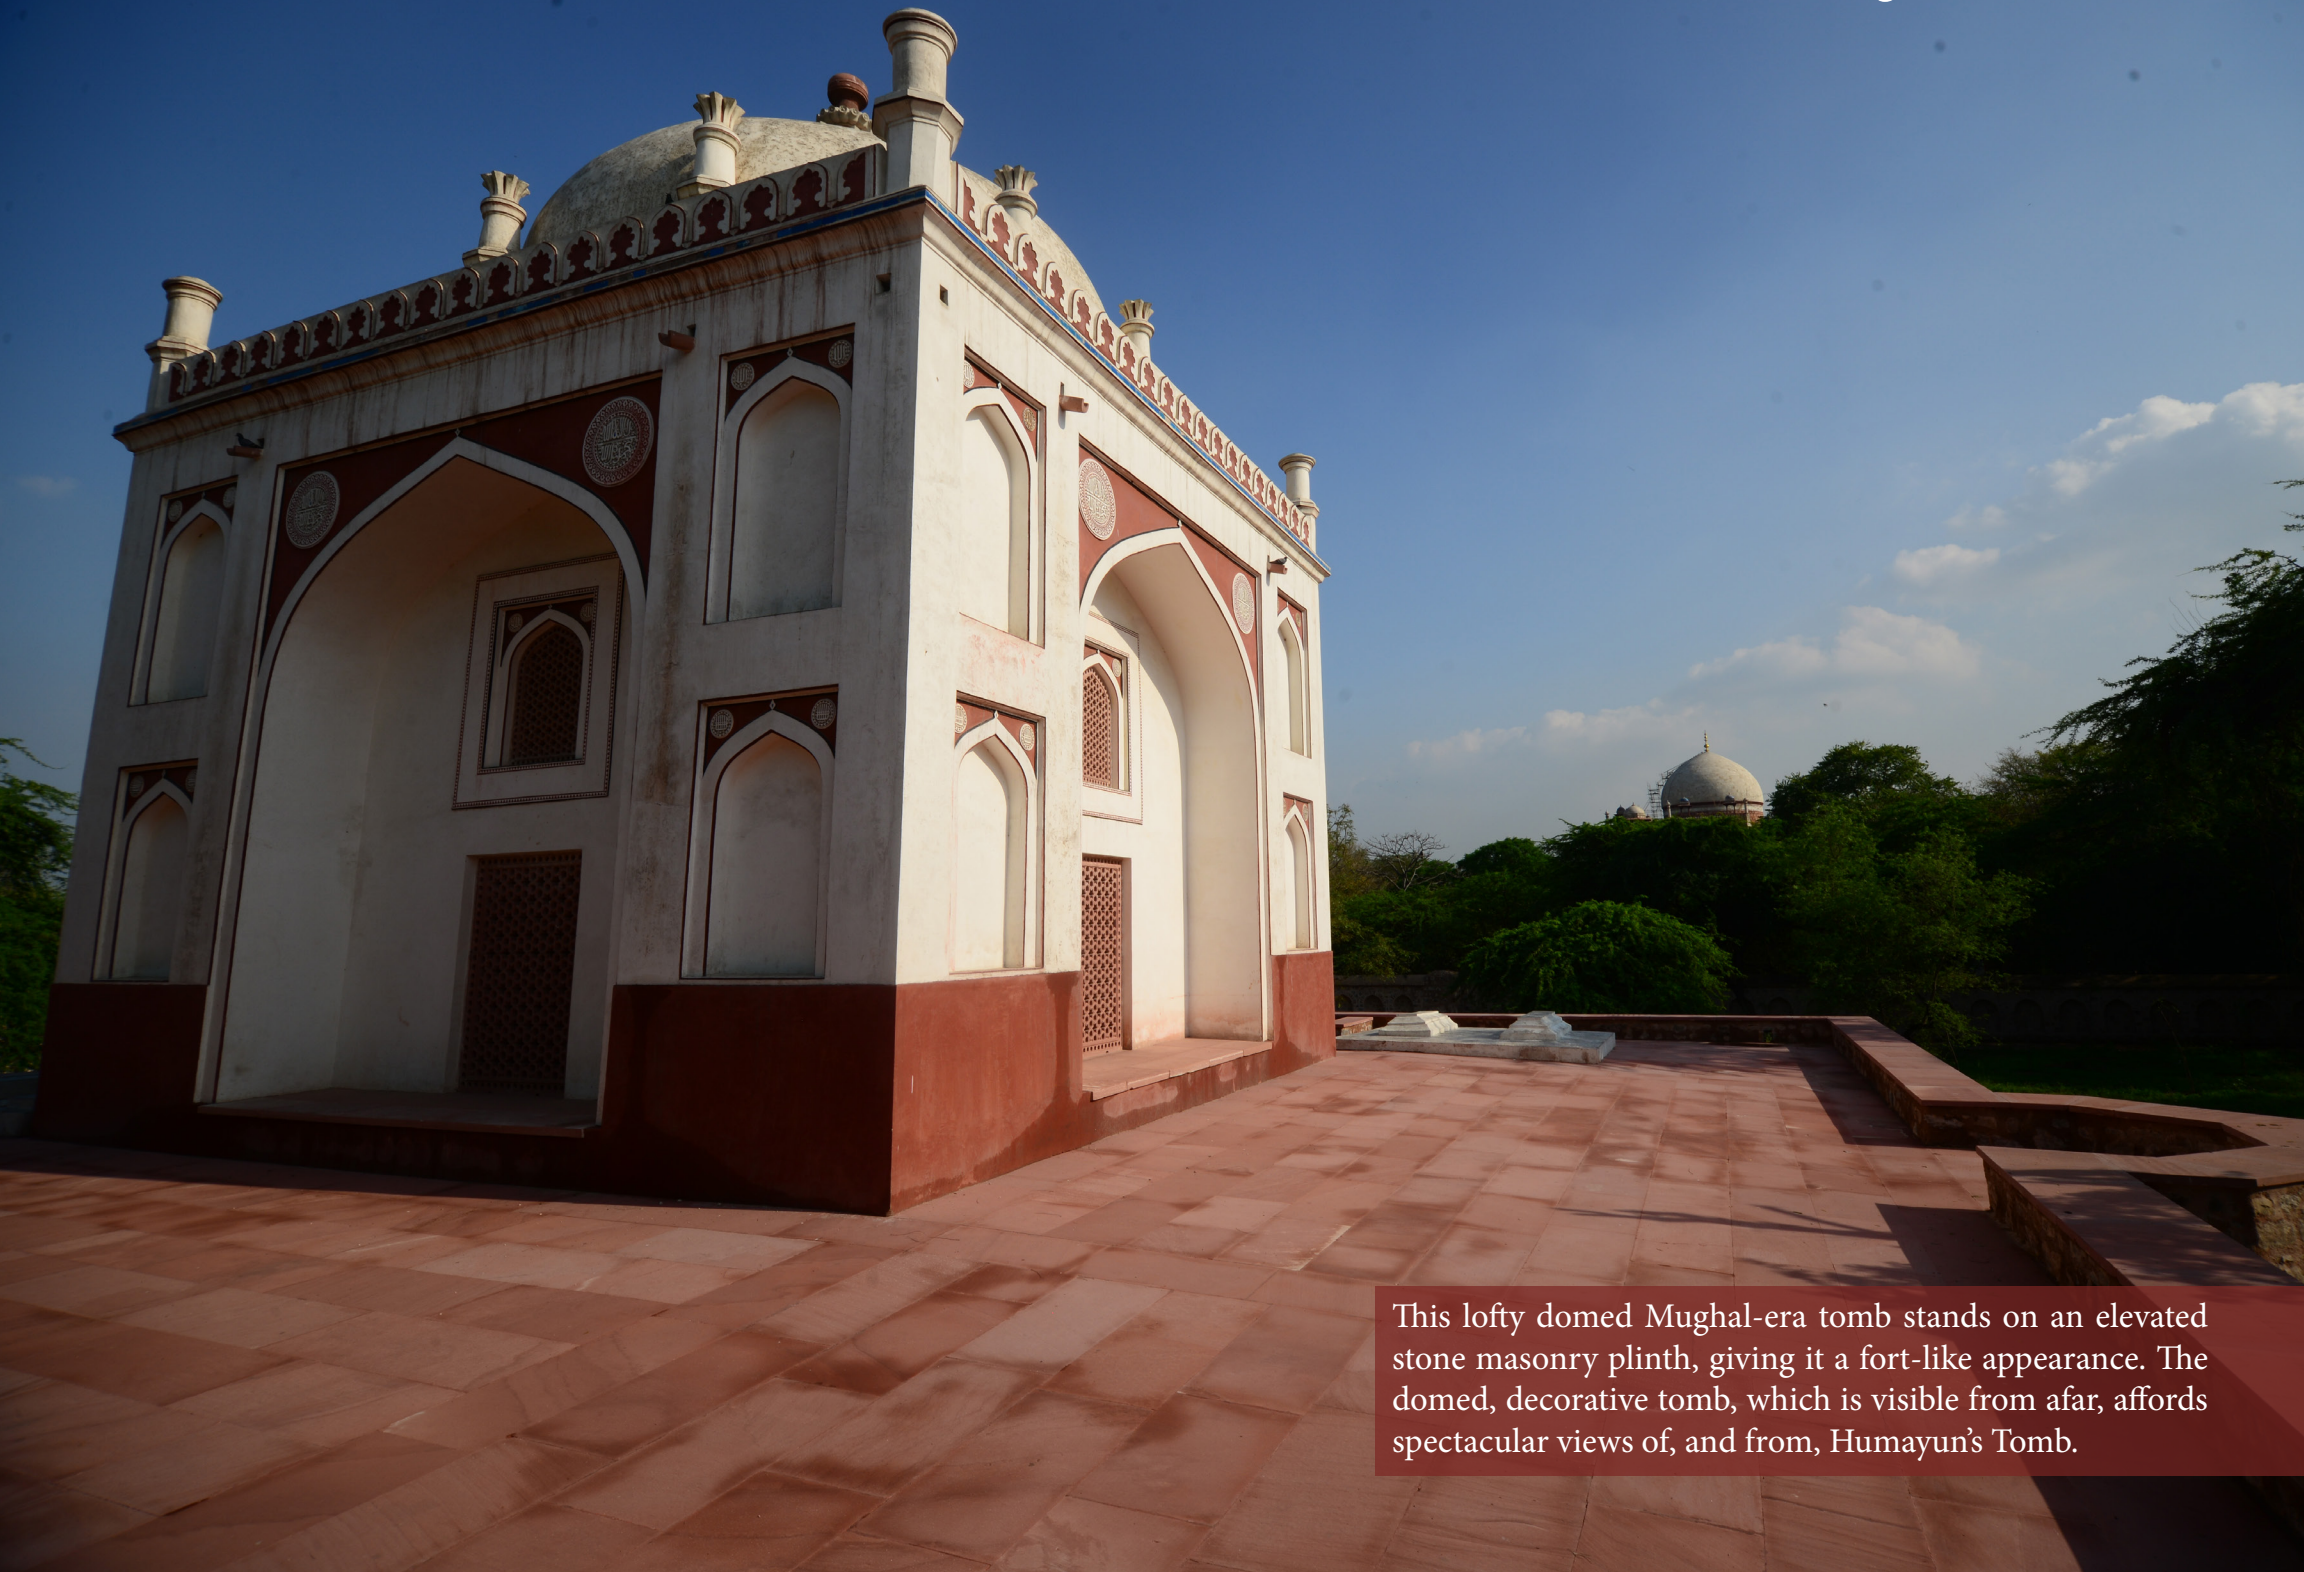
Mughal Tomb 2015

This lofty domed Mughal-era tomb stands on an elevated stone masonry plinth, giving it a fort-like appearance. The domed, decorative tomb, which is visible from afar, affords spectacular views of, and from, Humayun's Tomb.

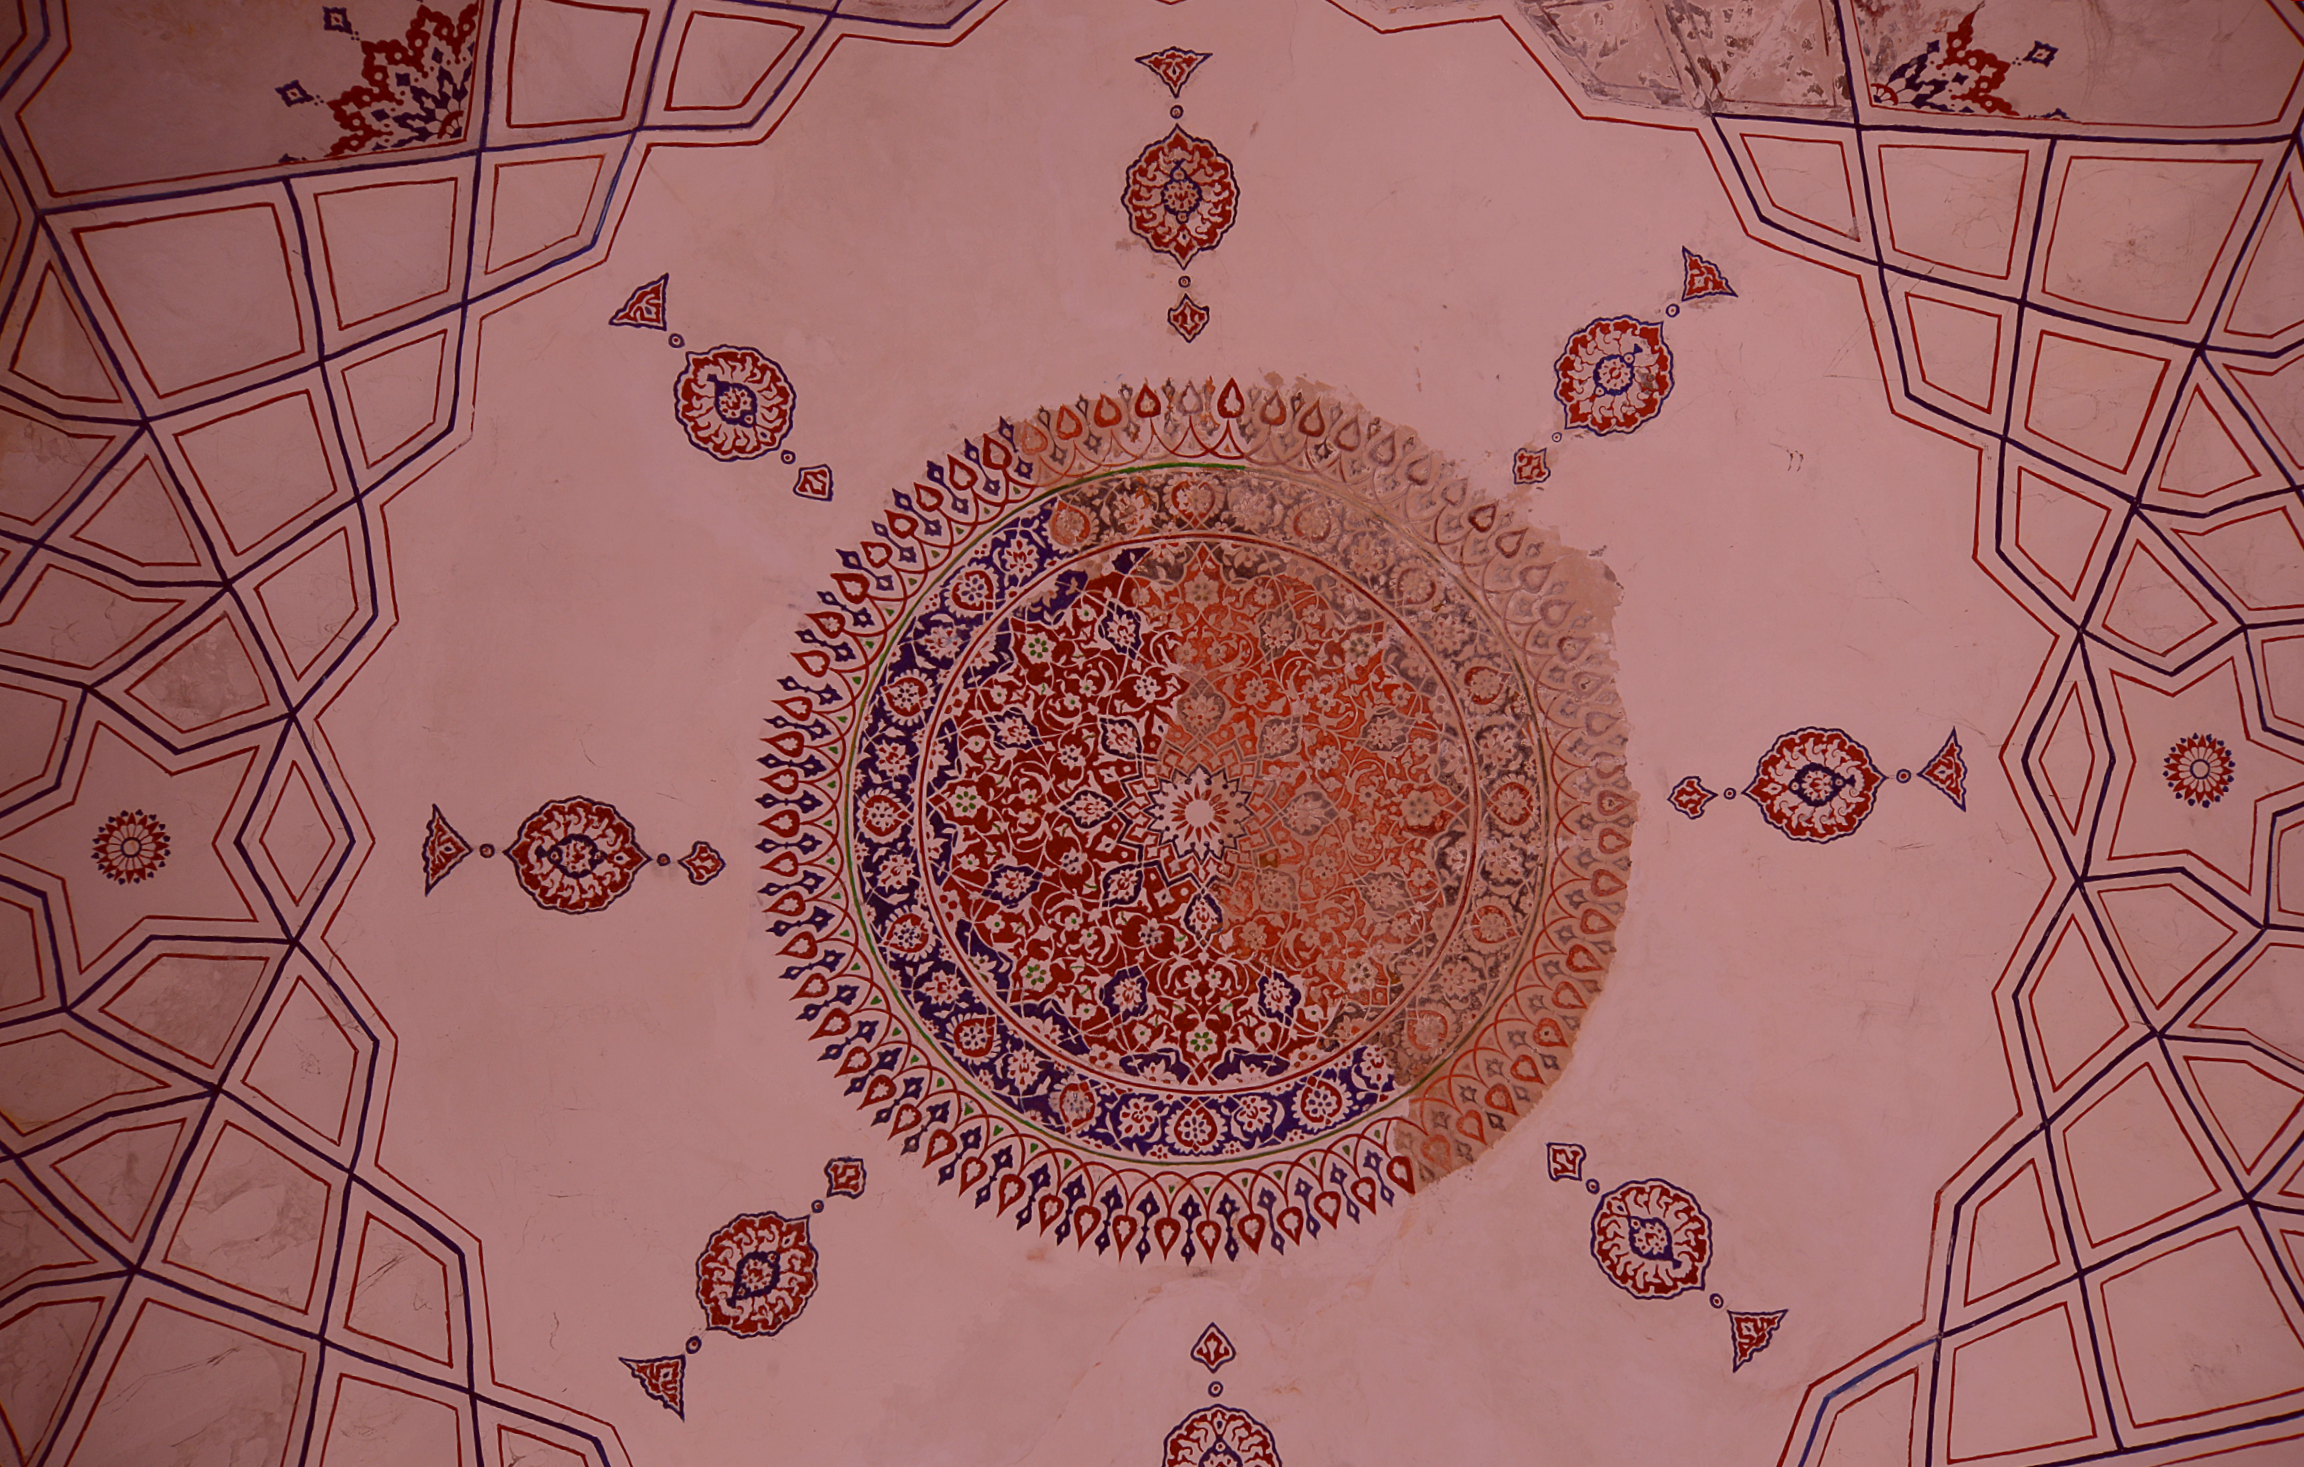
Collapsed portion of the Serai were carefully stabilized by master craftsmen building with techniques and materials used by the original builders.
